# Sealing leaking connections into a stormwater manhole

*Storm drainage infiltration, sinkholes, stopped with polyurethane chemical grout injection*

**Client:** Military housing community, Richmond, Va.

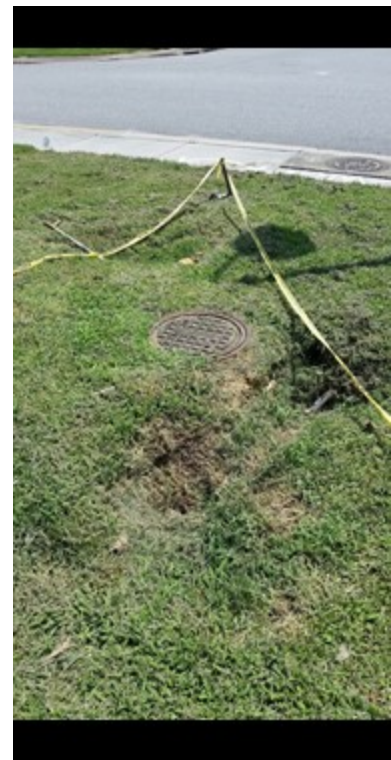
**Identifying the source:** To pinpoint the sources of the problem, the contractor's crew **flooded the existing sinkholes and monitored the dry manhole** to see where the infiltration entered. It was clear from accumulated sediment that some infiltration had occurred where the manhole barrel meets the bench; however, the flooding showed multiple additional infiltration points further up the structure. There were a few leaking cracks, but the **connection of the inlet pipe from the surface catch basin and the connection of the storm main near the bench** were the sources of most leaks. These connections have brick aprons that have been surface sealed. There were no rubber gaskets (boots) present. Water leaked between the bricks through cracks in the surface seal.
