Large Diameter Pipes

2nd generation rehabilitation – Severely deteriorated 89” diameter concrete pipe

City of Everett, Washington

89” diameter pipeline in Everett, Washington

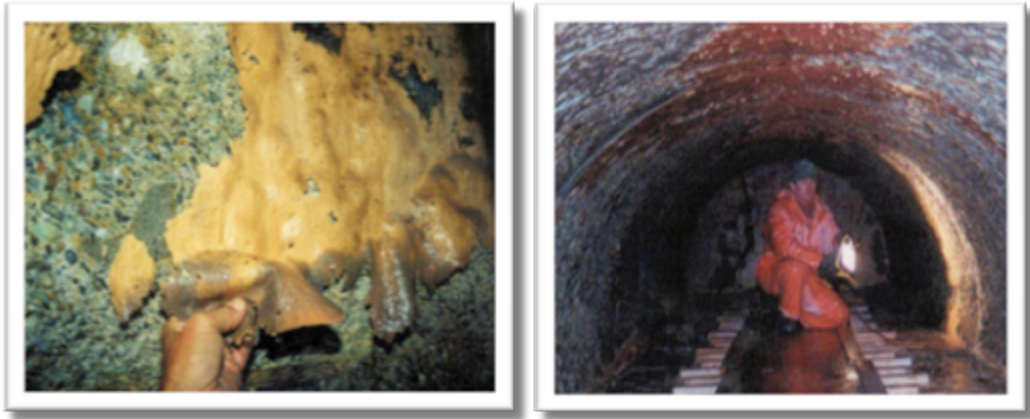
This pipeline had previously been rehabilitated with an epoxy coating. Pinholes in the coating system had allowed sewer gases to continue to attack the host structure, resulting in failure of the coating and further deterioration of the pipe. Pipe has benches or shelves in the bottom forming a channel for the sewage flow.

Upper Left: Epoxy has failed due to pinholes in the coating allowing gas penetration to further attack the host structure.

Upper Right: Structure has been thoroughly pressure cleaned and remains of epoxy coating removed. Structure is now prepared for the Poly-Triplex installation.

Poly-Triplex Certified Installer bridged the flow in the channel with a sub-floor and allowed the sewage to flow underneath, saving the city many thousands of dollars. The liner was then pulled through, inflated with an internal bladder and cured-in-place from waterline to waterline.

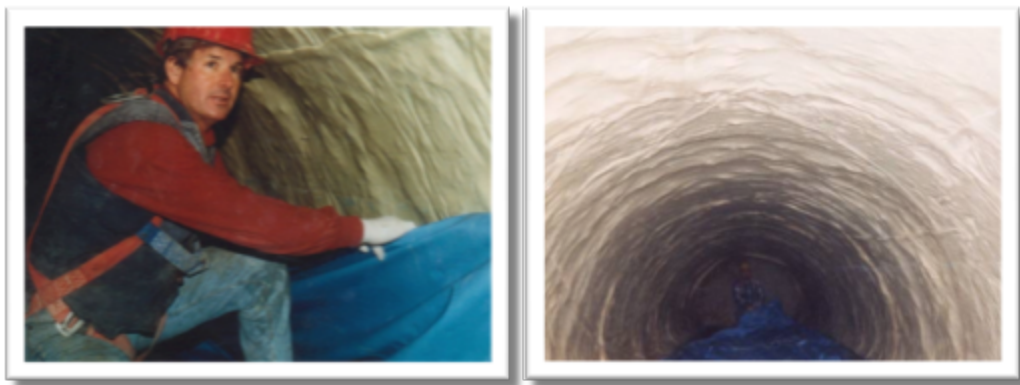
Upper Left: Poly-Triplex Liner has been cured-in-place using the removable inflation bladder.

Upper Right: Inflation bladder is removed to reveal a completely monolithic and permanent rehabilitation.
