Environmental – Case Study 2

Severe infiltration of lake-to-lake equalizer control pipe

Rehabilitation of lake-to-lake equalizer control pipe

Georgia Department of Natural Resources

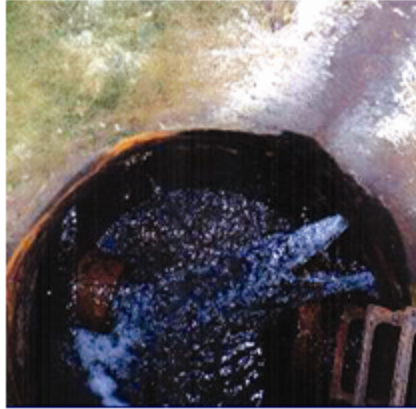
Vertical overflow control pipe structure is located approximately 18 feet inside the lake in Tifton, GA with problems of deterioration and infiltration. Infiltration was impossible to stop with cement or chemical grout. Numerous attempts had been made to solve the problem, with no success.

Upper Left: Photo of severe infiltration of lake water flooding through the wall of this structure.

Working from a barge, the Poly-Triplex Liner was installed. The liner was inflated with air pressure sufficient to hold back the hydrostatic head pressure until the liner was cured-in-place and bonded to the host structure. Installation was complete, start to finish, in one day.

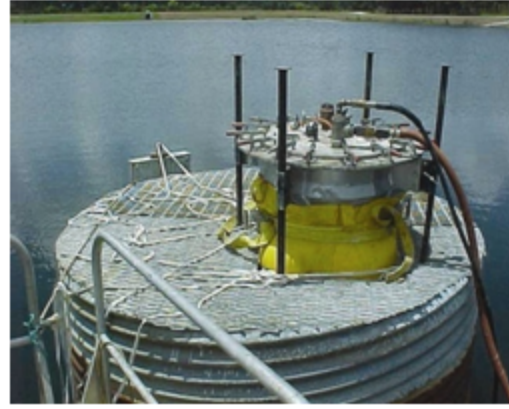
Upper Right: Photo of the Poly-Triplex Liner being cured in place 18 feet out into the lake.

The Poly-Triplex Liner completely stopped the infiltration and ex-filtration as well as further deterioration.
