36" PCCP Transmission Main Upgrade

Project Overview

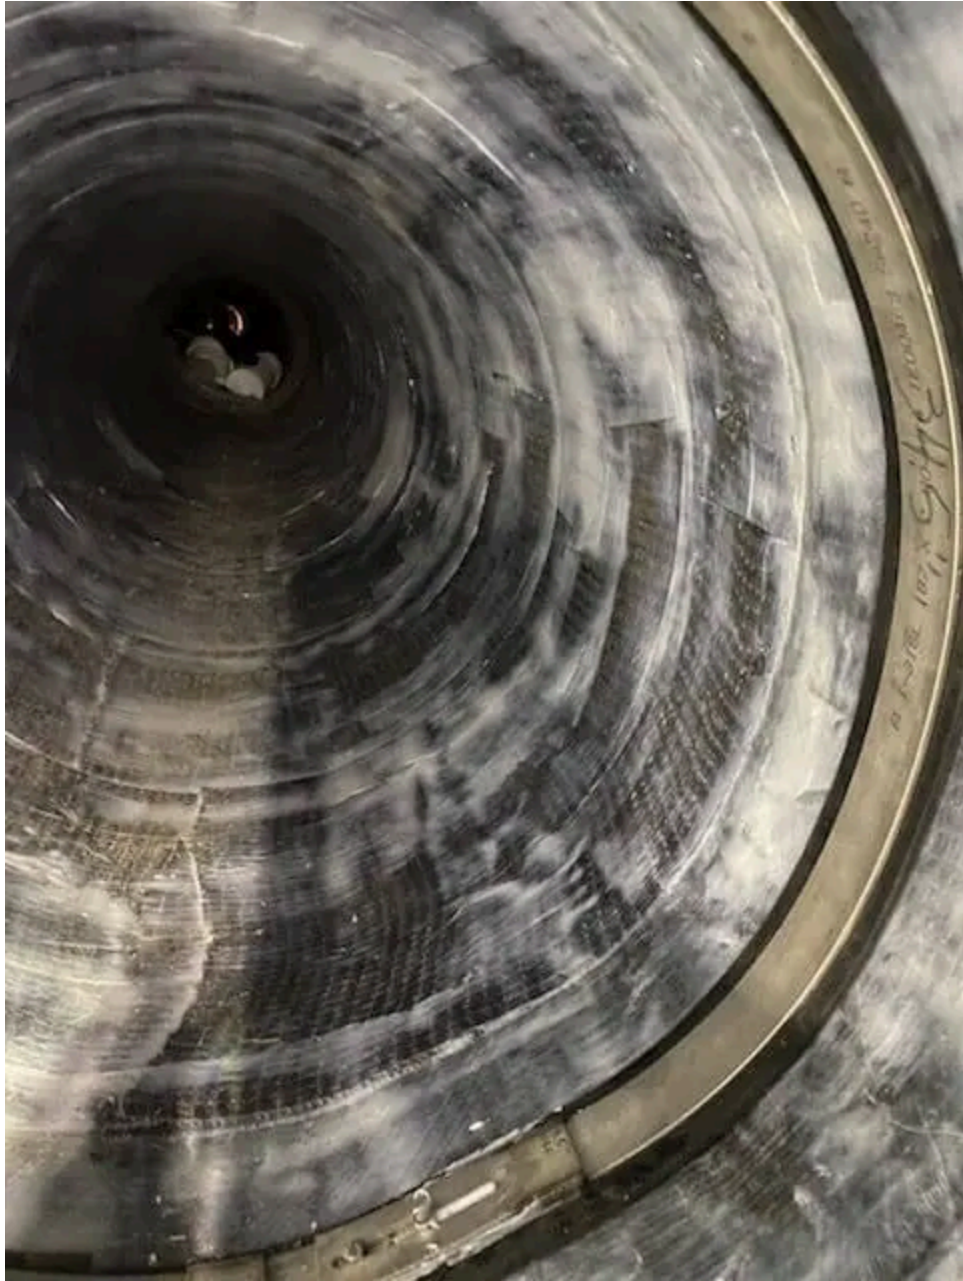
Completed StrongPIPE® V-Wrap™ installation restores the pipe's structural capacity.

STRUCTURAL TECHNOLOGIES StrongPIPE® V-Wrap™ was ultimately selected as the repair solution. Crews internally applied the system on pipe segment 18-17, approximately 16 LF.

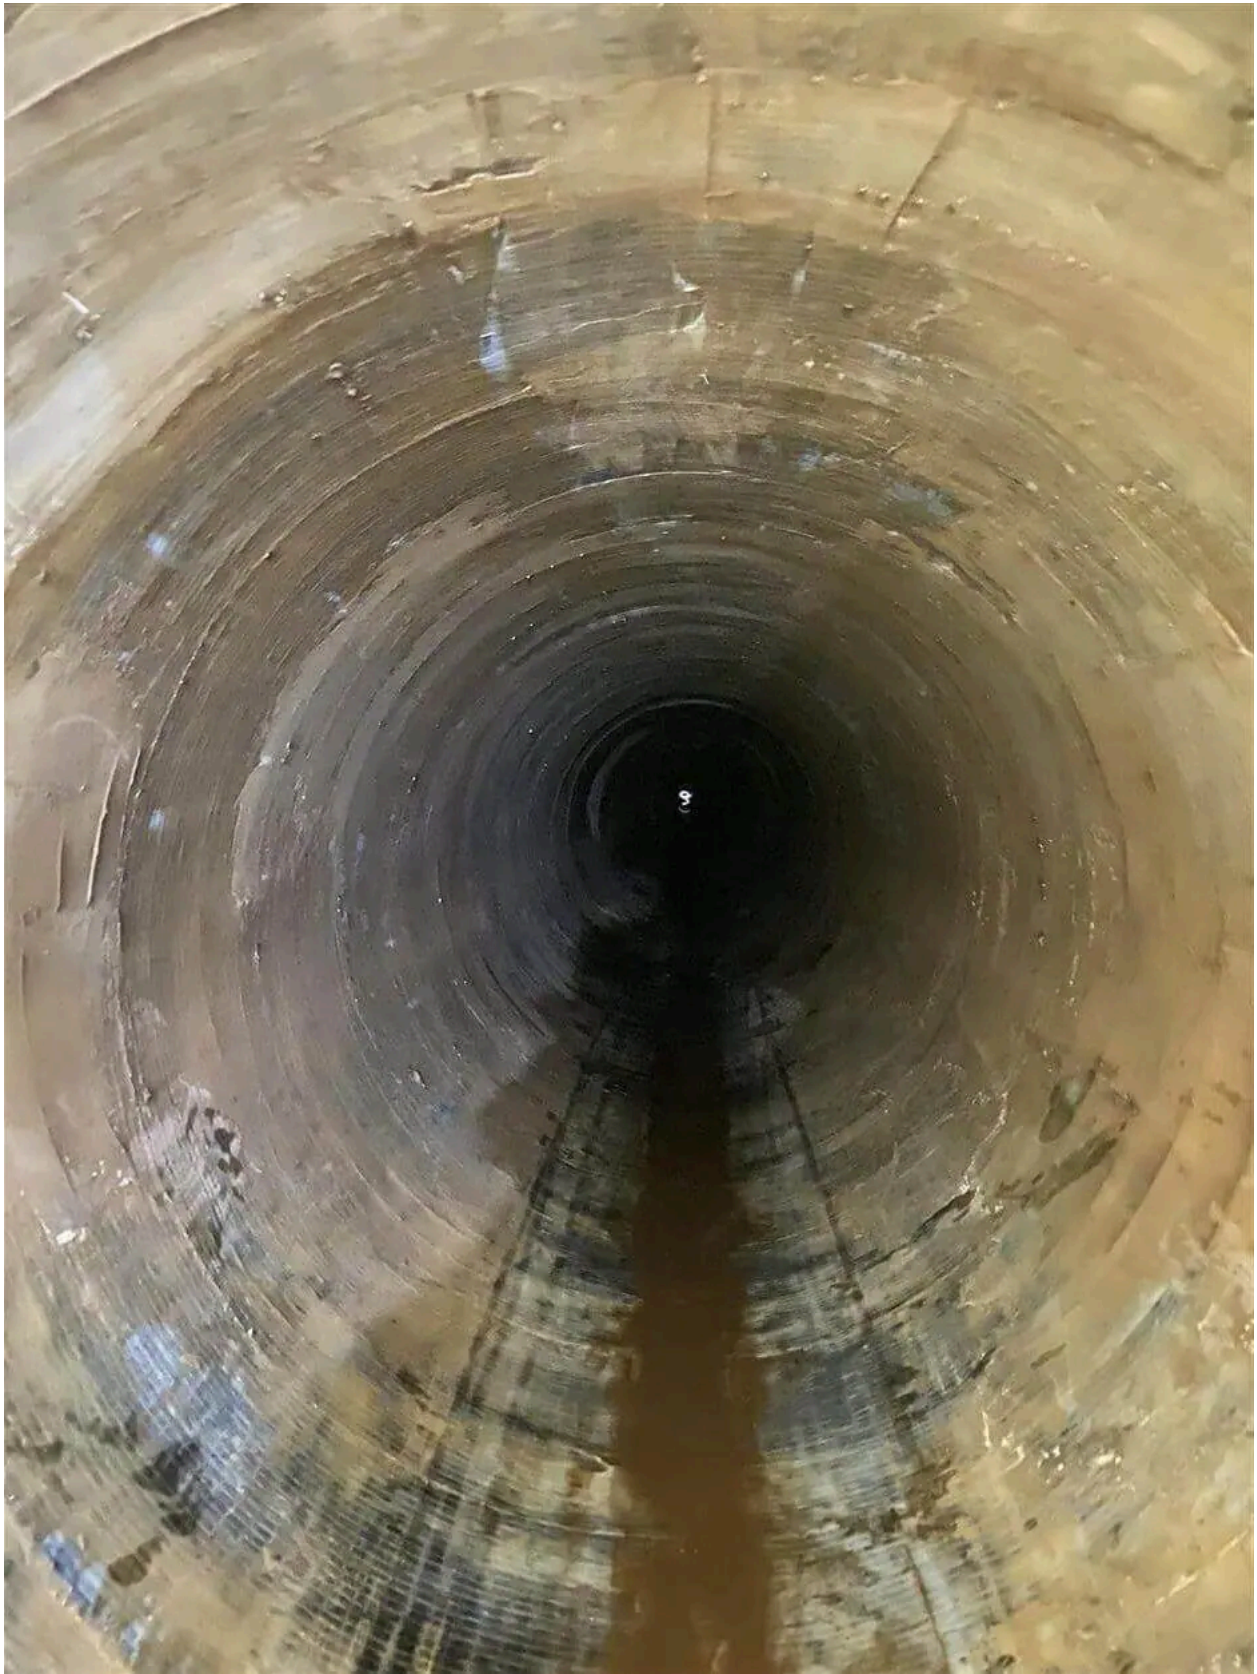
Pipe section before repairs.

When an Acoustic Fiber Optic System (AFO) alerted the City of Baltimore that a 36" PCCP pipe section experienced 21 wire breaks within a 10-day period in Arbutus, MD, the transmission main was shut down for investigation.

The affected pipe section had been repaired previously in the early 2000's but did not conform to current standards. Due to the pipe's location running near several major rail lines, excavating and replacing was not an option as it would impact railroad operations. Therefore, the city sought an internal repair solution to restore the pipeline's capacity.

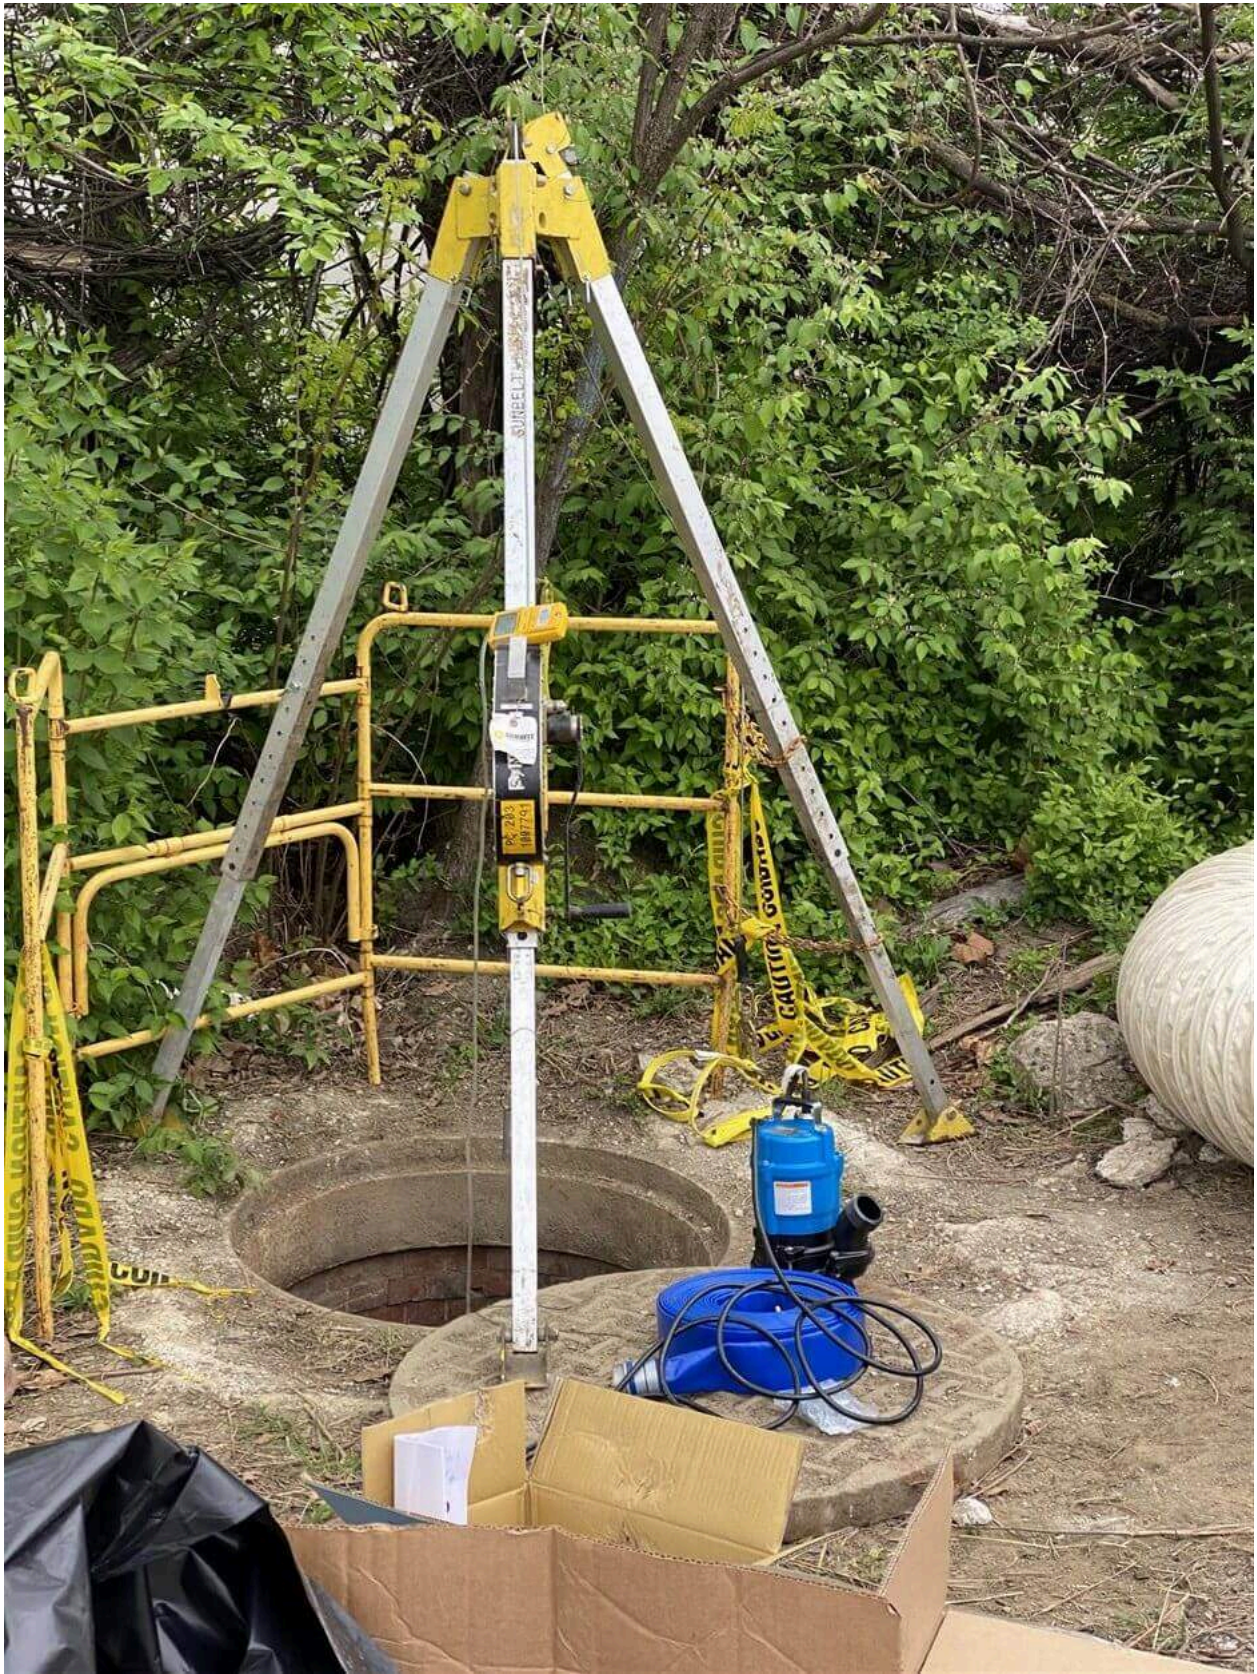
Access point to affected pipe section.

During the repair of this single pipe section, the team faced several access challenges. In a typical repair scenario, two access points are used to allow for proper ventilation. However, in this case, the repair location was 250 ft from a single 24" access point.

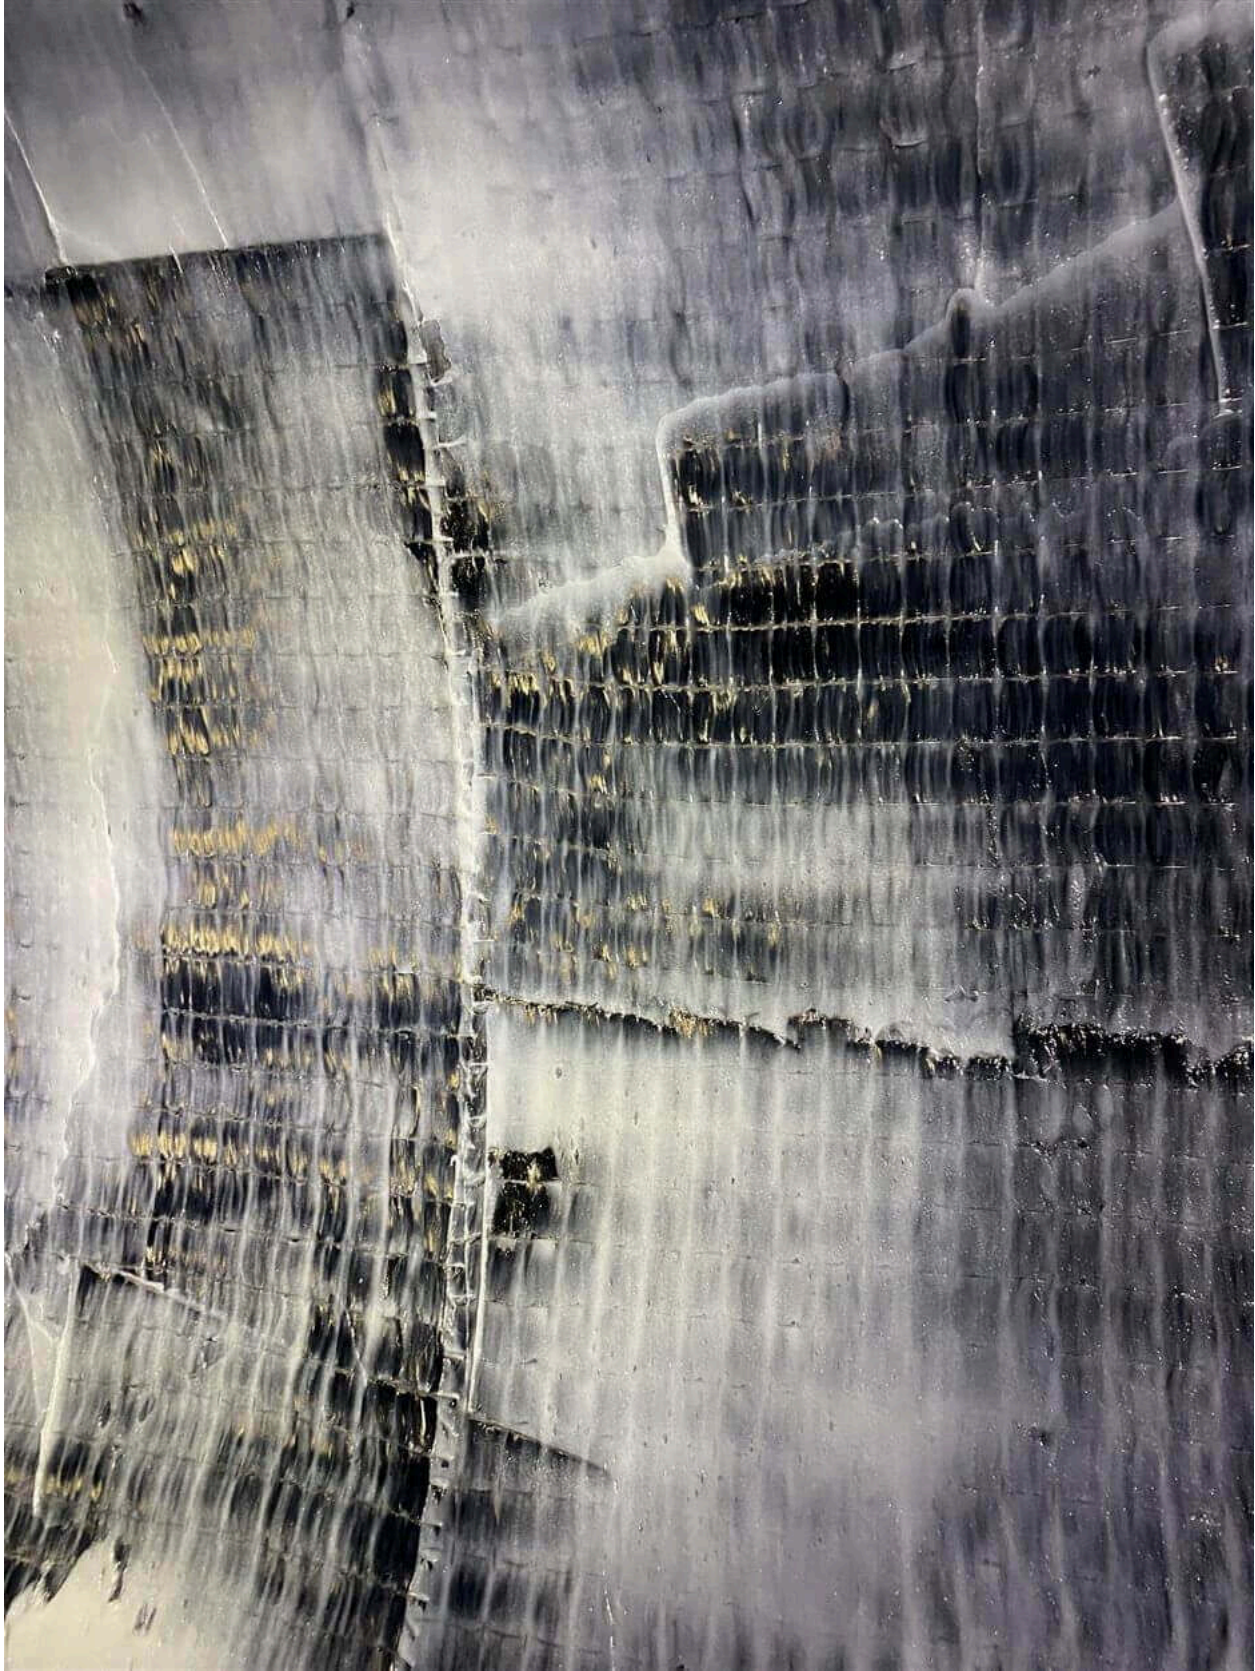
StrongPIPE® V-Wrap™ is internally applied to 16 LF of the pipeline.

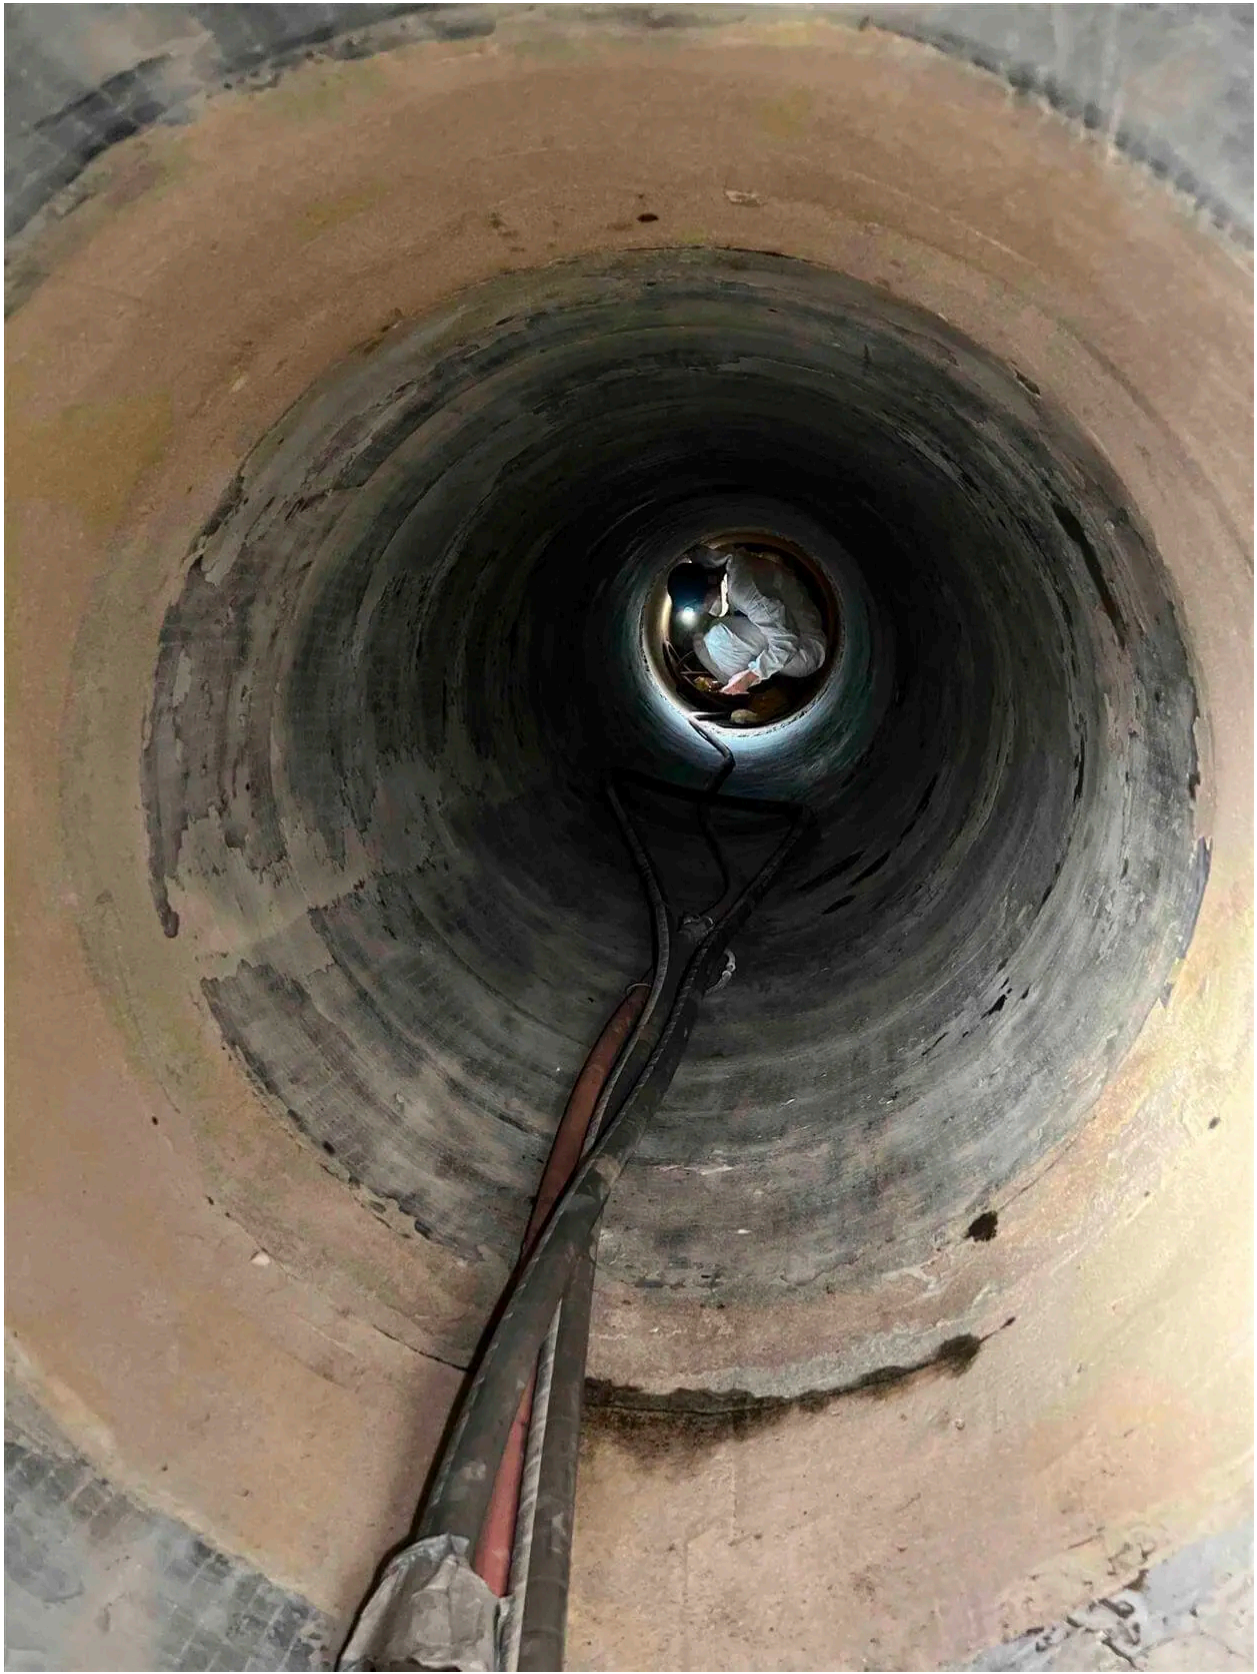
Crews abrasive blast pipe to prepare for installation of upgrade solution.
