# CMP Culvert Lining

**Application:** CMP Culvert Lining

**Client:** Town of Cary, NC

**Location:** Cary, NC

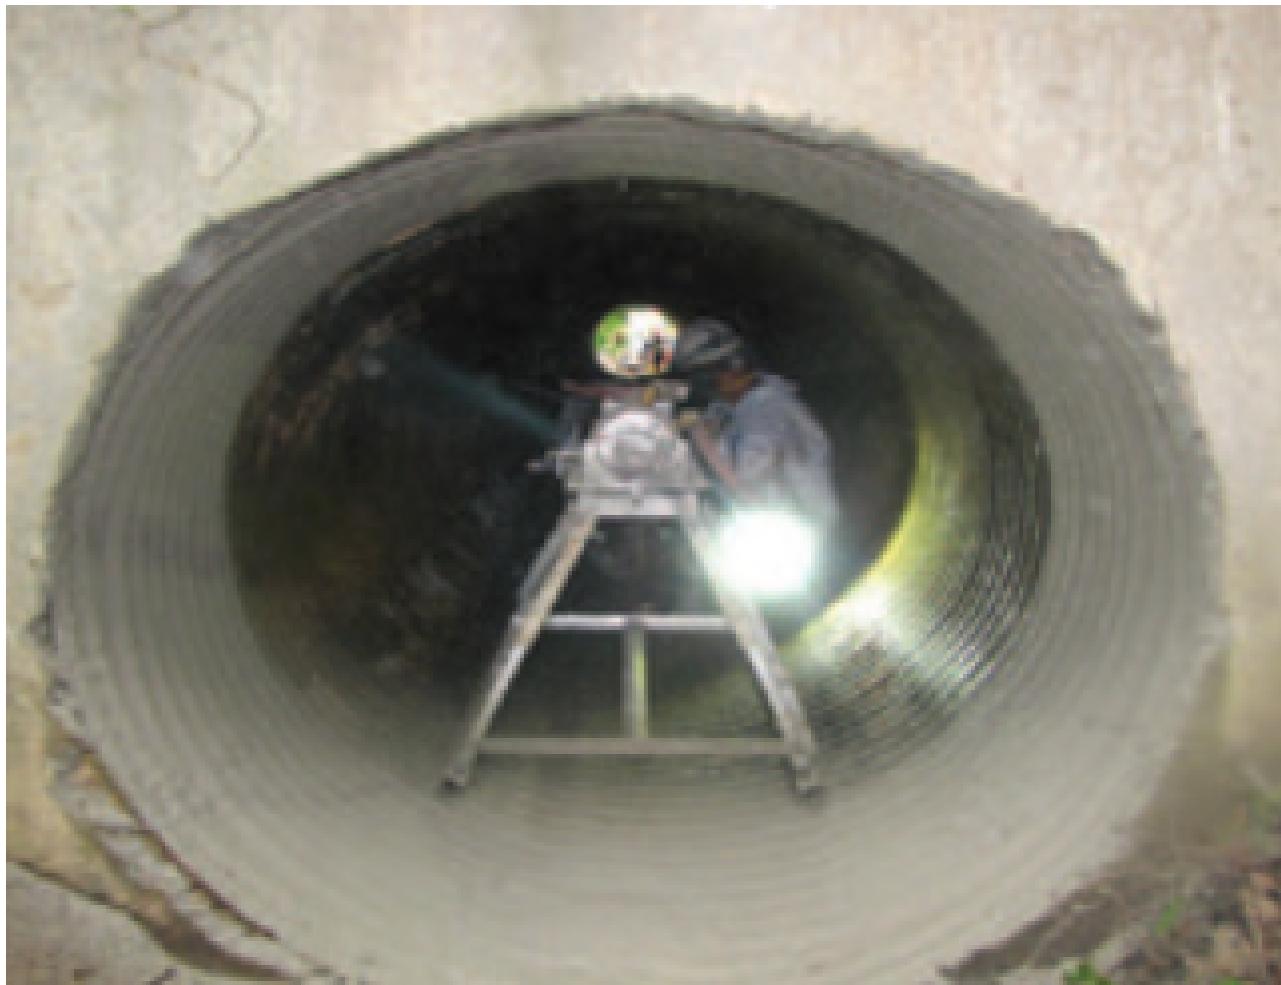
Starting of the GeoSpray Lining.

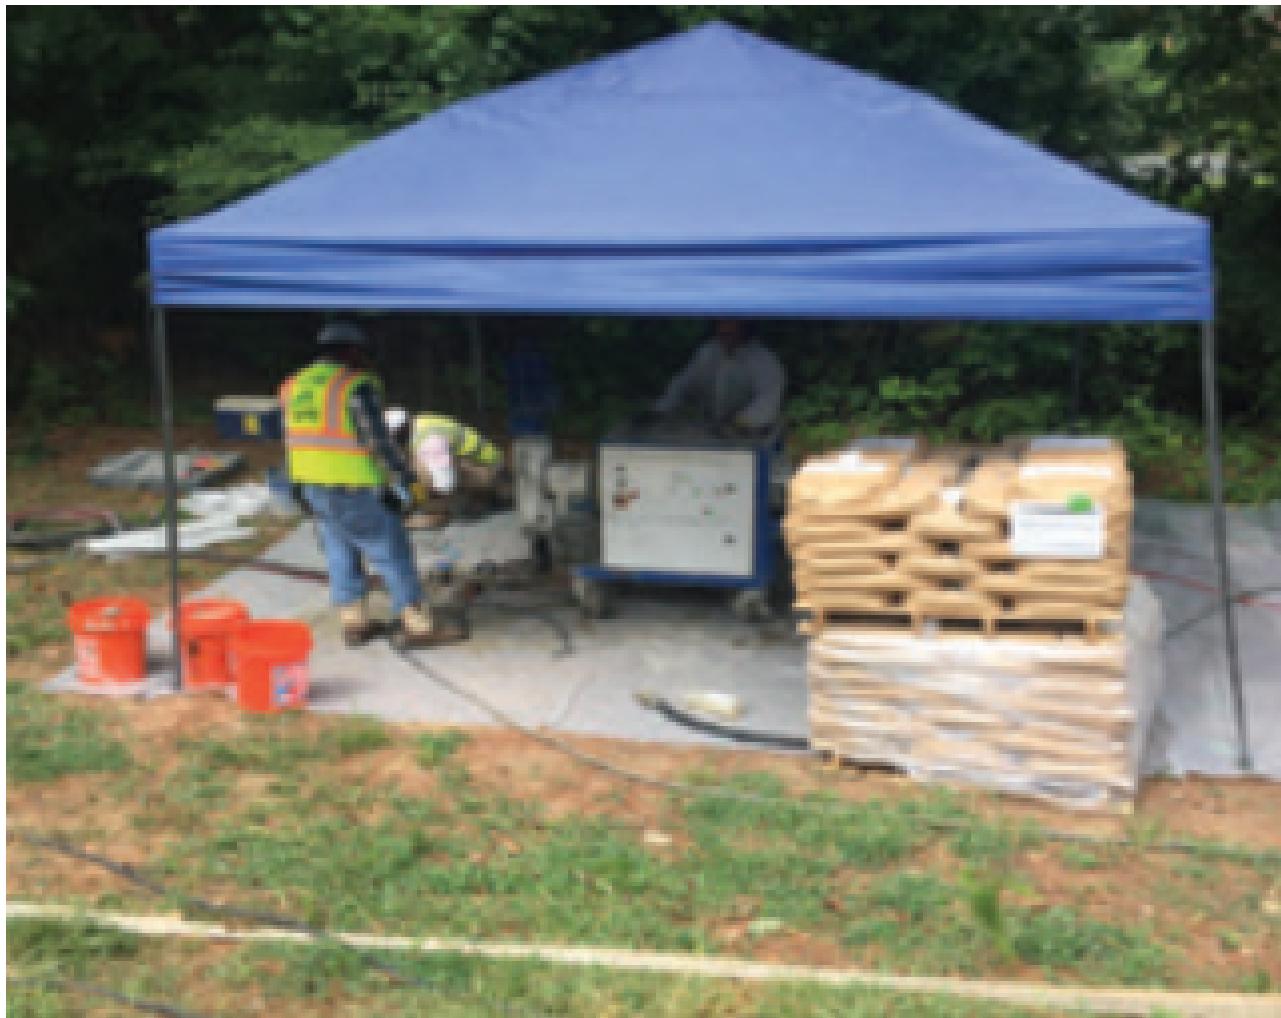
The footprint of the equipment allowed for the roadway to remain open.

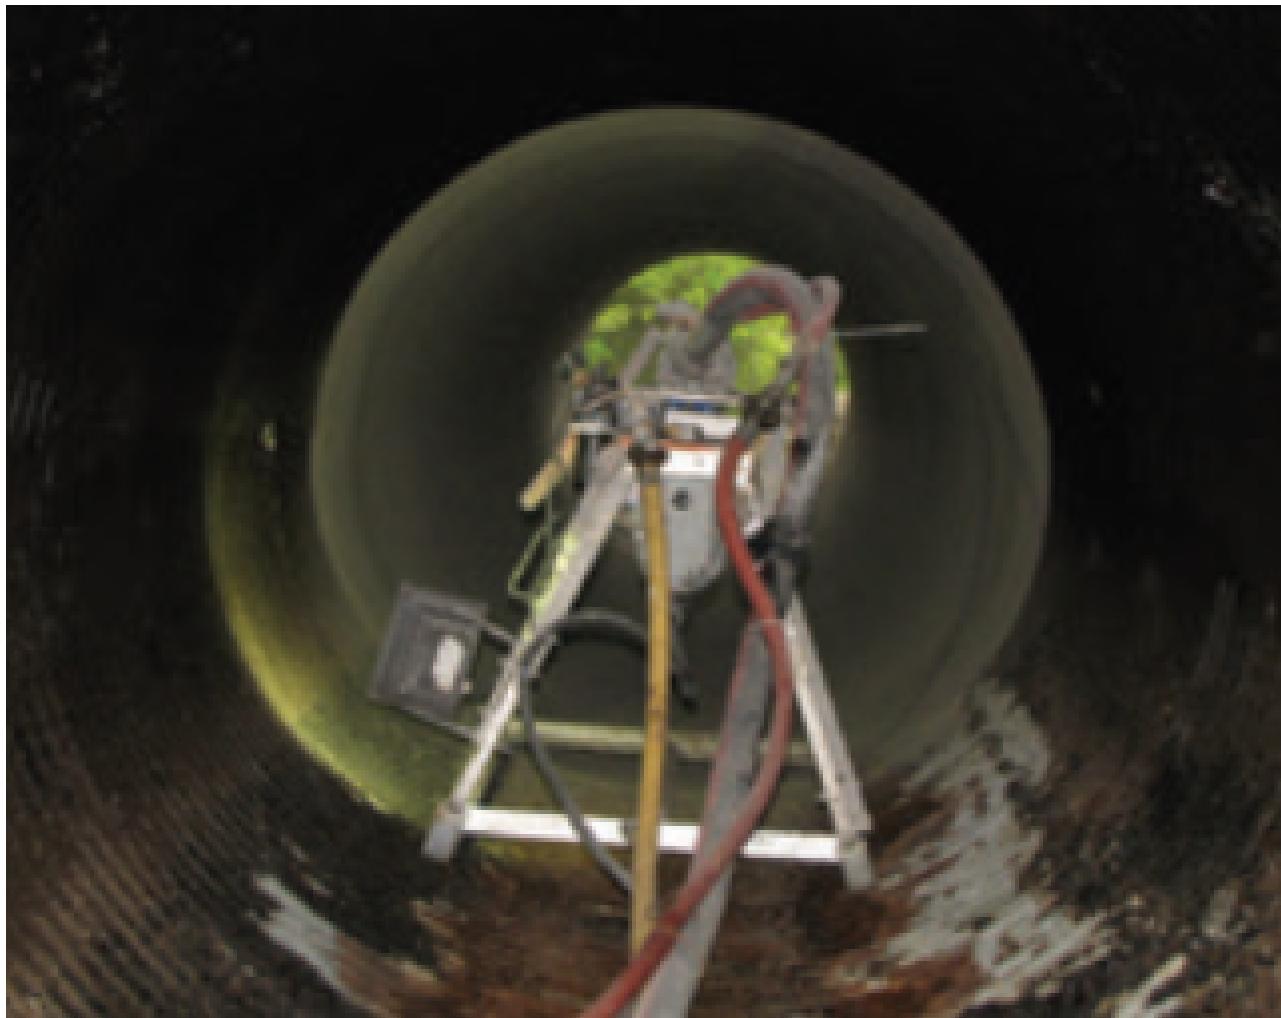
Application of the GeoSpray mortar lining to the CMP Culvert.

In May 2017 the town put out a project for bid for the pipe renewal using a centrifugally cast-in-place cementitious lining of 1" thickness. The bid was won by Inland Pipe Rehab with a low bid of \$79,725 for the lining of 175 linear ft of 52" CMP and an additional 20 linear ft of 54" CMP. Once the project was awarded, the contractor began construction in August. There were three sideby- side pipes, so the flow was diverted into a single section and each of the pipes were pressure washed and cleaned. There was little to no infiltration do to the low bury depth of the pipes, but several missing sections of the inverts were filled. Then the GeoSpray geopolymer mortar lining was applied to each of the three pipes section over a three-day period. The 1" coating was applied to each section of pipe in a single application.

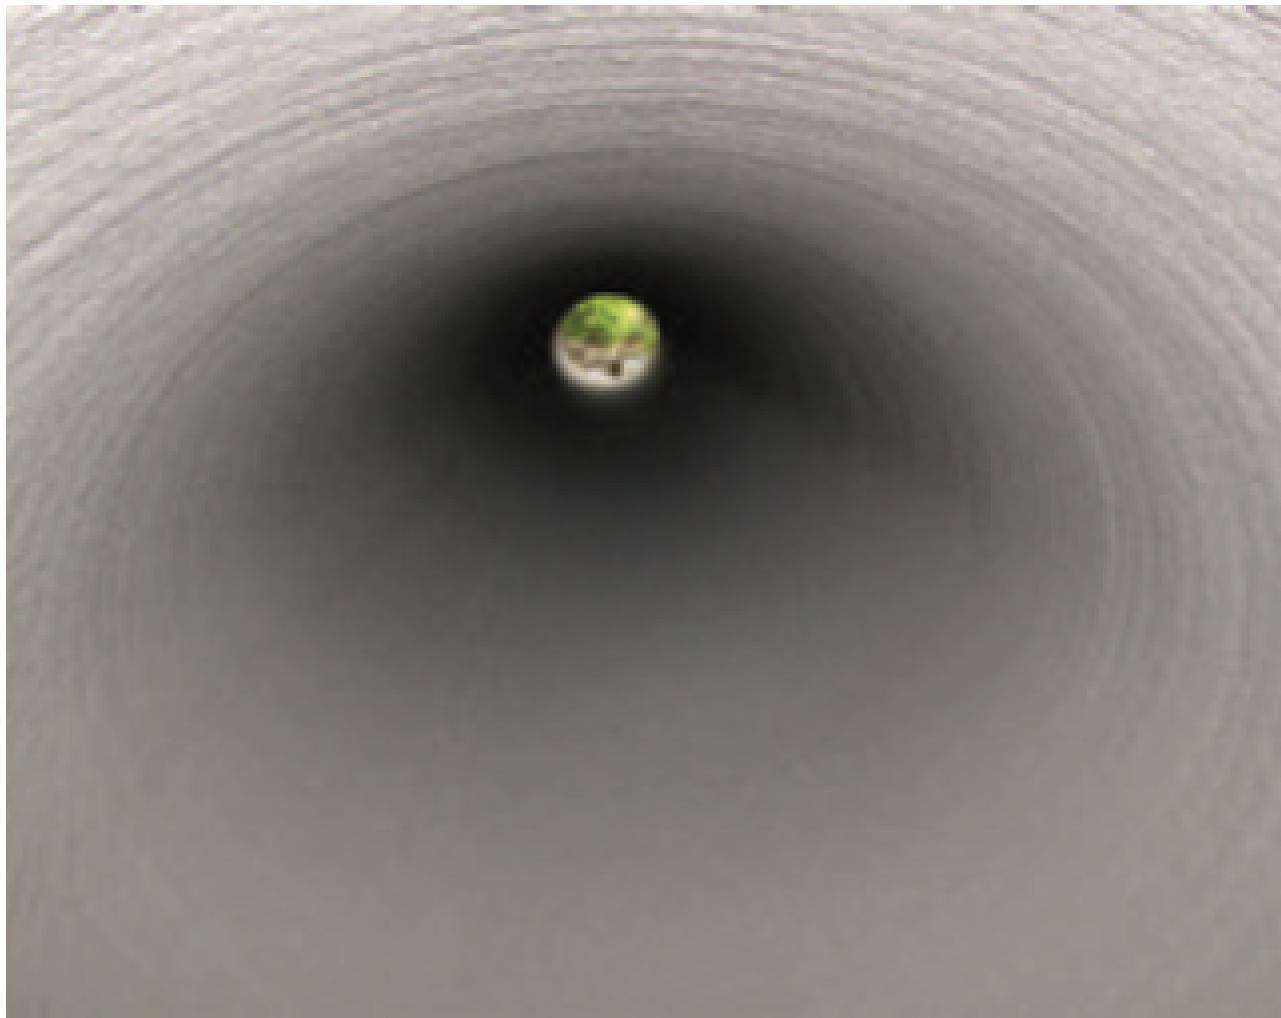
The completed 1" GeoSpray mortar lining.

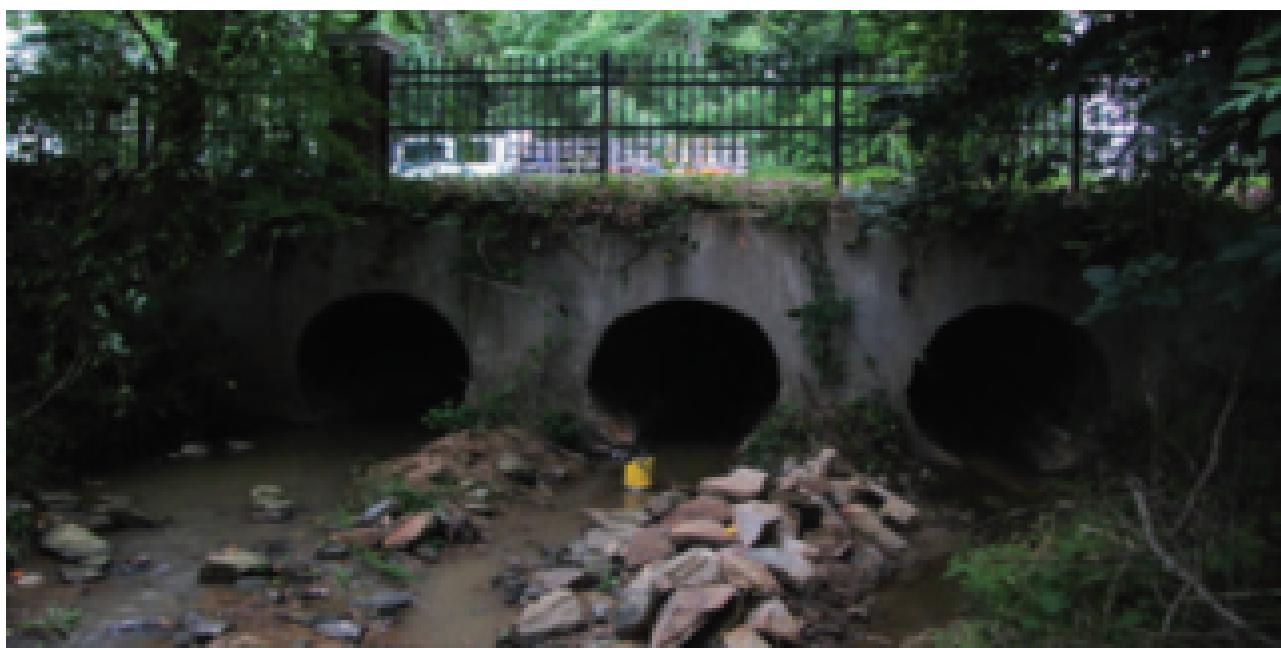
Inlet view of the 3 CMP Culverts to be lined.

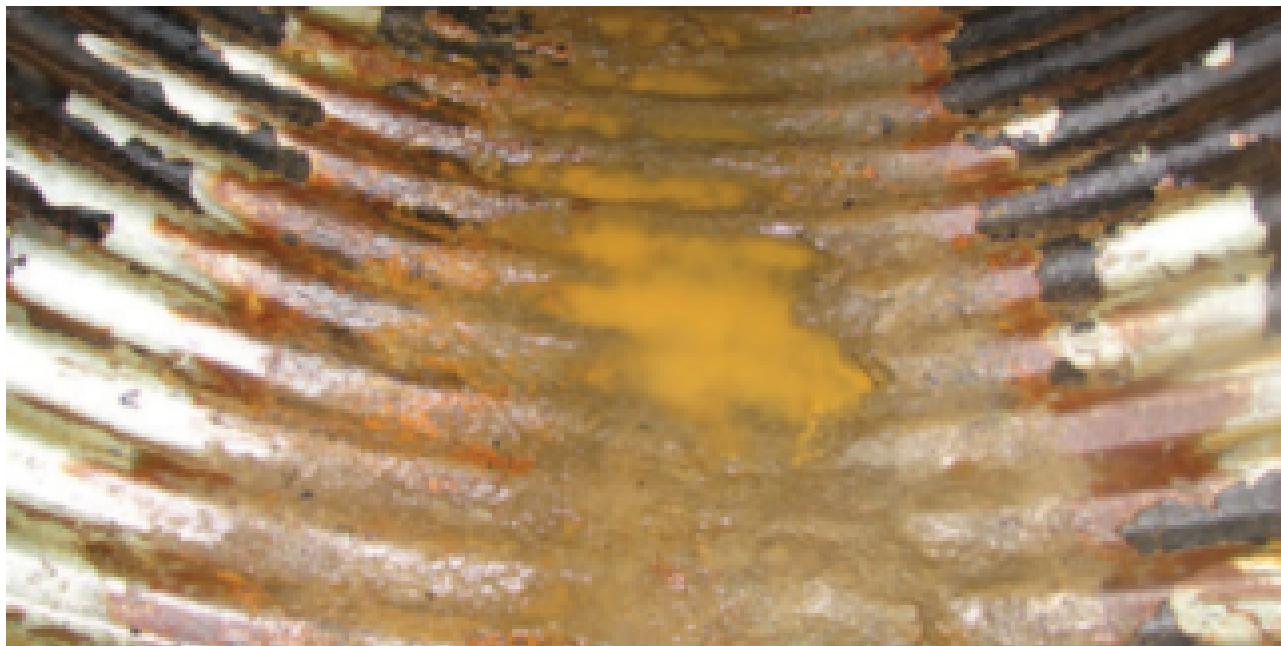
The town of Cary, North Carolina, is an affluent municipality located southwest of Raleigh. The town is near the center of the Triangle region, a commuter area consisting of three major universities: Duke, UNC and NC State as well as the technology hub located in Research Triangle Park. The housing development of Preston is located adjacent to the Prestonwood Country Club, where housing values range between \$300,000 and \$1M. Bridle Creek Dr. is the main entrance to the community, and the golf course with Bridle Creek crossing though a triplet of 52"-54" CMP culverts. In 2016, a section of one of these culverts collapsed, creating a sinkhole on the side of the road. The collapse was quickly repaired with a new section of CMP, but the community was concerned that the remaining CMP sections were showing corrosion in the invert and it would be only a matter of time before a more serious collapse occurred.

Corrosion of the CMP invert.

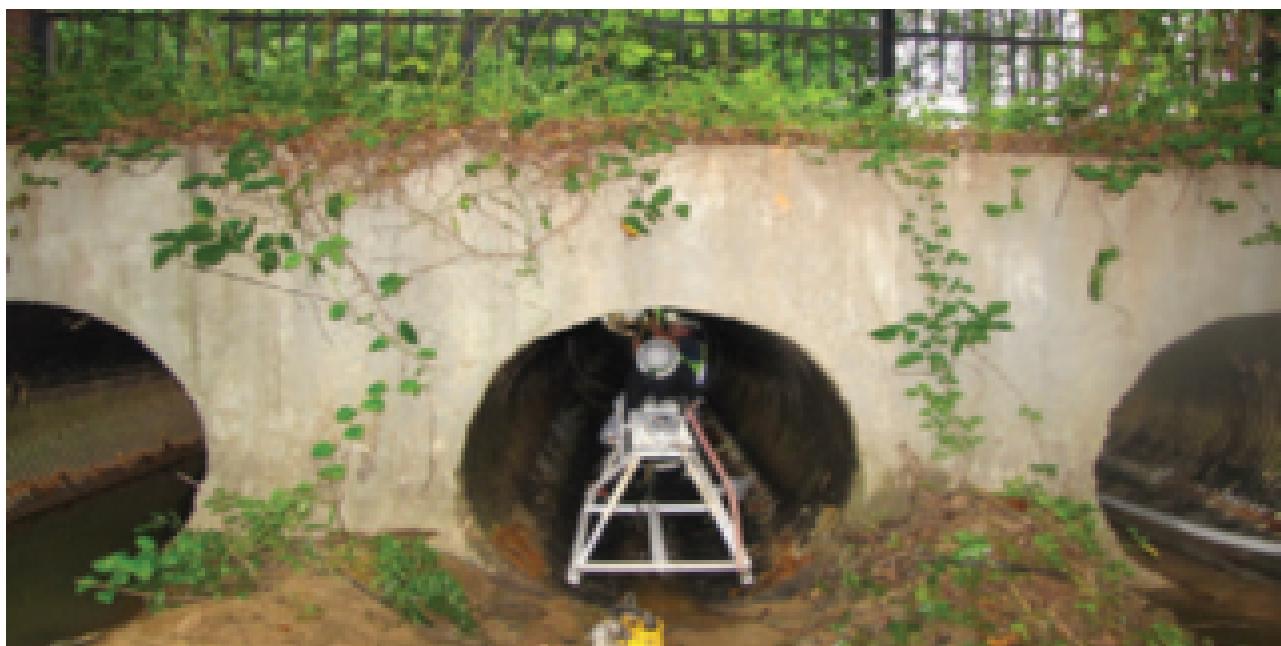
The casting equipment being positioned in the pipe prior to GeoSpray mortar application.
