Manhole Repairs - Cypress, TX

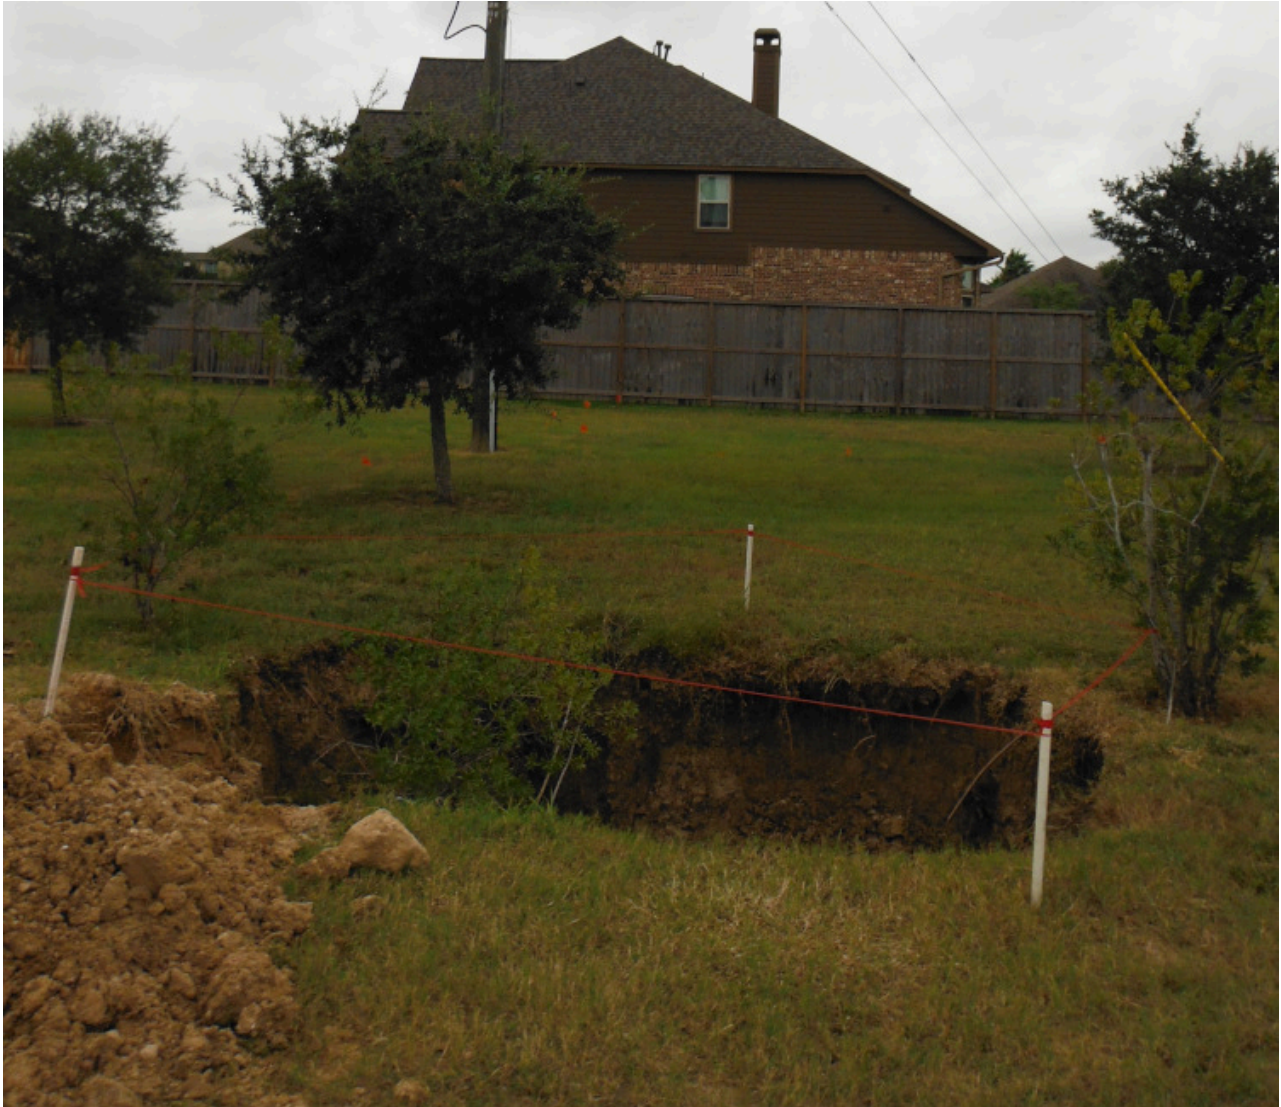
a) This project was deemed an Emergency because 48" manhole had collapsed creating a sinkhole in the surrounding soil. Prior to installation of the Danby liner, the contractor had to bypass 1 of 2 10" force mains and excavate the remains of the manhole out. The contractor installed 27 VF of 8' ID liner plate, then reconstructed the manhole with a double mat of rebar and proceeded to install Danby PLIII 1" flat panels (3½) 8' vertical sections. The (2) 10" force main were reconnected using a custom fabricated 24" HDPE force main drop. An 8'x8'x18"

thick concrete HS20 load rated manhole lid was also constructed with the underside having the corrosion resistant Danby PVC liner. b) A 48" manhole was rehabbed using Danby PLIII 1/2" profile spiral wound method. A 5'x5'x18" manhole lid was constructed with the underside having Danby PVC liner. This project was done by Boyer, Inc. of Houston, TX
Cleaning method used (if required) and who cleaned the line:
