Rehabilitate 524 Linear Feet of Brick Sewer

Application: 49" Brick Sewer

Client: City of Los Angeles

Contractor: Inland Pipe Rehab, LLC

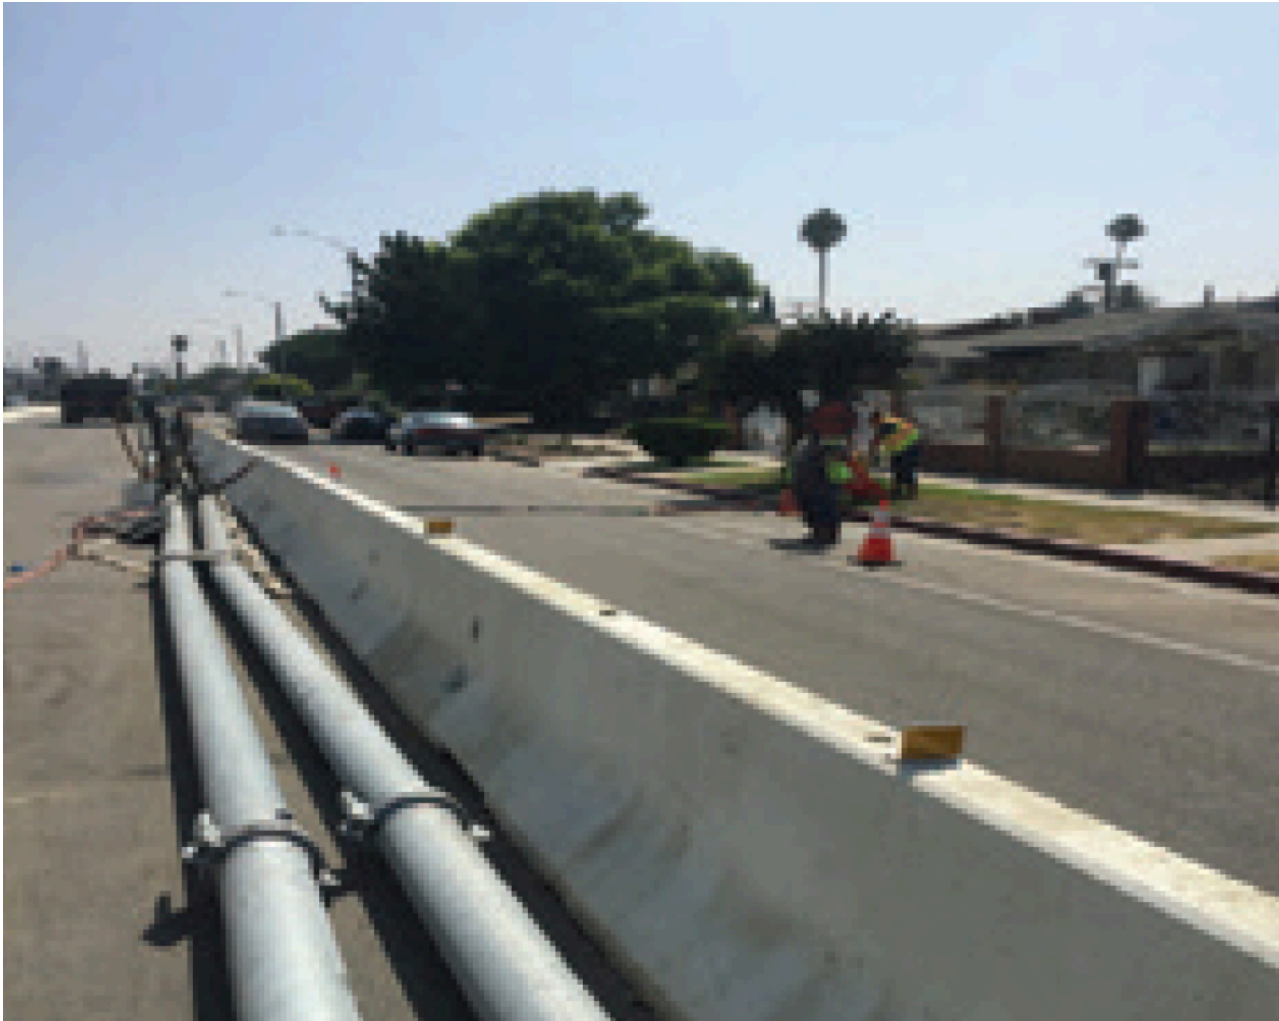
A bypass system was used along Rodeo Road during the lining of a brick sewer underneath.

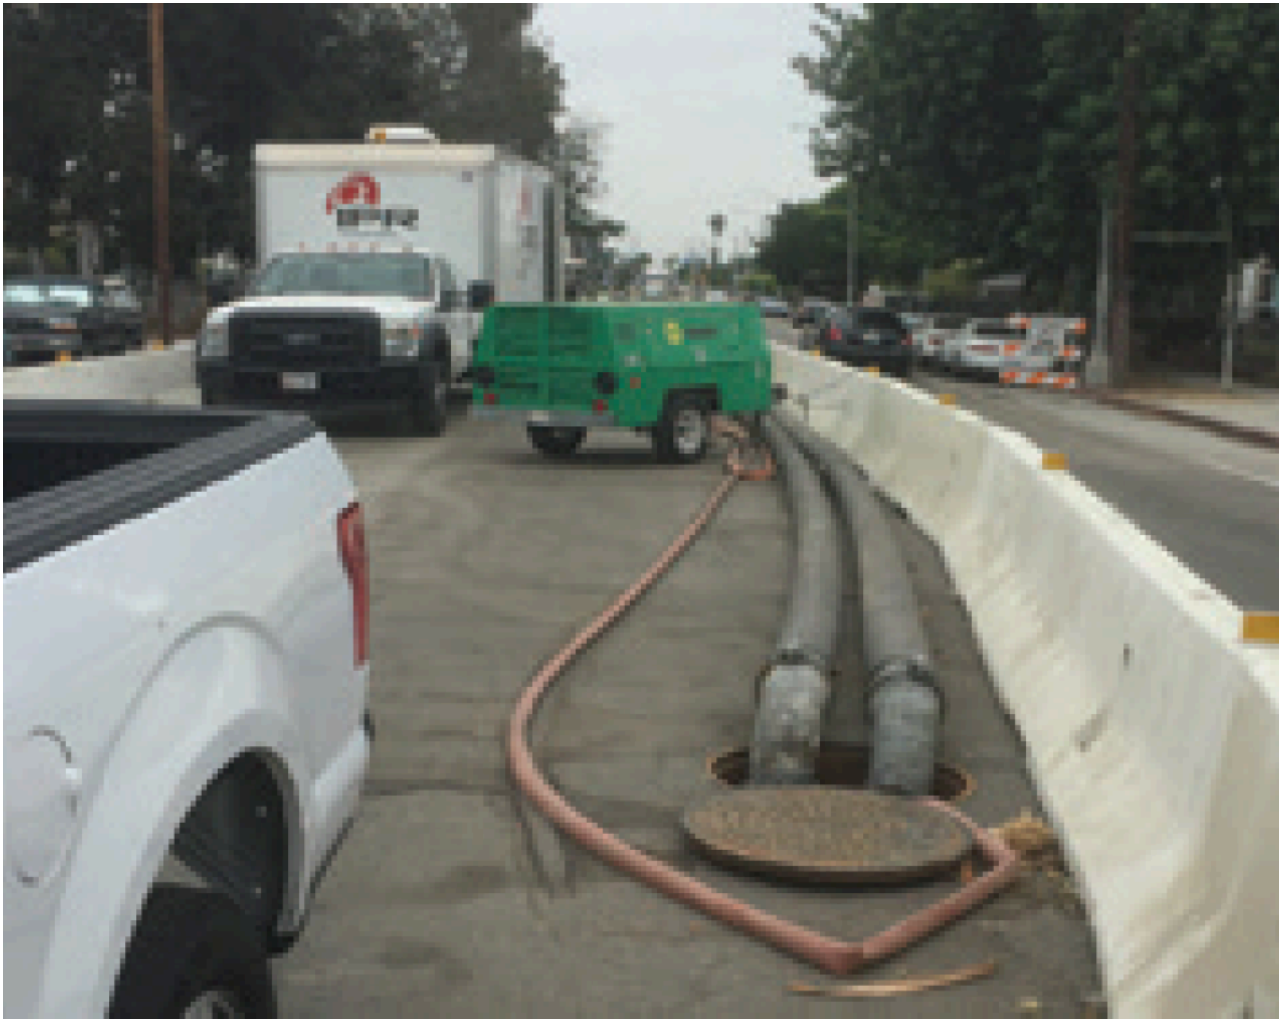
Bypass of the sewer.

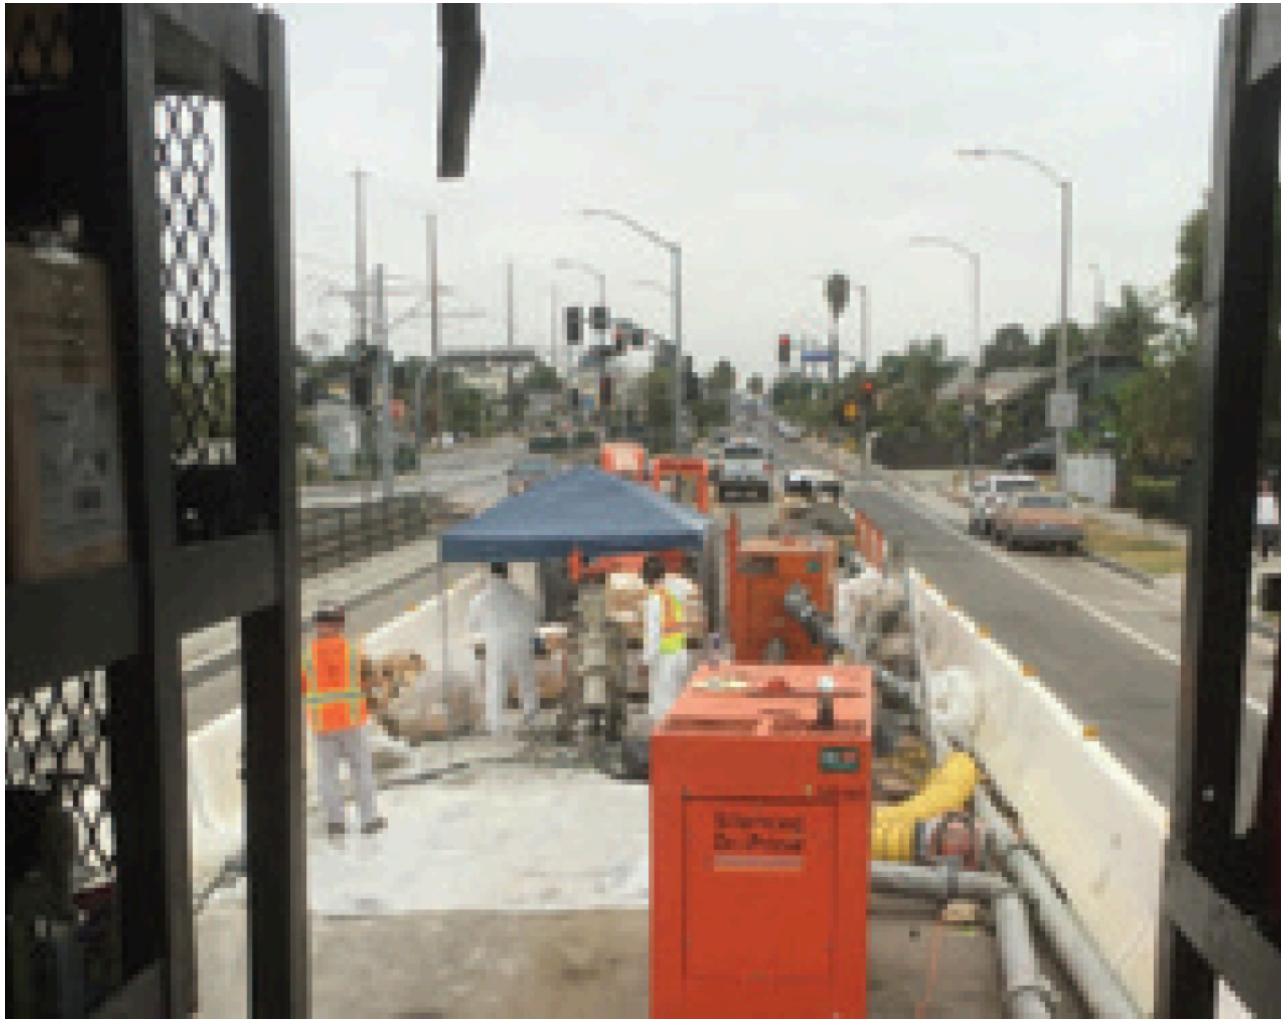
View of the construction footprint. Completed lining.

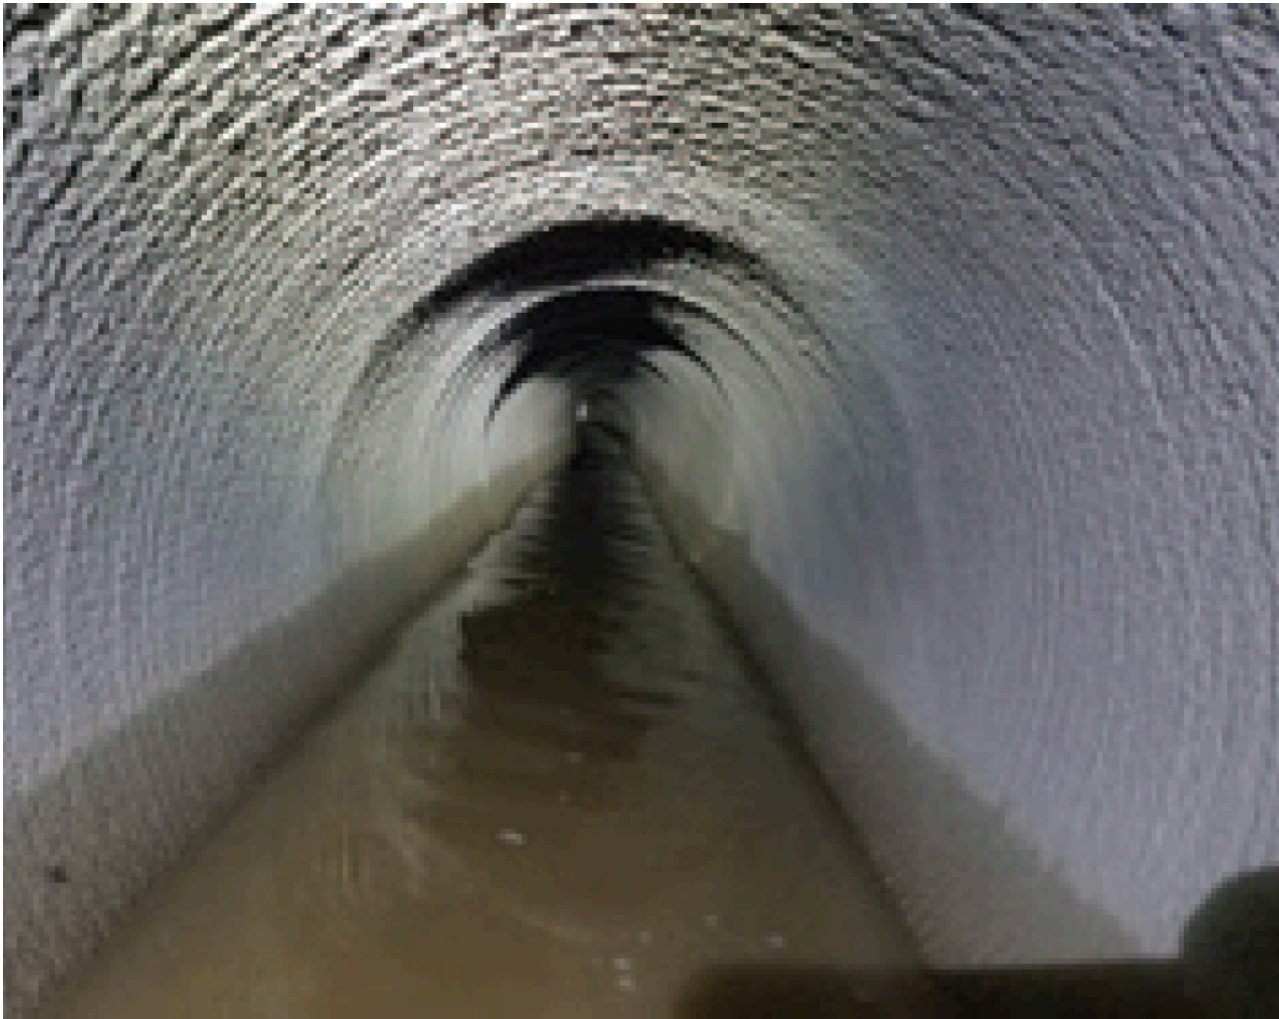
Completed lining.

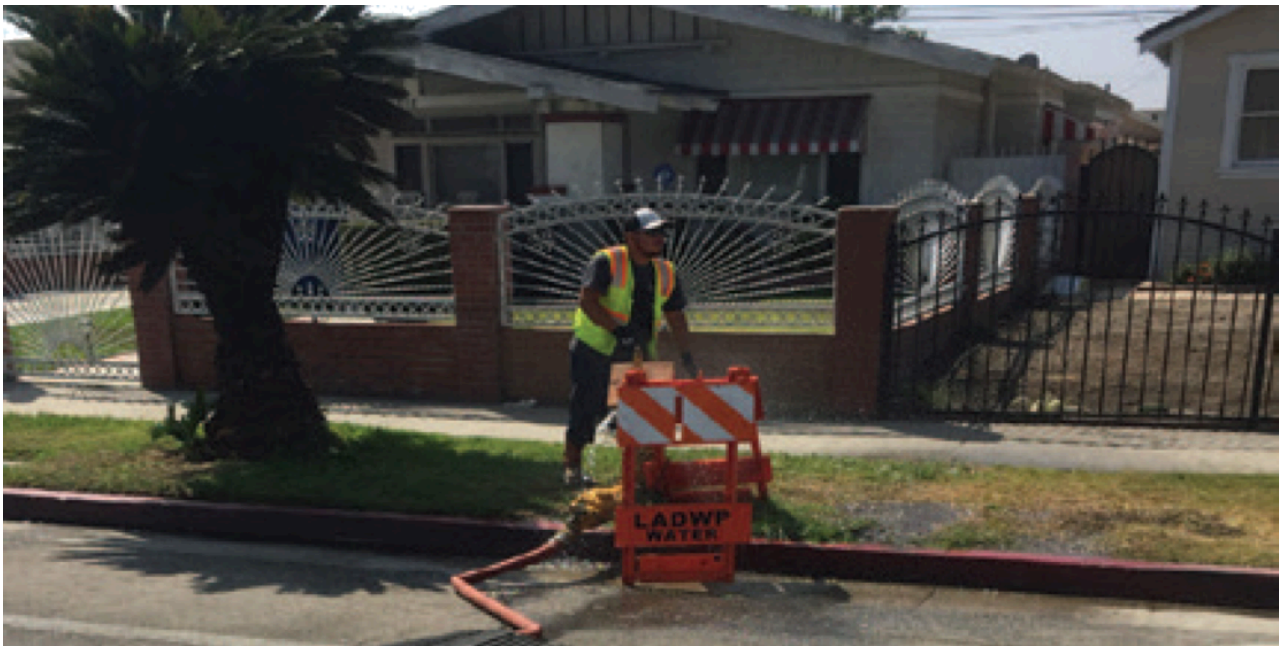
GeoSpray left very little impact on the traffic that surrounded the site.

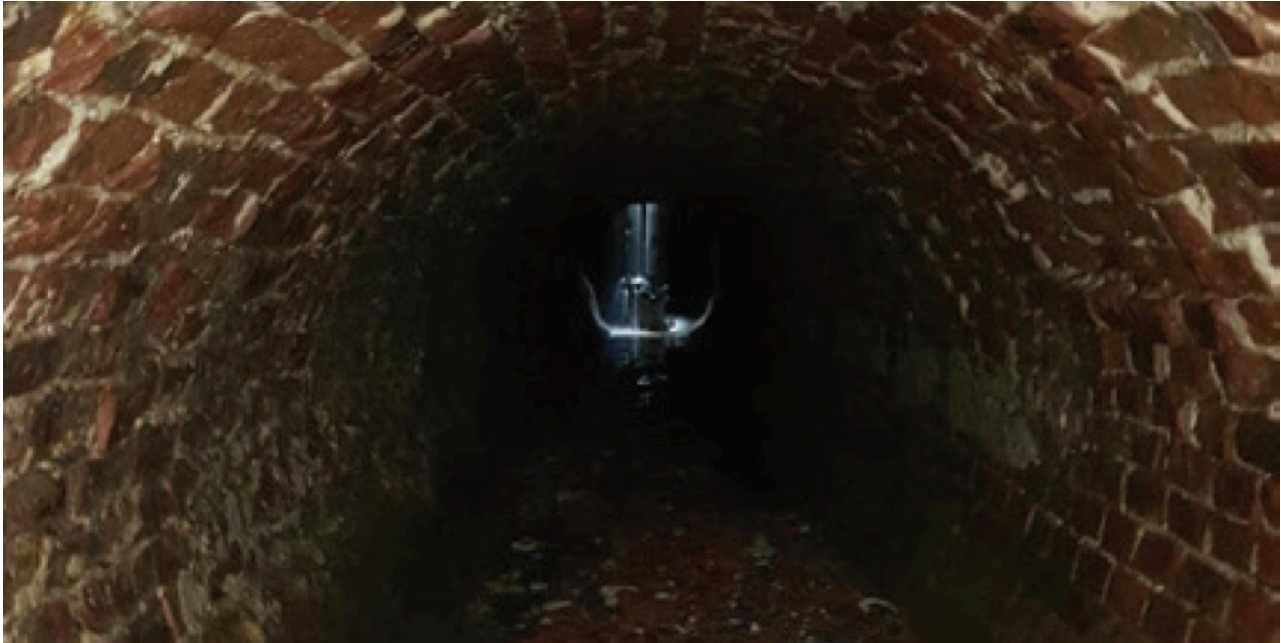
The pilot project was to rehabilitate 524 linear feet of brick sewer, likely installed in the early 1900s, along Rodeo Road. The sewer had significant loss of mortar between the bricks and damaged or missing brick. The project consisted of several phases including: bypass setup and testing, cleaning and preinspection, lining and post-inspection. A one-inch thick GeoSpray mortar lining was applied to the structure to serve as a new structural lining for the system. The lining was applied by hand spray so that the multiple live connections from local homes could be maintained as operational with minimal time disturbance during the lining.

Initial brick structure with debris and missing mortar.

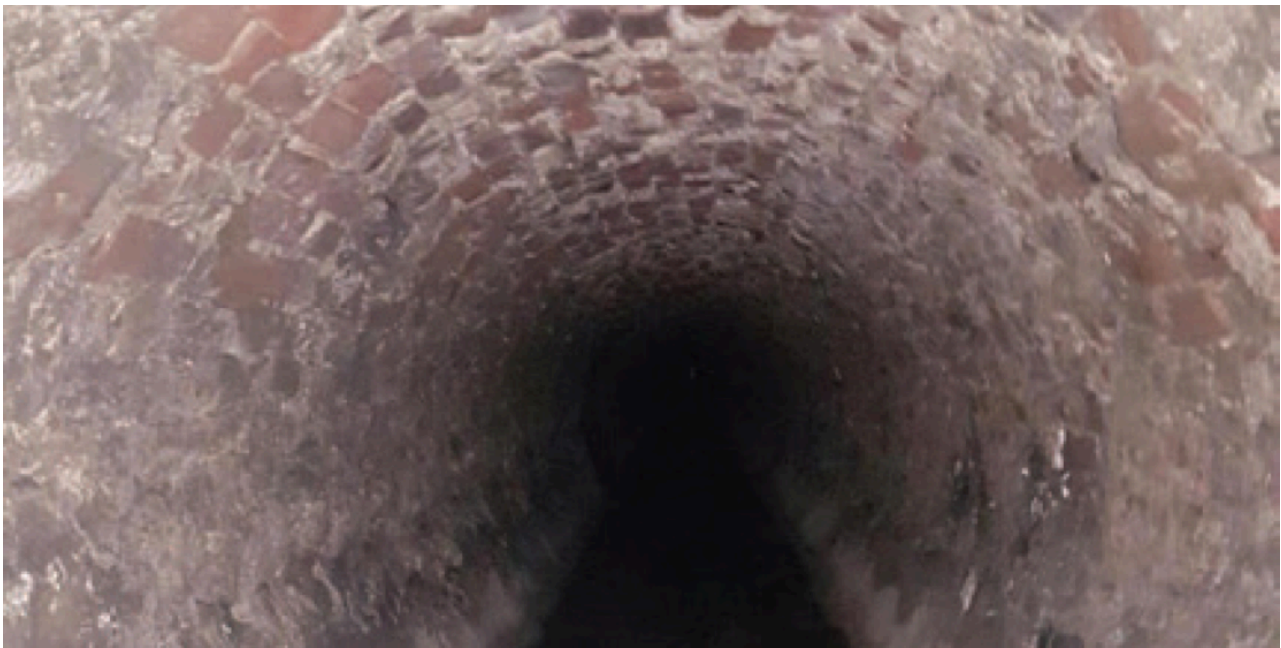
Initial structure under flow conditions.
