Successful BulletLiner Project in Northern Arizona

Our team recently completed a 350-foot rehabilitation project on a 10-inch diameter ductile iron pipe using the H-Series in Northern Arizona-showcasing both efficiency and precision in pipeline renewal.

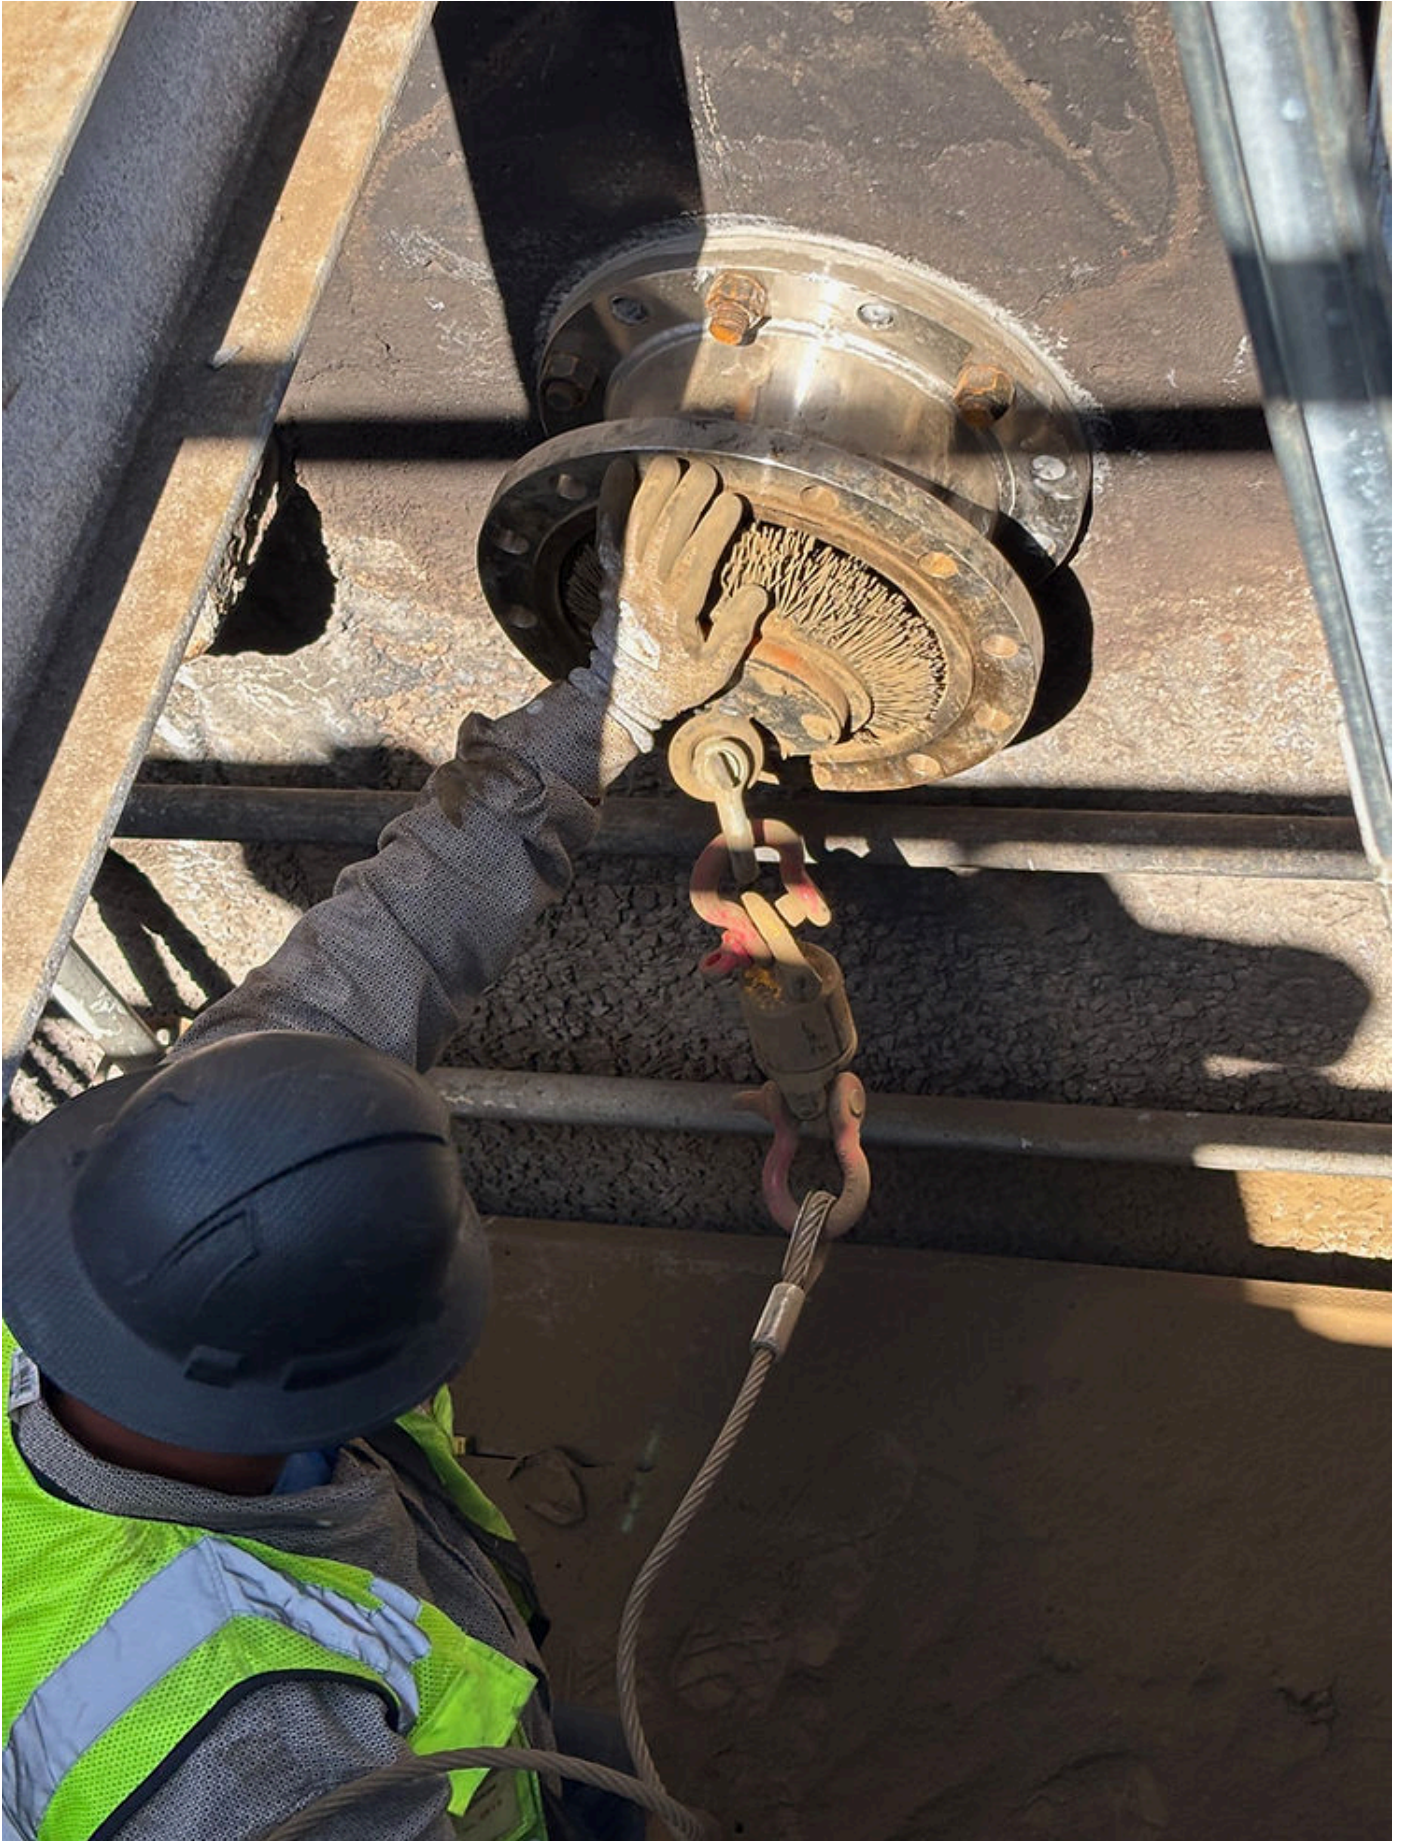
Before lining, we performed a thorough cleaning and CCTV inspection of the line. During this process, we identified a few obstructions and buildup, which our crew addressed to restore the pipe to optimal condition for lining. The team cleaned the line to the best achievable standard, ensuring proper surface preparation for installation.
