Sealing leaks with acrylates - Prime Resins

Contractor: SSESCO Inc.

Client: Private property owner in the Bronx, New York

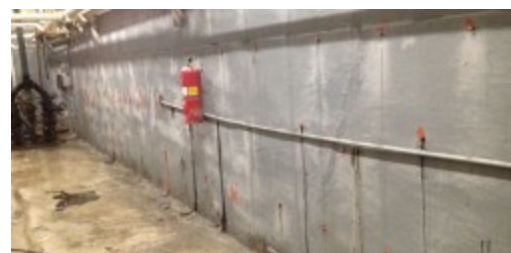
The groundwater seeping in through the drilled port holes was contaminated with old heating oil.
