# A polyurea coating seals a fountain at the centerpiece of Piazza d'Italia, a prominent attraction in downtown New Orleans.

**Client:** New Orleans Building Corporation, City of New Orleans

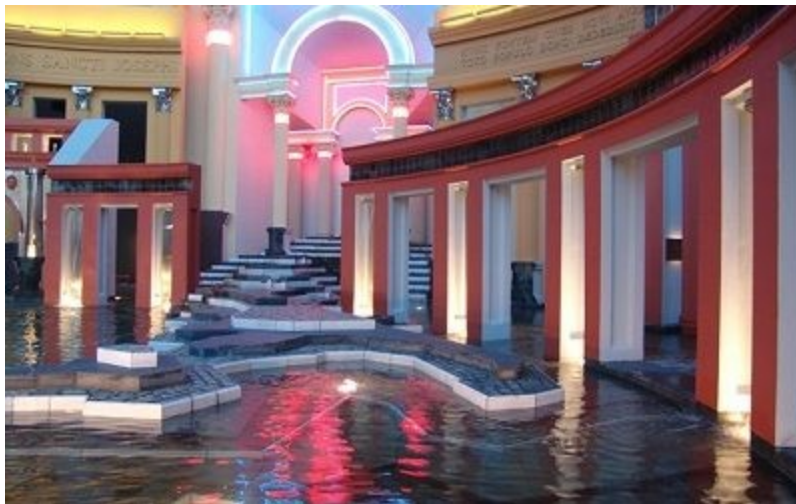
The Piazza d'Italia needed renovation. One of the issues: **The fountain was leaking.** The 6000 square feet of pools needed to be sealed and waterproofed.

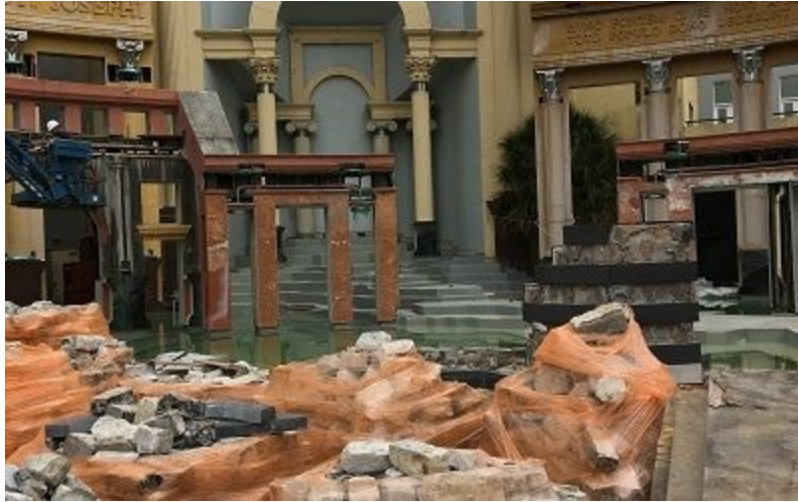
The fountain has a lot of stairs so there are a lot of corners to go around and underwater lighting fixtures that had to be sealed off. In addition, there are cobblestones and marble bonded to the pool surfaces.

The pools were drained, the cobblestones and marble were removed, and the remaining surface was prepared for coating. The contractor sprayed the polyurea on about 6000 feet of the stair-stepped pools and fountains. After that was finished, the polyurea surface was prepped, a new fountain liner was installed and water tested, and stone masons used an epoxy bonding agent to reattach the cobbles and marble.
