Box culvert repair with chemical grouting

Client: City of Tallahassee, Florida

Design Engineer: Environmental and Geotechnical Specialists, Inc. (EGS)

Contractor: Foundation Professionals of Florida, a Cal-Tech Testing, Inc. company

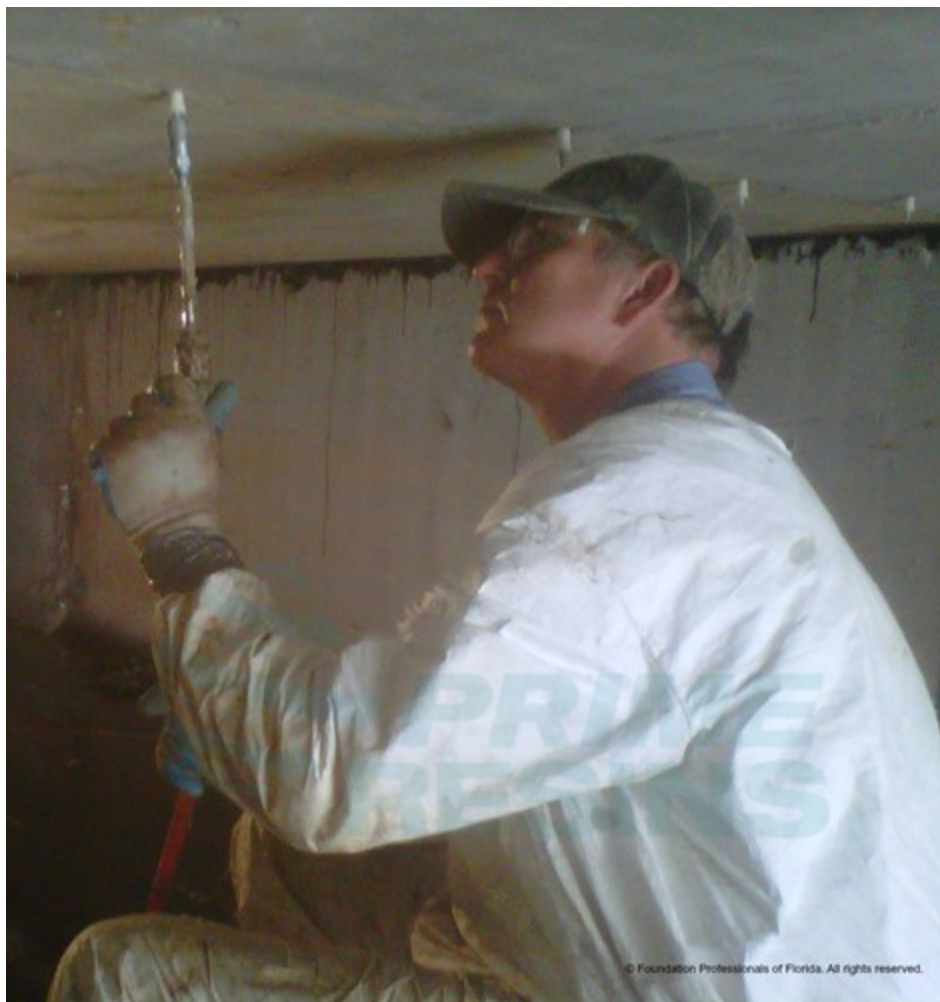
The repair had two phases. The **first phase** was to install a series of equally spaced holes at each joint through the culvert flange into the seal. A small injection port was installed in each hole and surface sealed. **Prime Flex 900 XLV**, an extremely low viscosity hydrophilic resin, was installed under pressure until it was observed exiting the adjacent port. 900 XLV reacts with water and expands to form a closed cell, watertight foam. In addition, this product complies with NSF/ANSI Standard 61 for contact with potable water. The process was repeated until all the injection ports at each joint were grouted.

In phase two, the crew identified and filled existing voids around the culvert. After grouting all the joints, they drilled small holes through the culvert sidewalls to identify and map the voids. Next, the crew installed injection ports in the culvert and weir sidewalls, and filled the voids with **Prime Flex 910**, an expansive, hydrophobic polyurethane that reacts with moisture to form a rock hard, watertight mass. Foundation Professionals of Florida out of Lake City, Florida, was the contractor. In addition, Prime Resins provided on-site technical service and manufacturer's representation throughout the grouting phases.
