# Case study for sealing stormwater pipes

**Client:**Regional airport authority in the U.S. Midwest

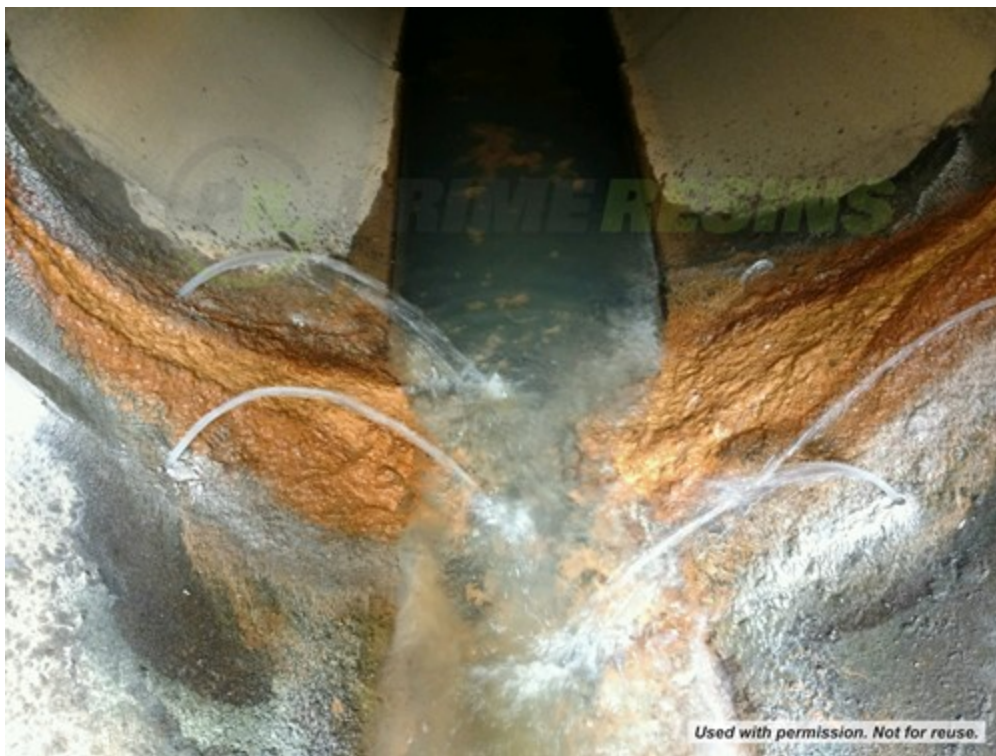
A regional airport in the Midwest has miles of pipe and storm sewers that stretch under the runways. These pipes carry surface runoff from rain events into the storm sewers. The airport sits near the Missouri River, in the river bottom, so the water table is extremely high. **Cracks and leaking joints caused erosion** around the pipes during major rain events. Eventually, the erosion would compromise the runways, potentially leading to sinkholes. The exfiltration had to be stopped.

The contractor, who also does mudjacking, proposed curtain grouting the pipes with **Prime Flex 920**, a highly expansive structural polyurethane foam. When cured, the hydrophobic material forms a water-tight rigid mass, sealing leaks in the concrete pipes.

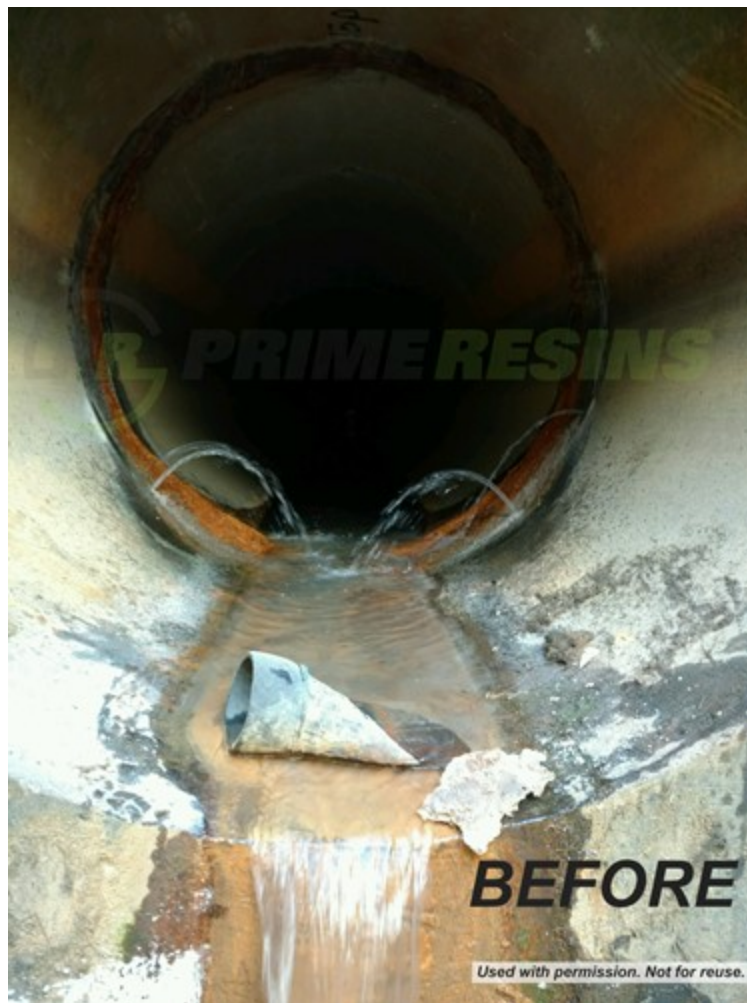
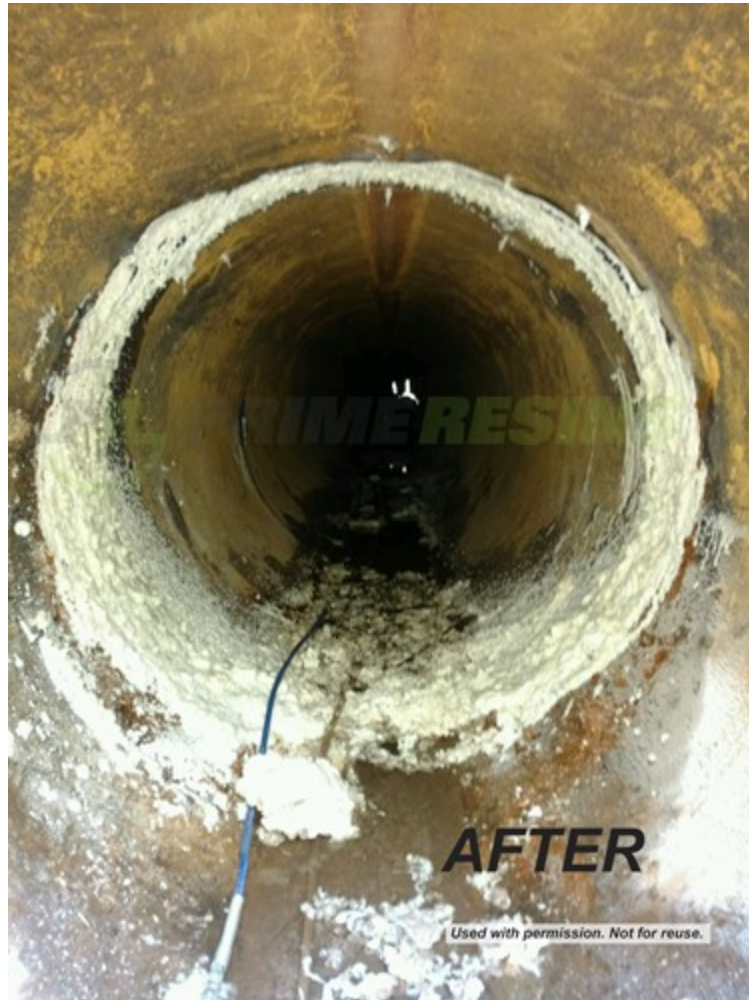
The crew pumped 700-800 gallons of Prime Flex 920 to encapsulate several leaks. “We sealed everything 100% and they were happy with it.”
