# Lake Lure, North Carolina, Finds a Solution to I/I

Aging manholes located along the shoreline of a large man-made lake were a source of inflow and infiltration (I/I) that was placing an excessive burden on the Lake Lure, North Carolina's small treatment plant during summer months when the town's population would grow from its year-round number of 1,200 to in excess of 12,000.

Trenchless methods using spray-applied polyurethane linings has now provided a sustainable fix and extended the life of these critical collection system structures.

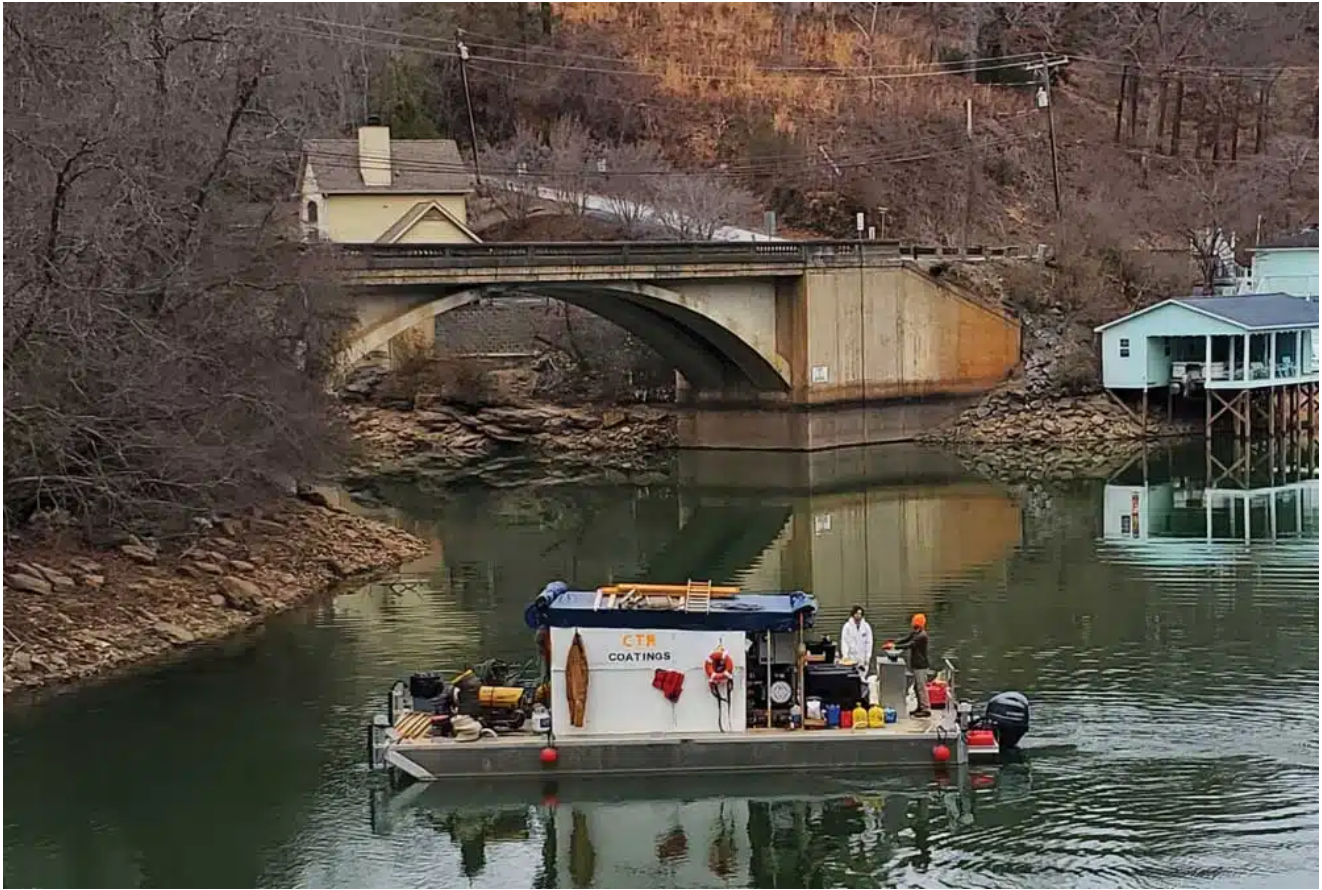
The barge was driven up to the structure and stakes were put into the lake bottom at the shoreline to function as anchors so that it would not drift or shift away. The spray crews would perform their work using a long safe walk plank to access and standard confined space entry procedures for the interior applications. Exterior application was completed by walk around. The OBIC 1200 lining was applied at 150 mils thick on both the interior and exterior surfaces.
