## MONOFORM PLUS™ CASE STUDY

Restoring Structurally Failing Manholes on Verge of Collapse with Patented Proprietary Repair Solution

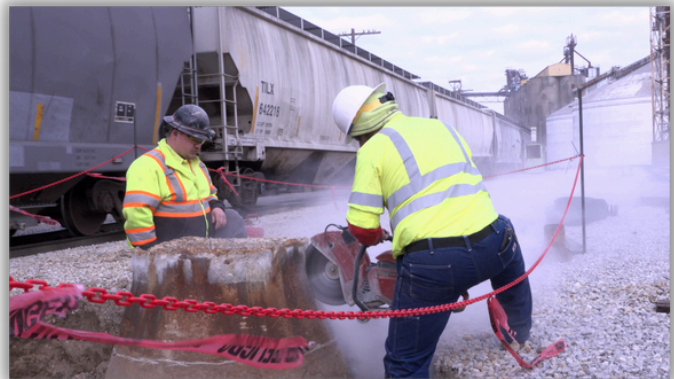
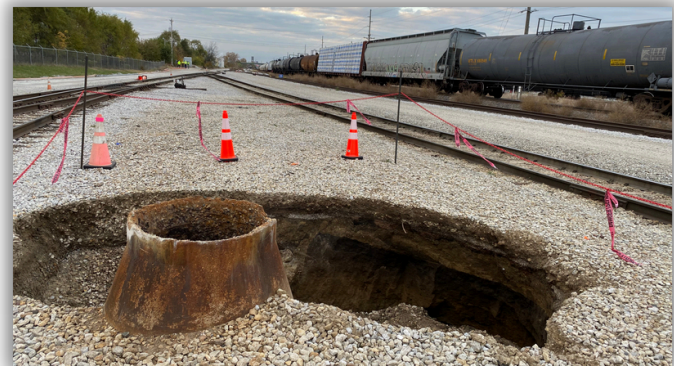
- Manhole base and flow line corroded causing loss of backfill severe sink hole
- Between two active track line
- Severe structural degradation caused by high-level H2S

- Caved in at base of manhole causing massive sink hole undermining railroad grade
- In between & under active railroad spur
- Severe degradation due to H2S

- Caved in at base of manhole
- On busy semi truck route
- Neglected for years
- Severe deterioration caused by high-level H2S

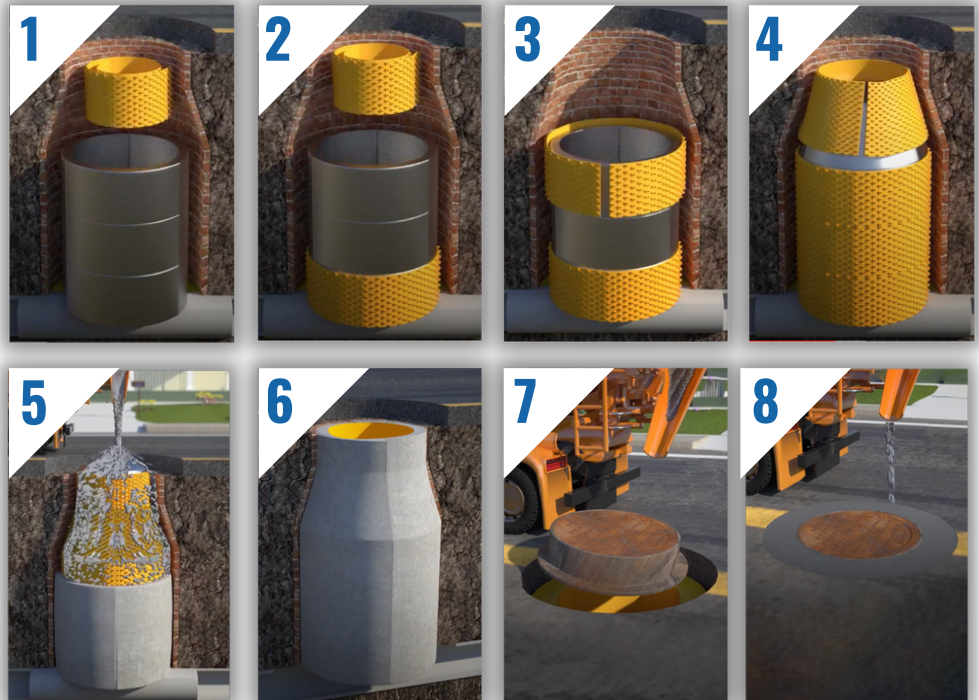
### THE MONOFORM PLUS™ PROCESS

- HK's patent pending manhole rehab solution
- 100% Structural
- 100% Corrosion-Resistant
- No-Dig Trenchless Technology
- Combination of the original Monoform™ process; fully structural trenchless manhole rehabilitation process, and Agru's HPDE Ultra Grip liner.
- HDPE Ultra-Grip interior liner provides corrosion protection from MIC (Microbiologically Induced Corrosion)
- Eliminates both exfiltration and infiltration
