Polyurethane chemical grouting seals leaks in a pit excavation

Client: New York City Department of Environmental Protection

Contractor: Infrastructure Repair Service, N.J.

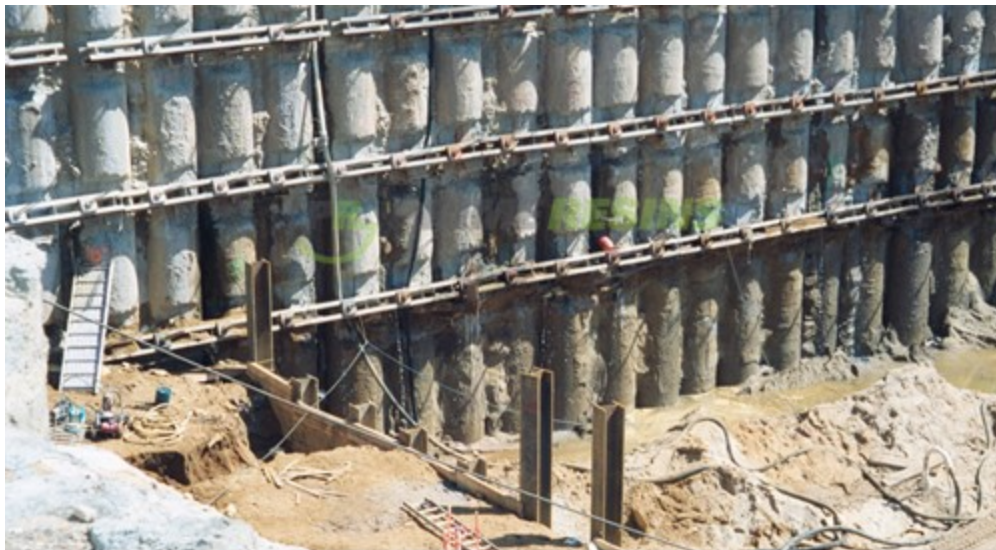
Before the installation of the tiebacks was complete, however, problems emerged. When the pit got approximately 25 feet deep, below the level of the surrounding groundwater, **water began leaking through and around the conduit sleeves** into the pit.

Some of the leaks were severe, gushing as much as 50 gallons of water per minute. In some places this made it impossible to continue welding the cable bracing beams.

Leaks through the tieback anchors used in excavation of an 80-ft-deep pit for the Flushing Bay CSO prevented welding. Note the water streaming from the lowest row of anchor plates. The leaks were ultimately sealed with Prime Resins polyurethanes.

For the gushing leaks, crews from Infrastructure Repair drove 10-foot-long sections of 3/8-inch pipe back into the conduit sleeves as far as they could toward the deadman. In some places they had several pipes joined together to go back as far as possible. They used the rod essentially as a giant grout needle and injected **Prime Flex 920** behind and into the sleeves. The 920 reacted with the water present and expanded to form a hard, watertight mass that sealed the sleeves.

In places where the water flow was too great, technicians used sections of hose as relief tubes, then packed the area around it with activated oakum. This is oil-free jute rope saturated with Prime Flex 900 LVSF (now **900 XLV**), a hydrophilic polyurethane grout. The activated oakum technique sealed the gaps between the end of the sleeve and the anchor plate attached to the waler. They then went back and injected the relief tubes and any remaining gaps in the tensioning assembly with the 900.
