Project Spotlight: What Lies Beneath

On an early winter morning in Parkersburg, West Virginia, collection system operators faced a major catastrophe when a garbage truck fell into a sinkhole adjacent to a manhole. Quick thinking and trenchless technology saved the day to return the area to service quickly, limiting the impact to local community businesses while protecting nearby buried utilities.

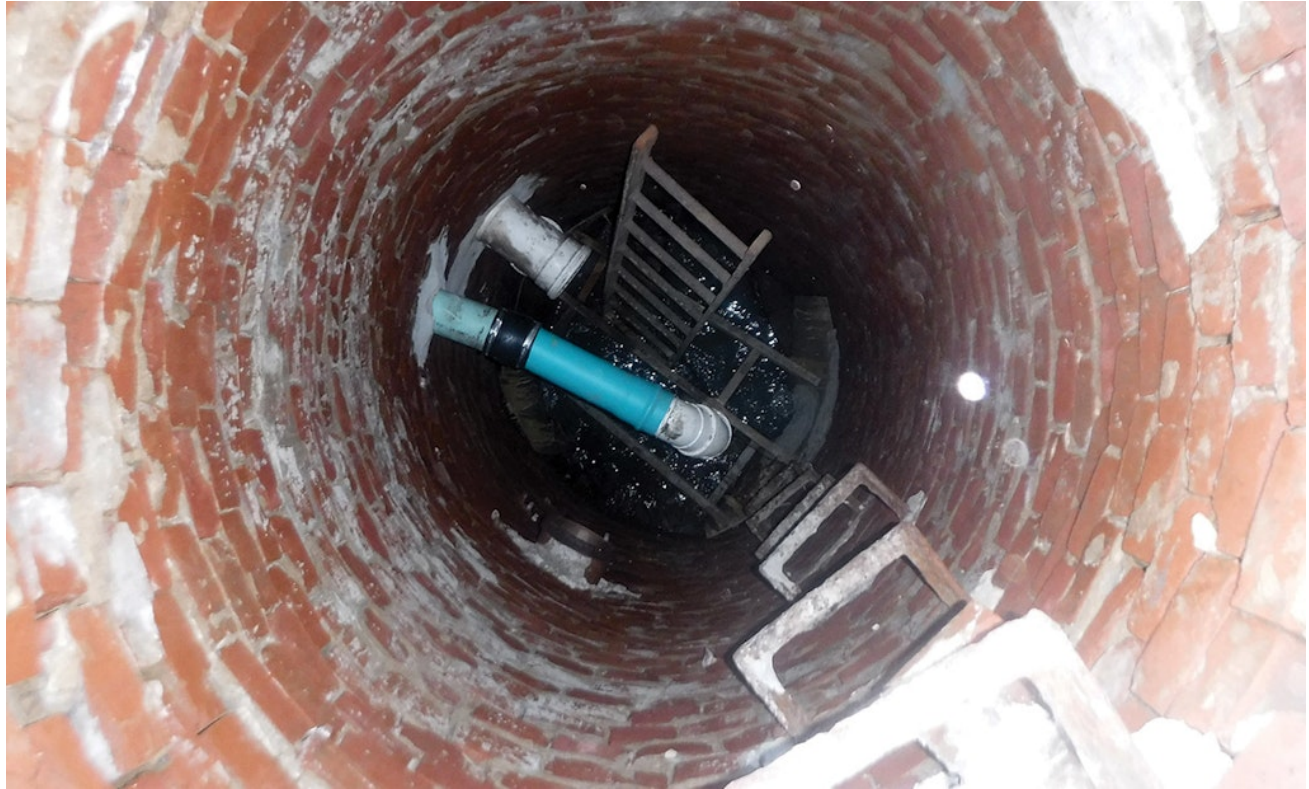
Water ran against the bricks of this manhole, which is more than 80 years old, causing it to lose mortar and some of its bricks. Infiltration from a broken stormwater pipe nearby then made its way into the sanitary sewer system.

An older storm drain located on a hill by the local community hospital which drains to the Ohio River ran parallel to a manhole structure on a busy mixed use area street. Over the years, the storm drainpipe had deteriorated from the outside, and all its collected water was running up against the bricks of the 80-plus-year-old manhole structure. This resulted in a slow but steady degradation of the structure, causing mortar to erode and its bricks to fall out of its sides down into the sewer mains, which allowed backfill around the manhole to enter the sewer system.

The key to the project success would be in the preparation of the manhole structure, which was 16 feet deep and 4 feet in diameter. The first step was to make sure that no additional excess debris got into the lines feeding the manhole. Bricks that had come loose were reset in place and mortared in with hydraulic cement. This was followed by the application of a combination of four different hydrophilic and/or hydrophobic grouts from OBIC via injection to seal any infiltration on the side walls and bottom areas of the structure.

Once all water ingress was resolved, the structure needed to be cleaned. A 4,000 psi pressure wash of the whole structure was performed, and afterward, drying with a torpedo heater was completed. The structure's surface needed to be dry before spray-application of the lining could begin. Because it had been compromised, ART felt that to really secure the bottom floor of the manhole, reinforcing the weaker areas with 3/8-inch rebar was called for. After all these initial steps were complete, the structure was ready for the application of the lining, which would be executed in three stages.

The first stage used OBIC 1000, a fast-curing polyurea coating with an elongation of 400% that could shift with traffic loading and withstand the freeze-thaw cycles common in the region. This was spray-applied at approximately 50 mils thick over the entire structure's interior. The second stage of the lining saw the application of OBIC 1306, a high-density polyurethane foam that adds structural integrity to the manhole and fills in any spots with missing or reduced mortar. This created a smooth profile for the third and final stage, which was a spray application of another layer of OBIC 1000 at 50 mils.

The layers fully bond to the structure, sealing and anchoring it to become monolithic. In total, an average of 500 mils of material were applied to the manhole walls and bench, adding significant structural integrity.
