Sealing Leaking Sewer Main Joints

Technical consultation and on-site training make the difference

Contractor:S.J. Louis Construction, Inc.

Client:City of Des Moines, Iowa

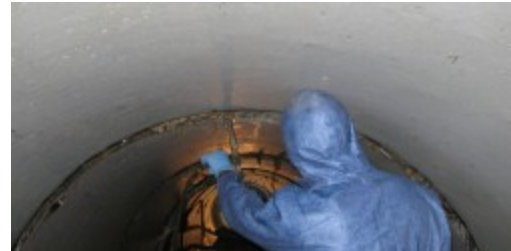
PROBLEM:The City of Des Moines, Iowa, was installing more than four miles of 60” diameter reinforced concrete pipe with Ameron Lining, bell and spigot in 8’ sections for a sewer main. After a large portion of the pipe had been installed and backfilled, the project engineer inspected the pipes and found groundwater leaking at the connection joints. Many of the gasket seals between the pipe sections were not sealing properly and hydrostatic pressures were significant enough to produce leaks. The Ameron Lining System that had been welded at the joint connections had formed “blisters” at the leaking joints. The city contracted S.J. Louis Construction, Inc. to repair the problem joints.

SOLUTION:The repair plan designed for this project involved a combination of simple but specialized equipment and installation techniques to use hydrophilic and hydrophobic water-activated polyurethane injection resins designed specifically for sealing leaks in concrete structures.

The products used included: **Prime Flex 900 XLV**, a water-activated polyurethane resin, injected with a dual-component **M2 Air Pump** assembled by Prime Resins, and **Prime Flex 920**, a water-activated hydrophobic polyurethane resin, injected by a Titanelectric airless single-component pump.

Prime Resins' material is engineered to maintain a flowable consistency, which enhances the resin's ability to completely fill the joint and seal out infiltration.
