# TOLL GATE SEWER REPAIR

## ONE-YEAR INSPECTION REVEALS GREAT RESULTS IN MANHOLE REHABILITATION PROJECT

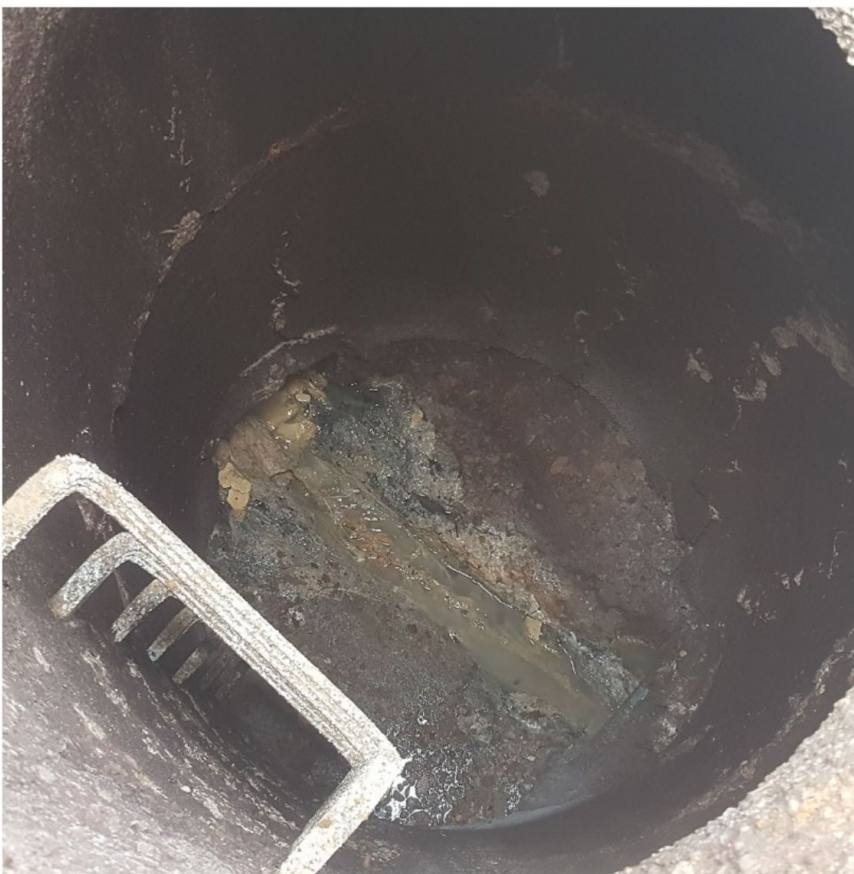
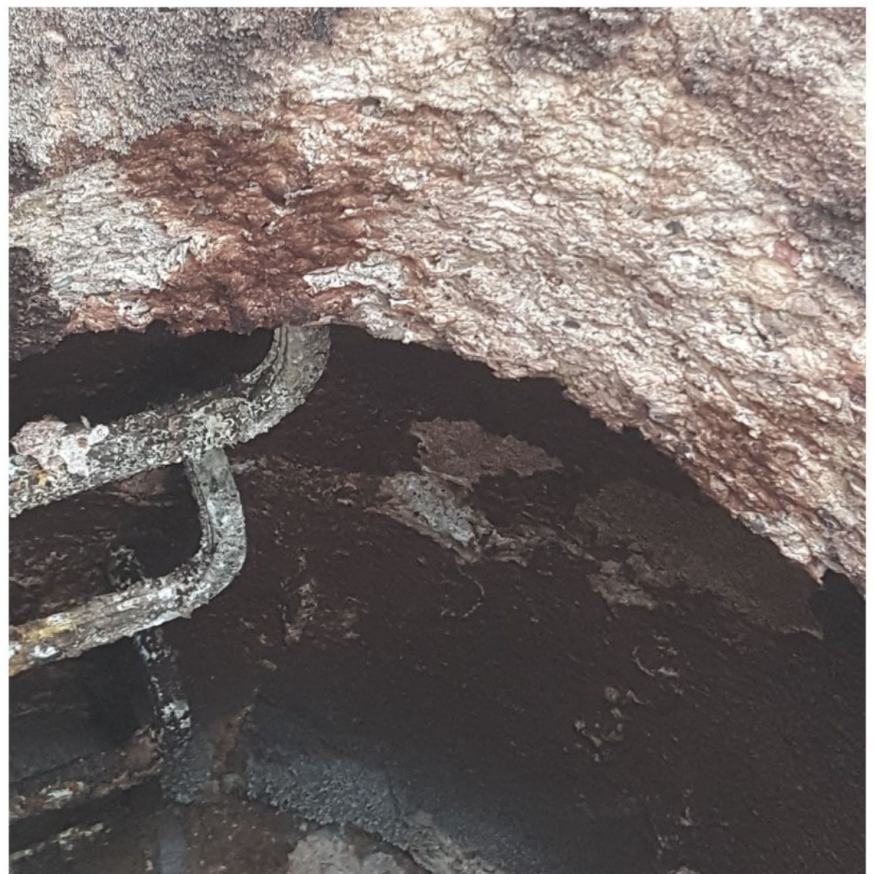
### PHOTOS

The project was completed in April 2019 and was inspected a year later. The inspection team pressure-washed the structures and then performed multiple pull tests. All the manholes were in great condition, with pull test results ranging from 730 to 1,422 psi.

Warren Environmental's 100% solids epoxy coating system was specified, and our approved applicator, A&W Coatings, was awarded the job. The manholes remained in operation while the project was completed. A&W internally bypassed the system utilizing flow-through plugs and was able to work in live-flow conditions. After the team prepared the surfaces through high-pressure water blasting, they coated the structures with a minimum of 250 mils of epoxy, with some requiring as much as 375 mils based on the deterioration. All interior surfaces were coated, including the bench and the invert.
