Undersealing a dam spillway with Prime Resins product

Prime Flex 920 hydrophobic polyurethane foam seals a leaking spillway on a manmade lake

Client: City of Lake Quivira, owner of the Quivira Lake spillway (Suburban Kansas City, Missouri)

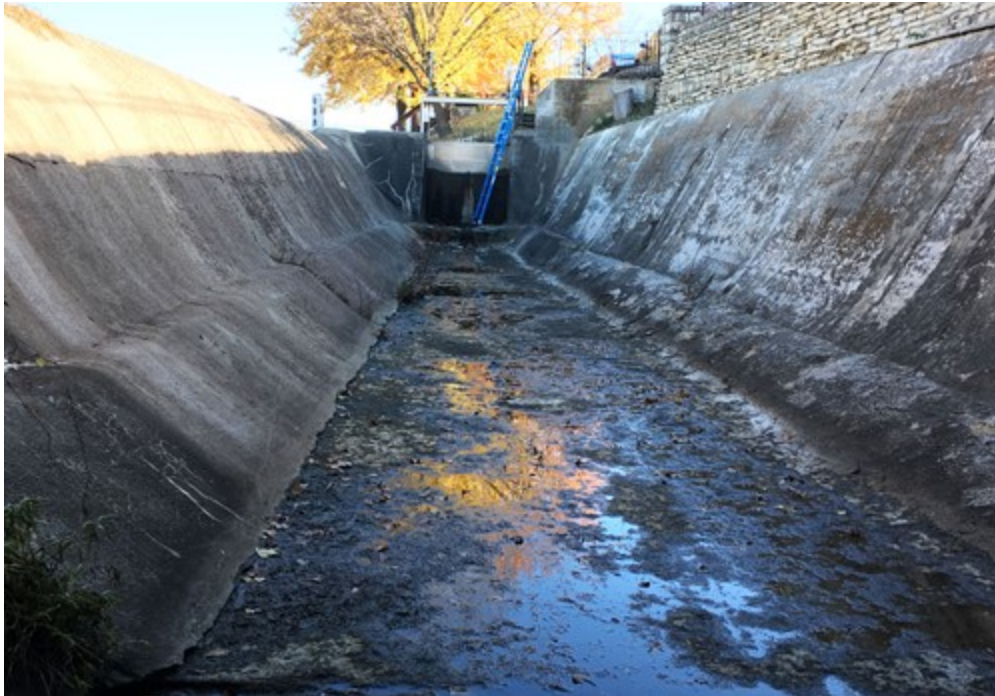
The spillway of a dam on a manmade lake in Lake Quivira, Kansas, was leaking. Water was coming from the lake side and seeping through the concrete across the sides and the bottom. There was standing water at all times. City officials were afraid the leaks would reduce the lifespan of the structure due to the constant water penetration.

The contractor, working with an engineering firm, consulted its Prime Resins technical consultant to explore chemical grouting options. The rep recommended **Prime Flex 920**, a hydrophobic, water-reactive polyurethane, to curtain grout the sides and underseal the bottom. This product has been used successfully in other dam projects and countless curtain grouting applications. The contractor was familiar with 920 since they had used it before though in much smaller applications.

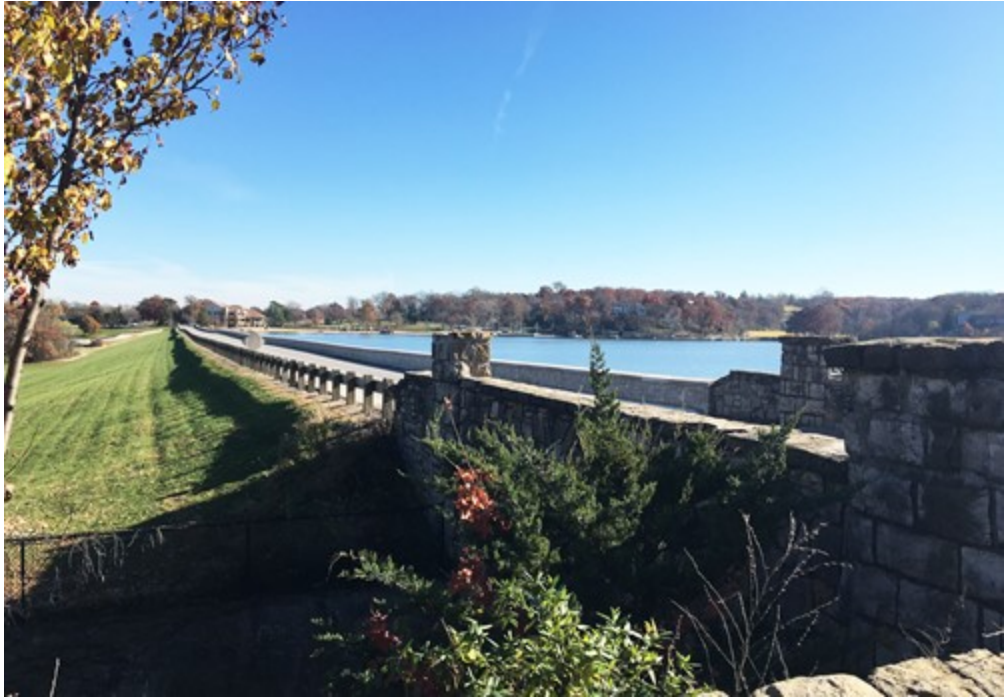
“Everyone is really happy,” said the contractor. “I went by there a few weeks ago (nearly six months after completing the work) and it was **bone dry with a full lake level. Nothing was seeping in.**” The contractor also got another spillway job as a result. A dam owner came by during the Lake Quivira project and saw what they were doing and hired them for a similar, though smaller, project.
