# Void Fill of Culvert Washout With Polyurethane Foam

**Client:**N.C. Department of Transportation

**Contractor:**Applied Polymeric Inc.,Mt. Airy, NC

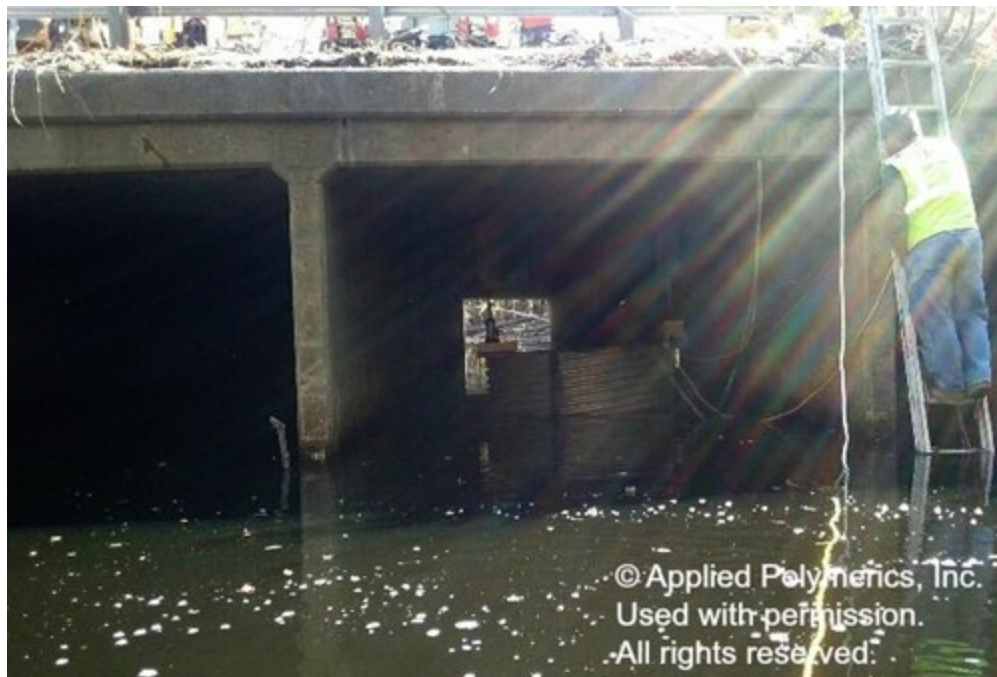
Approximately six miles north of Lumberton there is a triple barrel box culvert under I-95. Each barrel is 12' x 12', so essentially there is a 36'-wide culvert under the highway. Storm-related flooding caused a major washout underneath the inlet end, leaving a huge void threatening the culvert's integrity. That, in turn, would lead to a compromised highway in the long run. The North Carolina DOT completely shut down I-95 there for a time due to flooding. When flood waters receded, just one lane opened; the lane above the void remained closed.

NCDOT tried filling the void in-house with cementitious grout over a weekend, which was not successful. That Monday NCDOT officials hired one of its contractors, Applied Polymeric, to solve the problem. They opted to fill the void with **Prime Flex 985 LX20 Fast**,

a highly expansive two-component polyurethane. The Fast formulation reacts in 12 seconds versus 68-70 seconds and reaches full rise at 65-85 seconds.

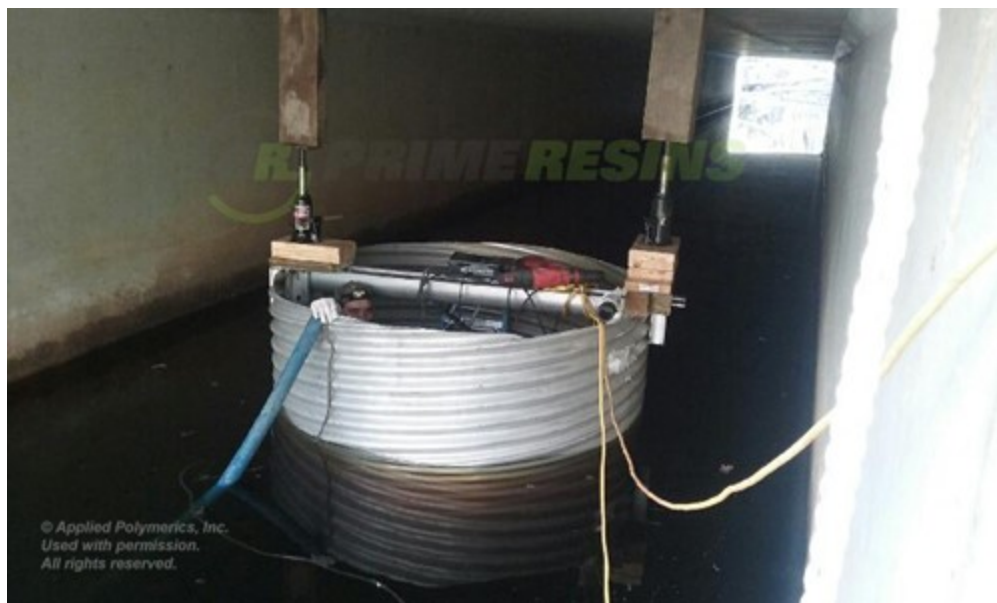
The flood level of the water created a nearly impossible work site, essentially an underwater grouting job. To preserve as much material as possible and to ensure the grouting technicians didn’t have to work in chest-high water, they installed a cofferdam of corrugated pipe. They secured the pipe with joists against the culvert ceiling and sealed it at the bottom.

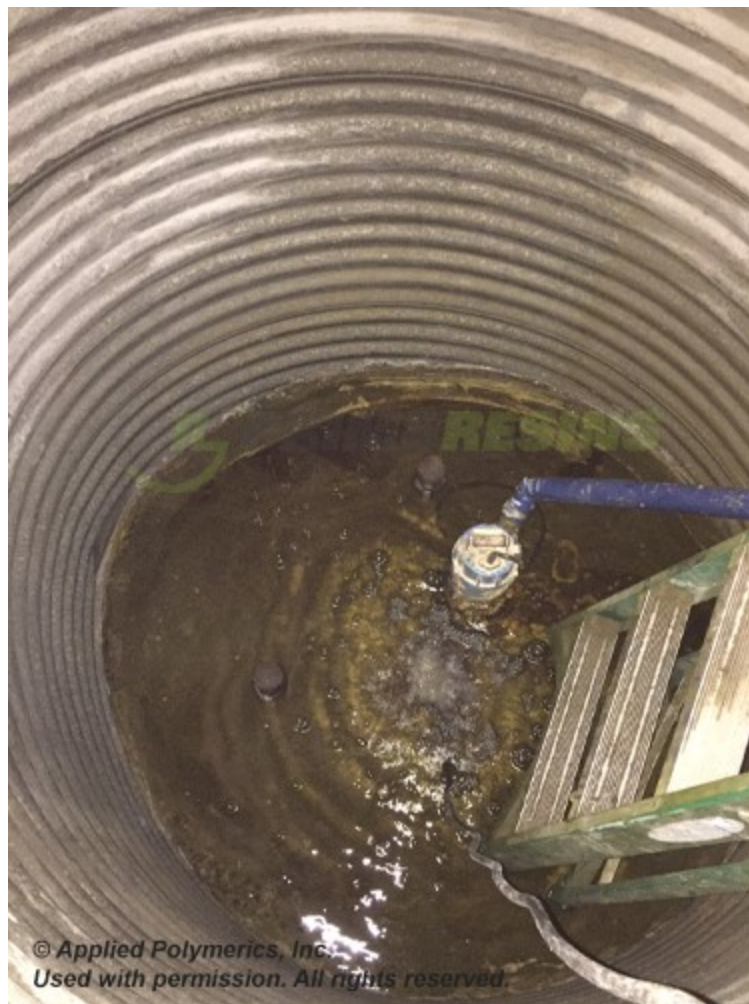
*A cofferdam sealed at the bottom minimized the flood waters so techs could inject polyurethane grout under the culvert to seal the massive void.*
