How to Seal Grout Joints in Boulder Seawall SealBoss Corp.

Cold joint and crack injection of grout joints in Natural Boulder | Rock | Stone | River Seawall using the SealBoss 1510 Water Stop Foam – NSF Listed and Drinking Water System Component Approved injection System

Location: Granite Boat Chute, Arkansas River, Colorado

Objective: To Seal Leaks and Repair Cracks in Seawall Grout Cold Joints

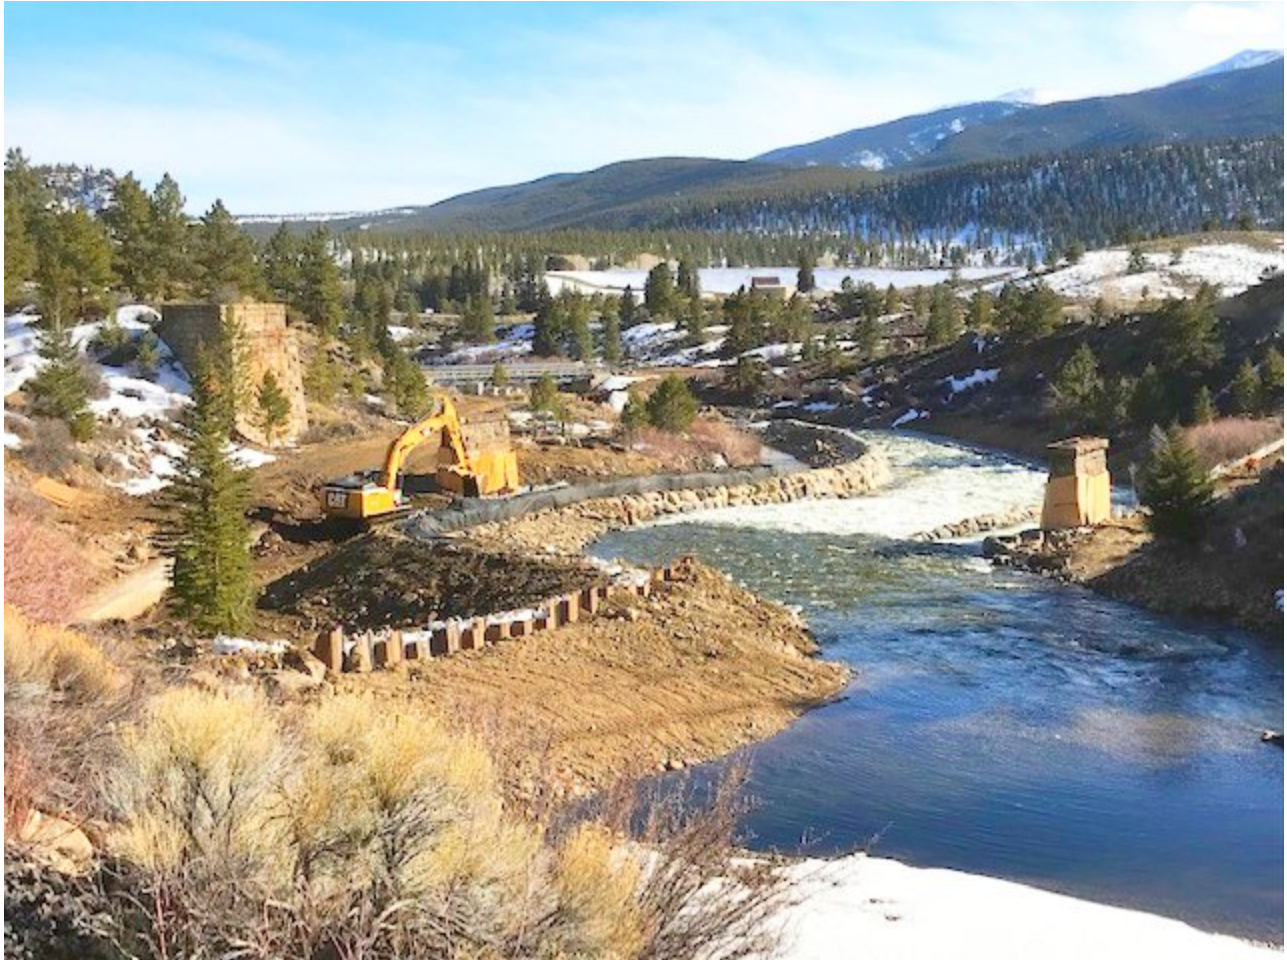
Granite Boat Chute | Arkansas River, Colorado

During a repair last season on the divider seawall and re-installation of a section of the boulder wall a cementitious grout was used to bond boulders together and to bond to existing boulders and existing grout. Over time some of the cold joints between the old grout and new grout started leaking. Leaks also developed at bond failures between the natural boulders and rocks, and the cementitious grout. Hairline cracks also developed to contribute to water seepage.

SealBoss 1510 NSF hydro active foam, an environmentally friendly product with NSF drinking water contact certification, was injected into the areas of bond failure to seal the boulder seawall from water intrusion and to prevent future water induced issues with freeze / thaw cycles that contribute to further damages and eventually could lead to blowing out the seawall.

Spacing of the packers was at an interval of 12” and the catalyst was initially at a 5% by volume to allow for travel down in to the areas between the stone to ensure a proper seal throughout the conglomeration. Later the accelerator was increased to a 10% by volume to 1510 to foster a more rapid reaction and cure to fill in some of the remaining voids.

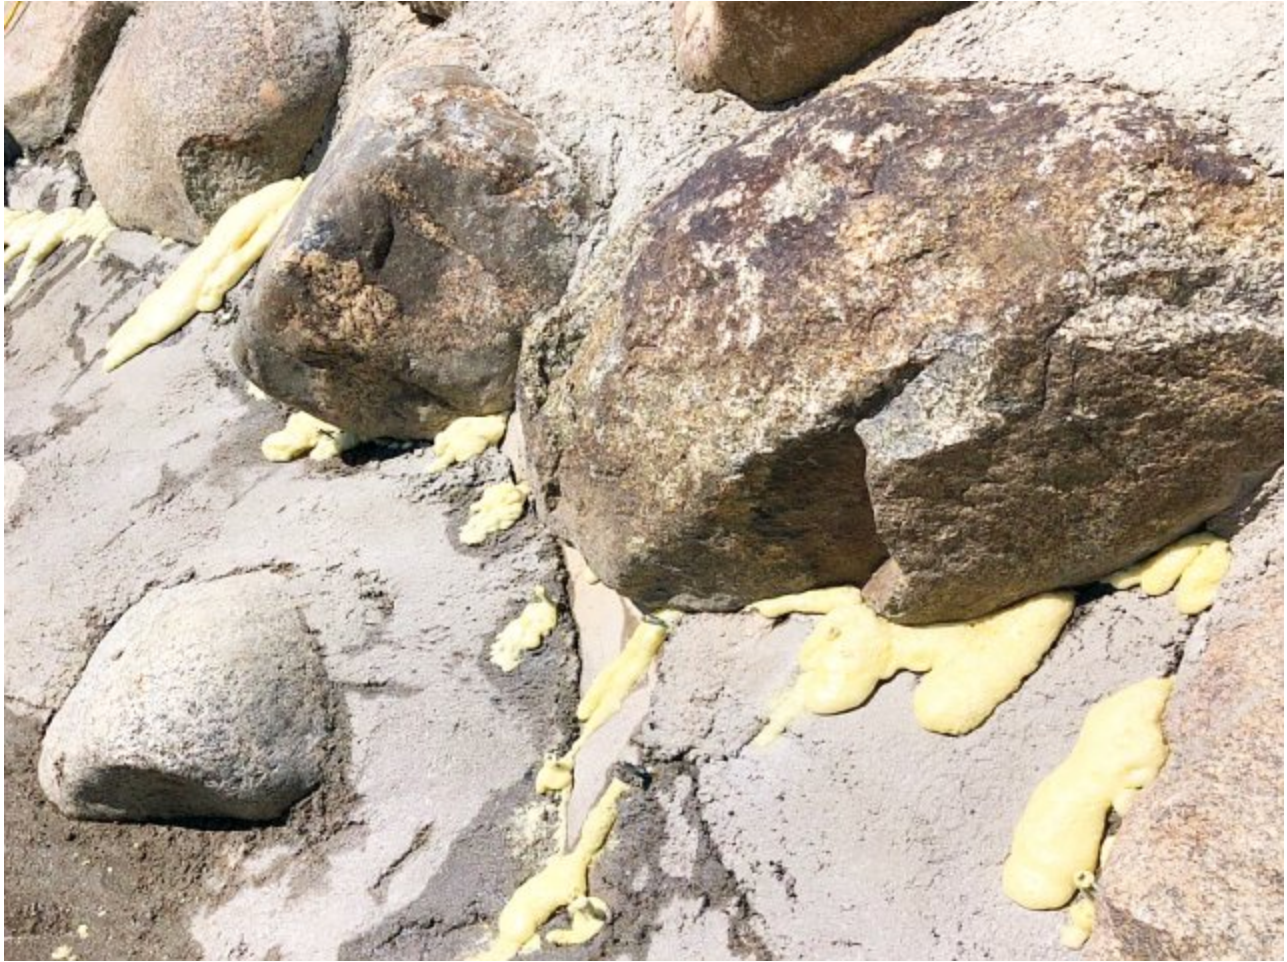
SealBoss® Seawall Repair | Cold Joint | Crack
