Manholes – Case Study 4

Manhole/vault rehabilitation –
Yellowstone National Park

National Park Service

Yellowstone National Park, Wyoming

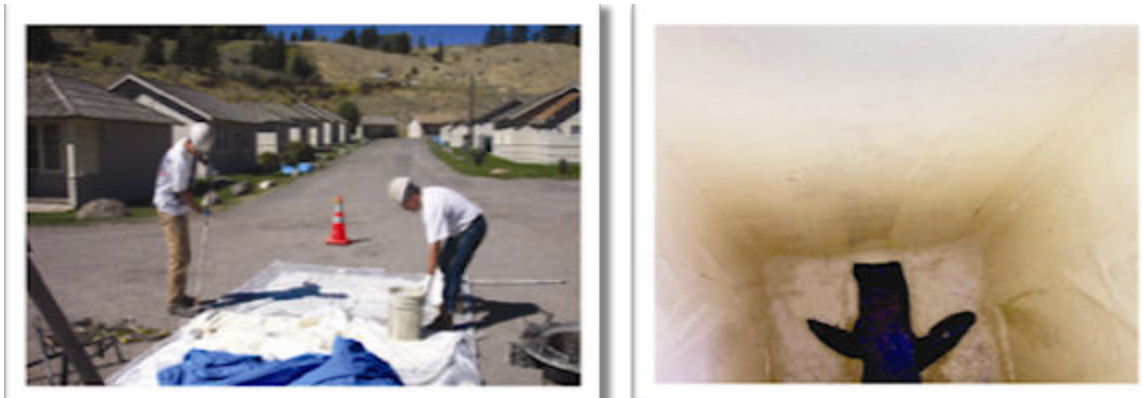
Upper Left: Liner is being saturated at the jobsite with 2-part epoxy resin.

Upper Right: Poly-Triplex Liner installation is complete and structure is back in service.

Custom fabricated liner was manufactured by Poly-Triplex Industries, LLC to fit the size and shape of the box structure. Liner was saturated at the jobsite with a 2-part 100% solids epoxy resin, then positioned into the structure. Liner was then cured-in-place with air pressure and steam heat forming a monolithic liner from the ring and cover to the benches.

This deteriorated vault was completely rehabilitated in one day with the Poly-Triplex Liner System. The entire project was completed in a timely manner. Since this installation, the National Park Service has become to rely on the Poly-Triplex System to correct problems in many other structures including manholes, pump stations and wet wells located throughout the National Park System.
