DC Water National Arboretum Aerial Sewer Crossing Renewal

Project Overview

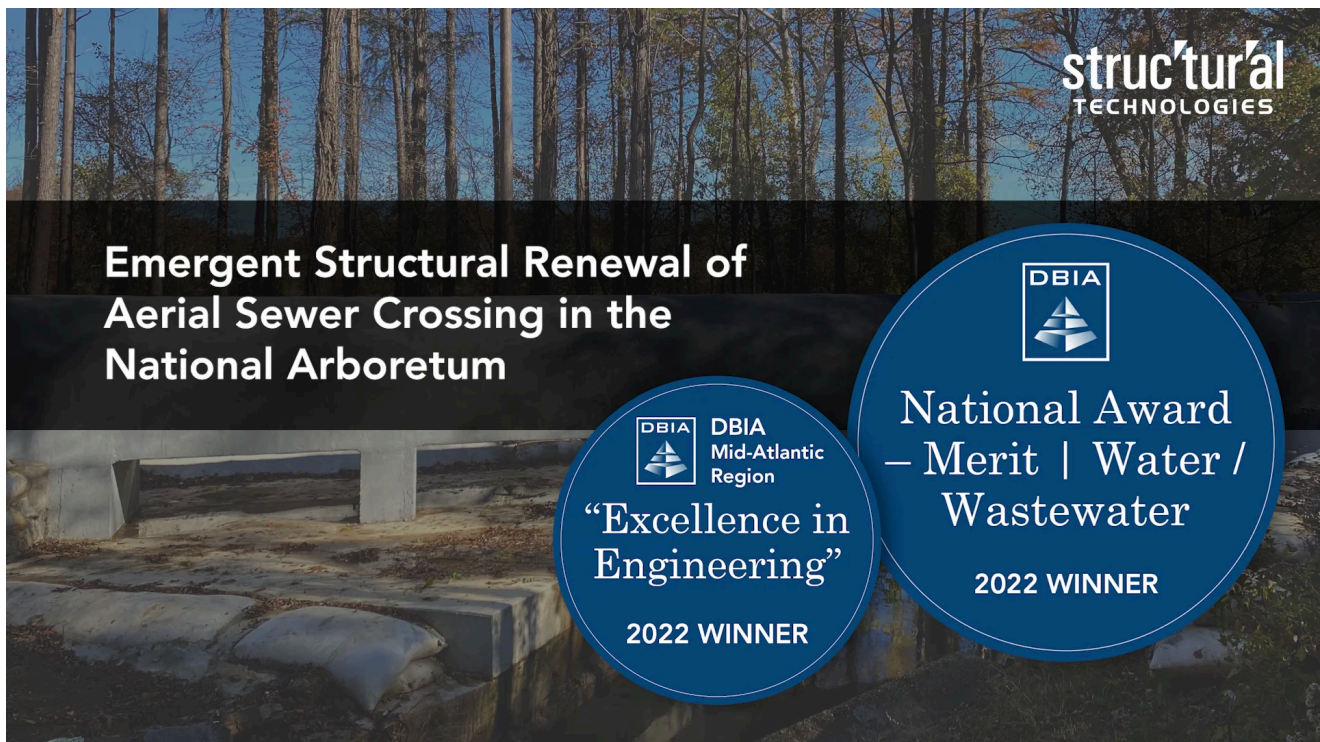
In the National Arboretum in Washington, D.C., an aerial sewer crossing over Hickey Run was significantly impacted by record-setting flooding and erosion.

Inspections revealed spalled concrete at the upstream abutment and that the foundation had become compromised.

The design-build approach led by DC Water brought together the project team to collaboratively develop a multi-faceted solution for the renewal of the pipe encasement and five piers. The in-situ rehabilitation consisted of 58 LF of the aerial sewer crossing and critical support structure.

Micropiles were augured into the ground and cored into the existing concrete to stabilize the foundation and tied into the newly placed concrete enlargement for the foundation. To provide support for the addition of new piers, a 20-inch-thick foundation was placed on the north and south side of the crossing.

rebar. Five new concrete pier-on-piles replaced in-situ piers. New stand-alone piers were installed adjacent to the stream and designed to support the load of the existing piers should they deteriorate.

The team also inspected the pipeline encasement and prepared the surface for 675 SF of concrete repair. STRUCTURAL TECHNOLOGIES designed and supplied an innovative strengthening system to minimize enlarging the pipeline while increasing its capacity to span the creek. The StrongPIPE® V-Wrap™ fiber-reinforced polymer (FRP) system was chosen for the repair for its ability to rapidly restore capacity and prevent future structural distress. The team installed 200 SF of the lining system on the pipeline encasement to address bending moment and strengthen the unsupported span over the creek. In addition, two layers of Glass Fiber Reinforced Polymer (GFRP) were installed along with a UV stable topcoat for durability and to protect against future corrosion. Lastly, grout bags were installed on the banks to prevent erosion.

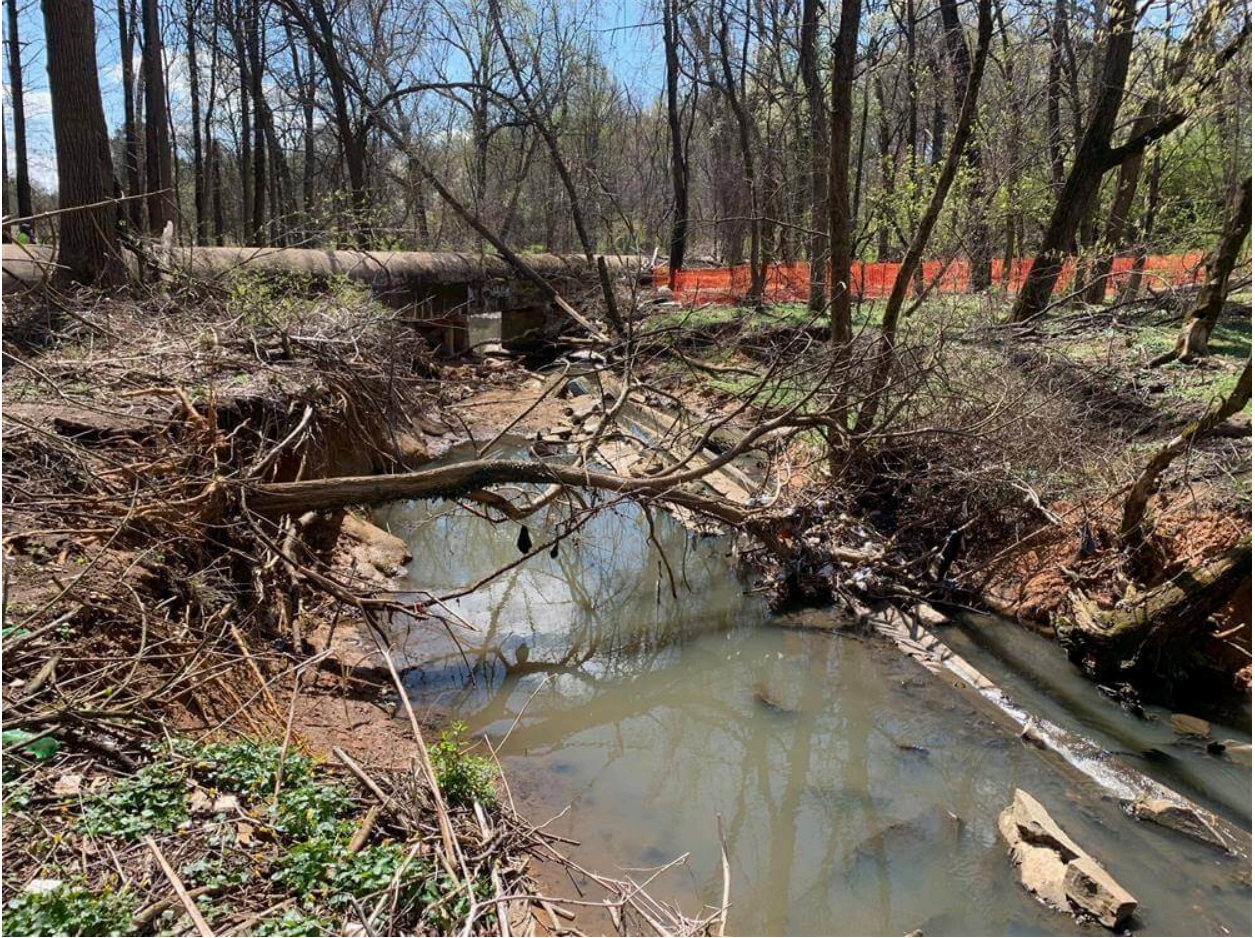
The aerial sewer crossing was significantly impacted by surge flow and required an emergency design-build repair

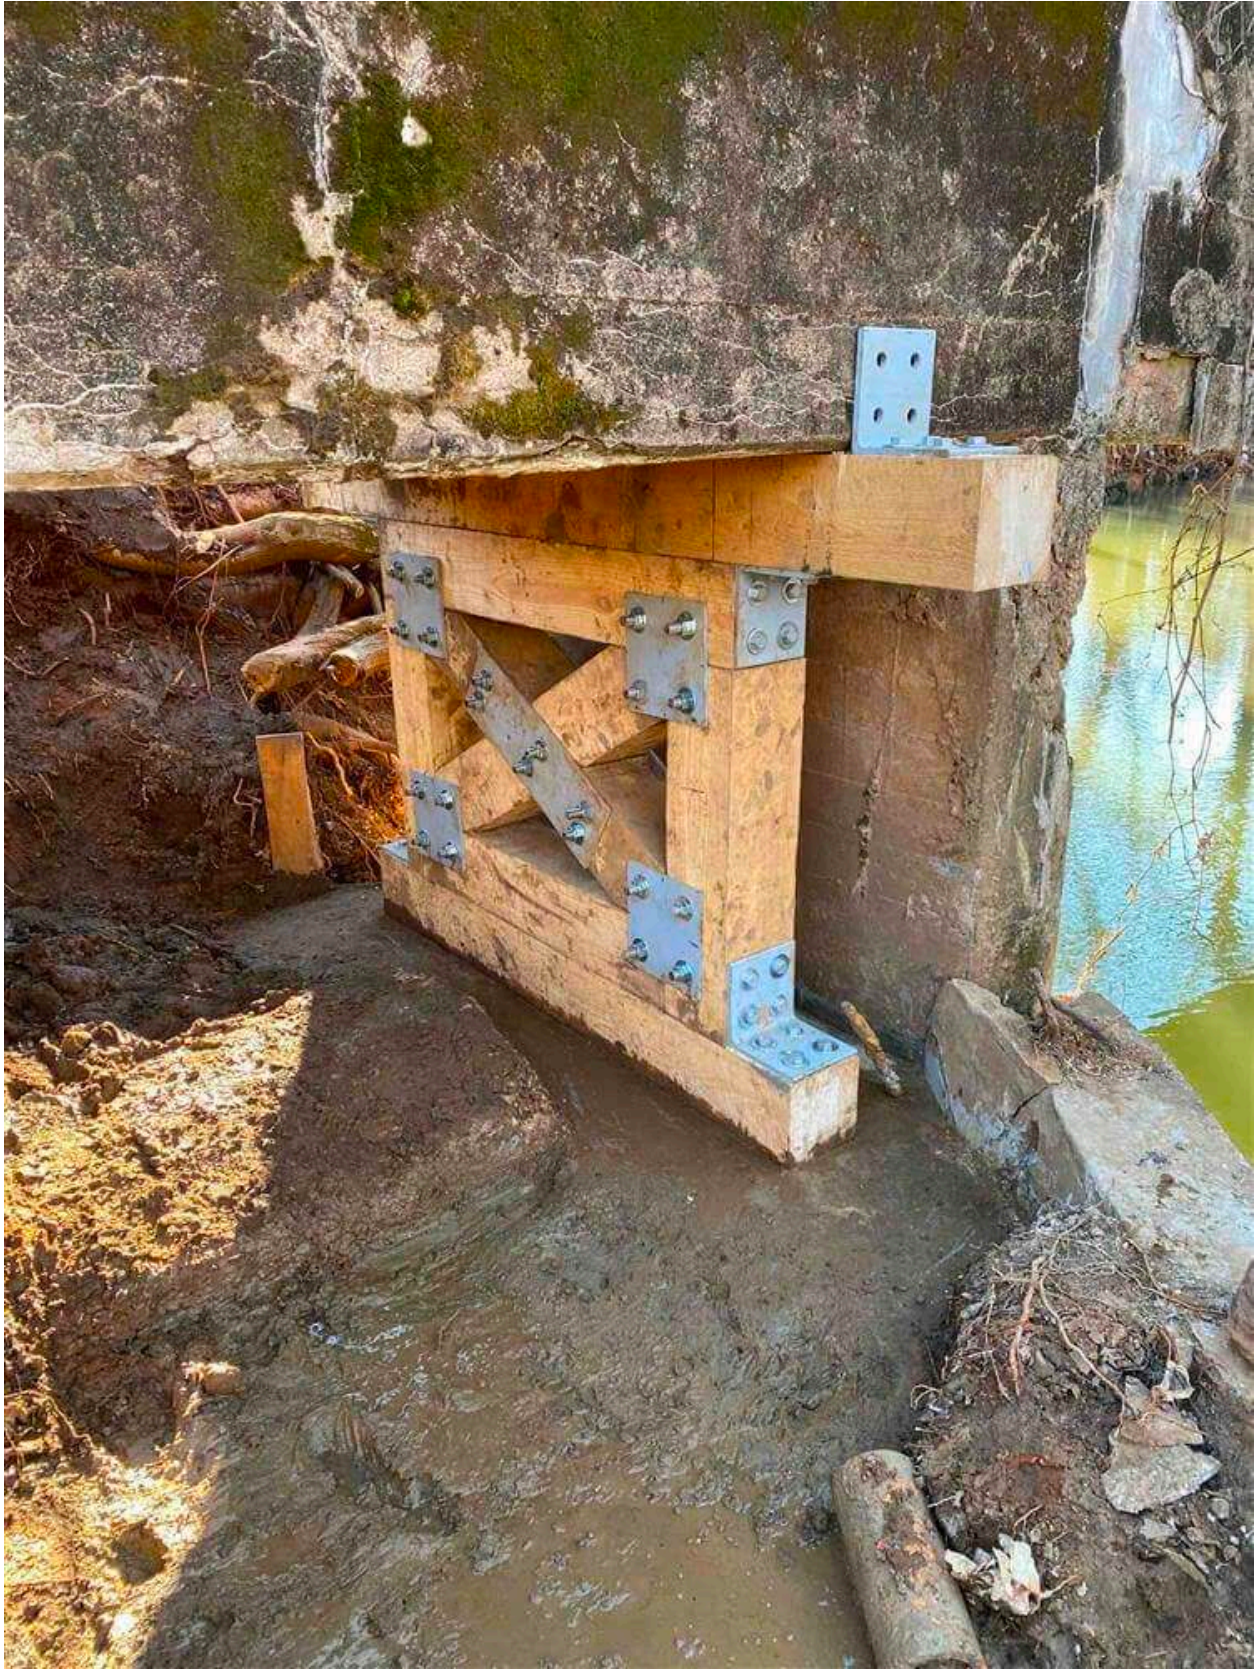
Emergency shoring was installed prior to access road construction and repairs.

The team installed emergency shoring prior to constructing access roads and implementing repairs. The project involved extensive coordination to ensure minimal disruption to the Arboretum, protection of native trees as well as avoiding contamination of Hickey Run. As such, the design-build team developed a repair plan to avoid contact with the creek. Crews worked outside the creek bed, used scaffolding to span the width of the creek, strengthened piers outside of the creek, and isolated the work area to prevent debris and contaminants from interfering with the environment.

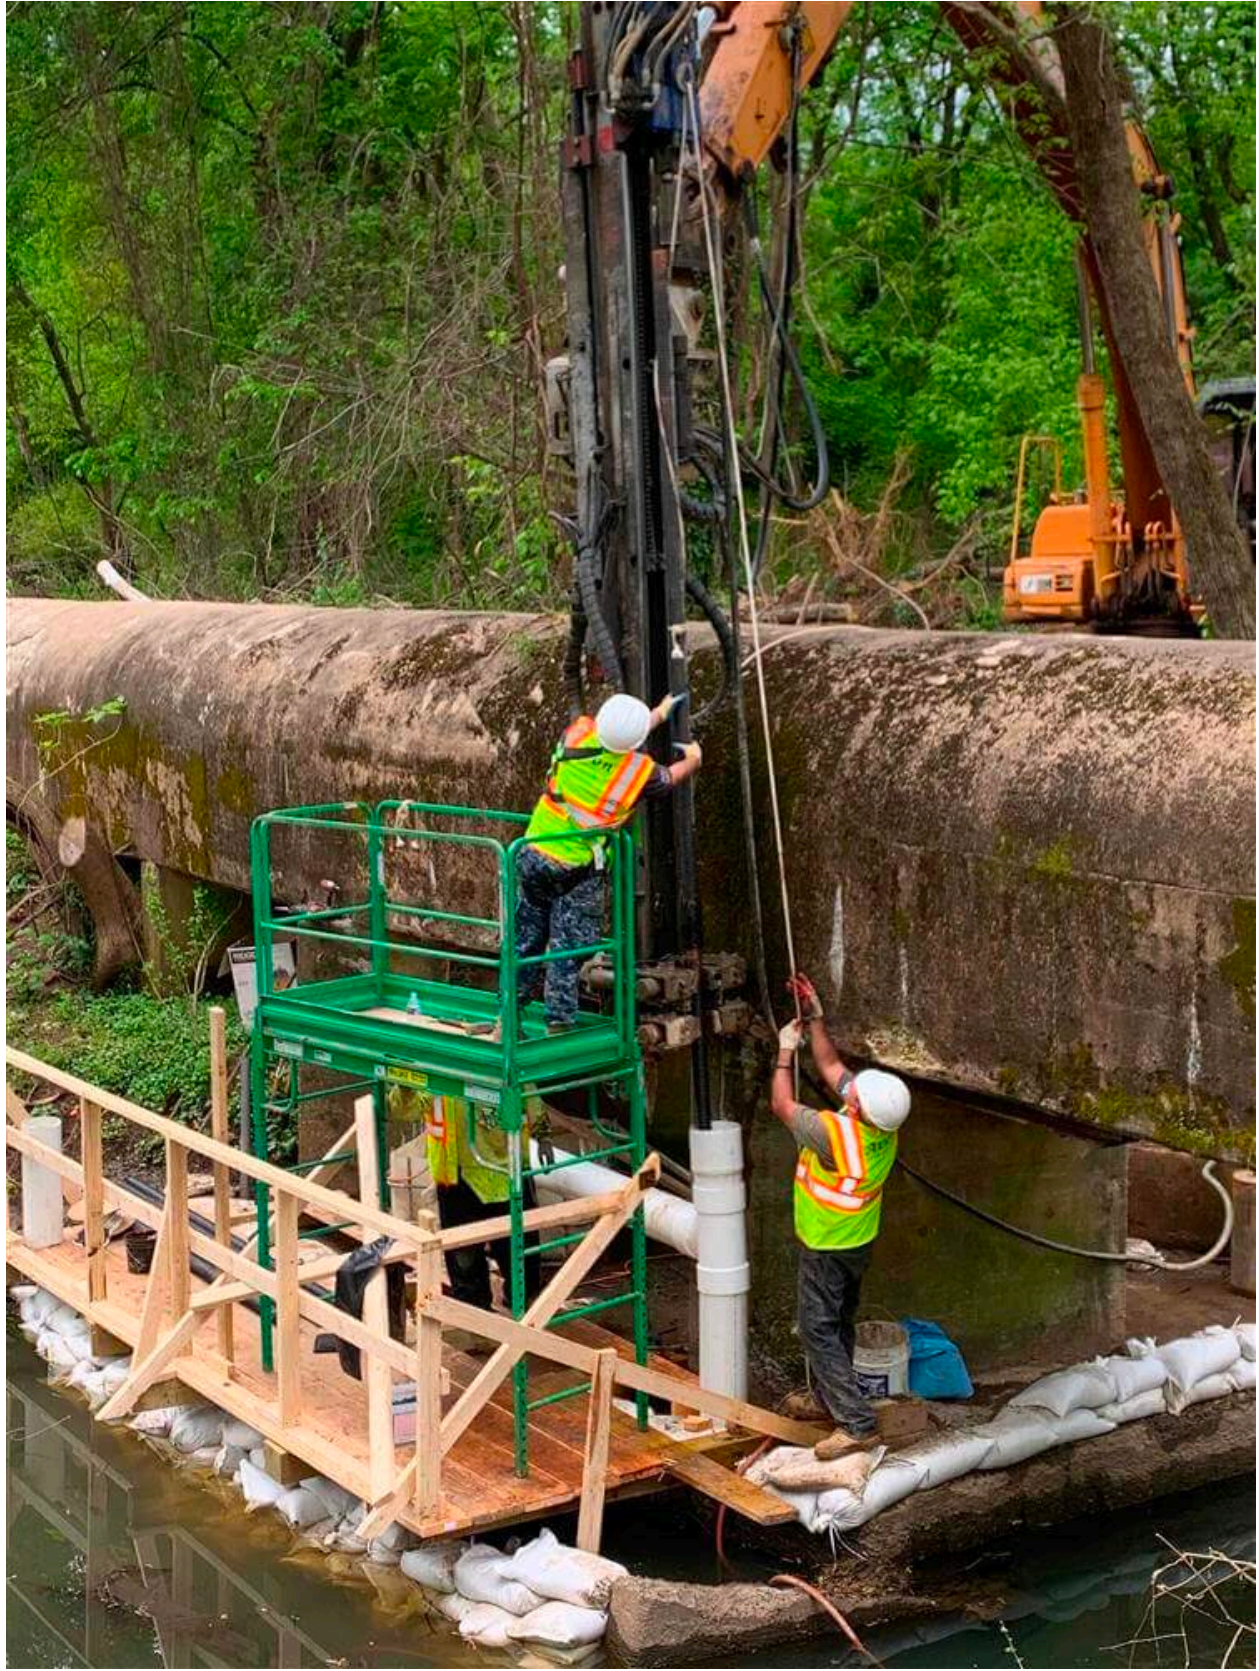
Twenty-six micropiles were installed to stabilize the foundation and were tied into the newly placed concrete enlargement of the foundation.

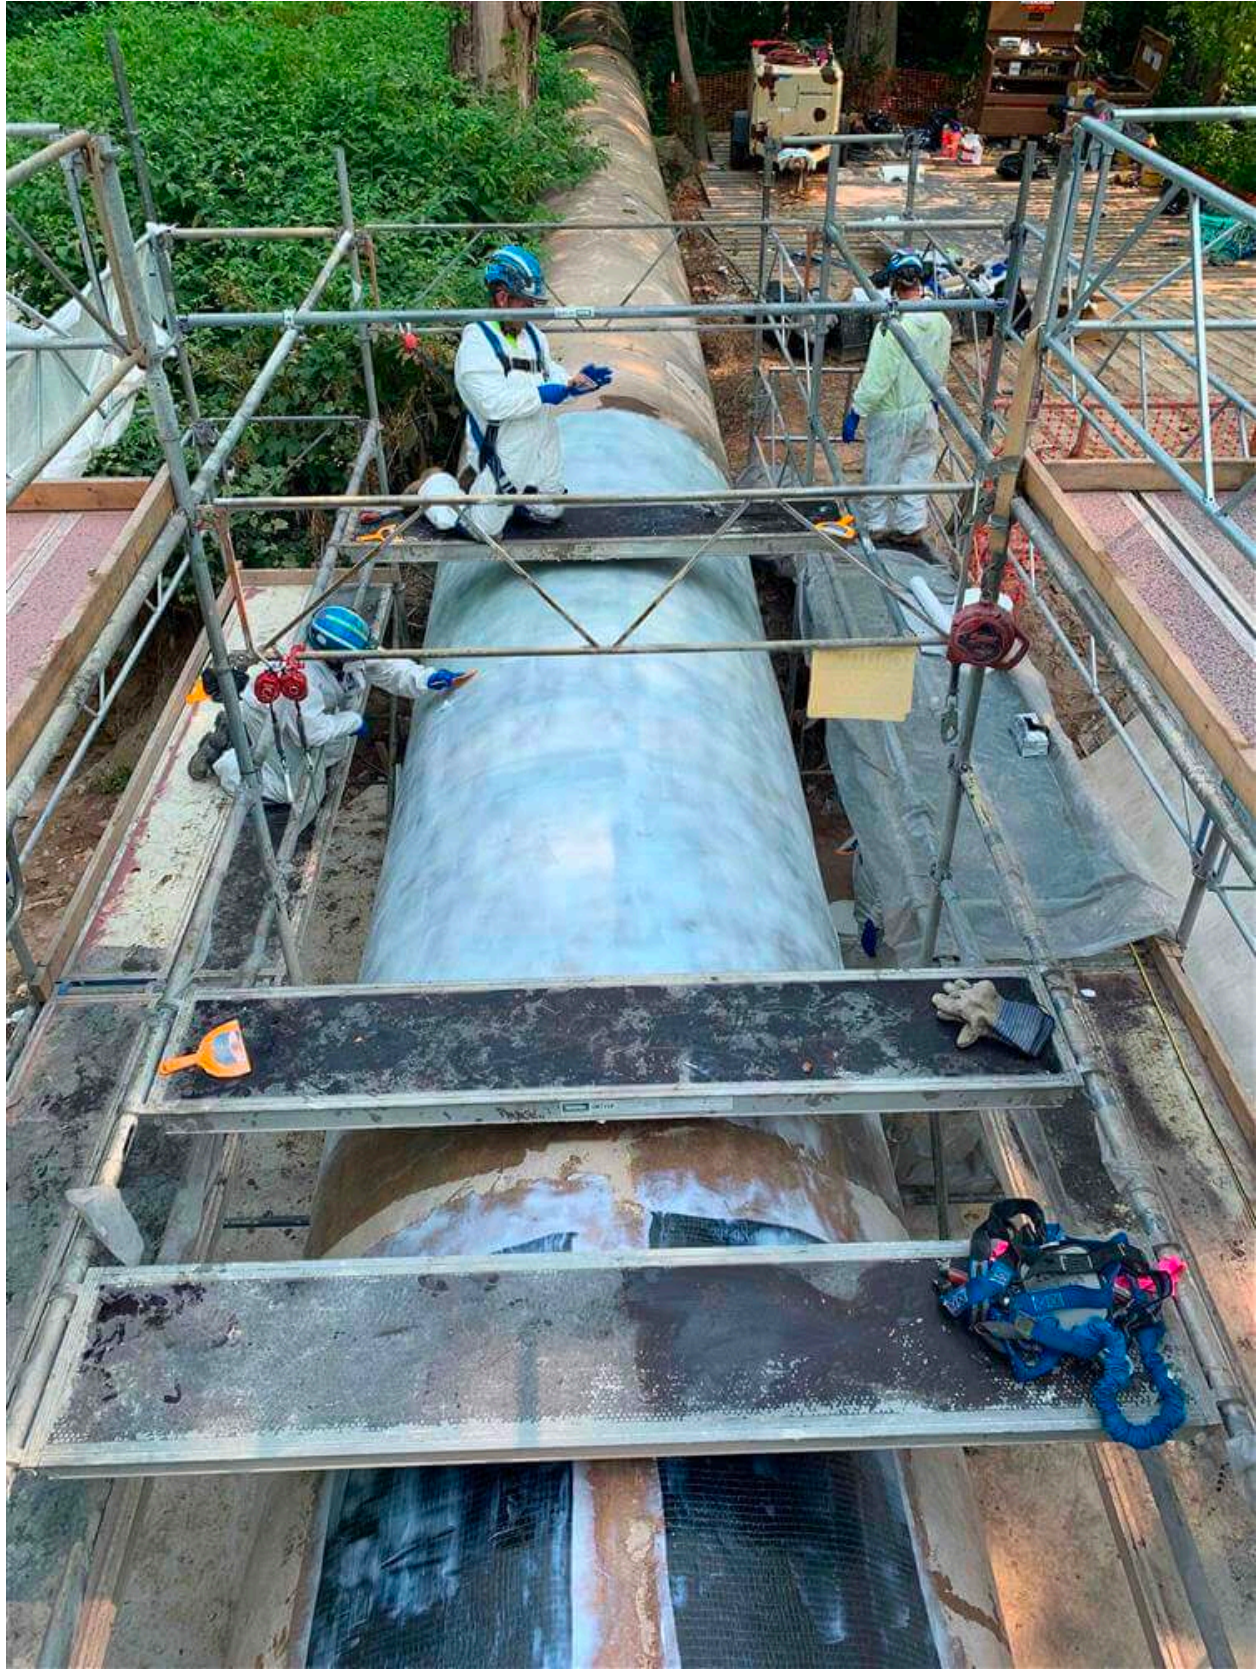
Crews installed StrongPIPE® V-Wrap™ Carbon and Glass Fiber Systems on the exterior of the aerial sewer.

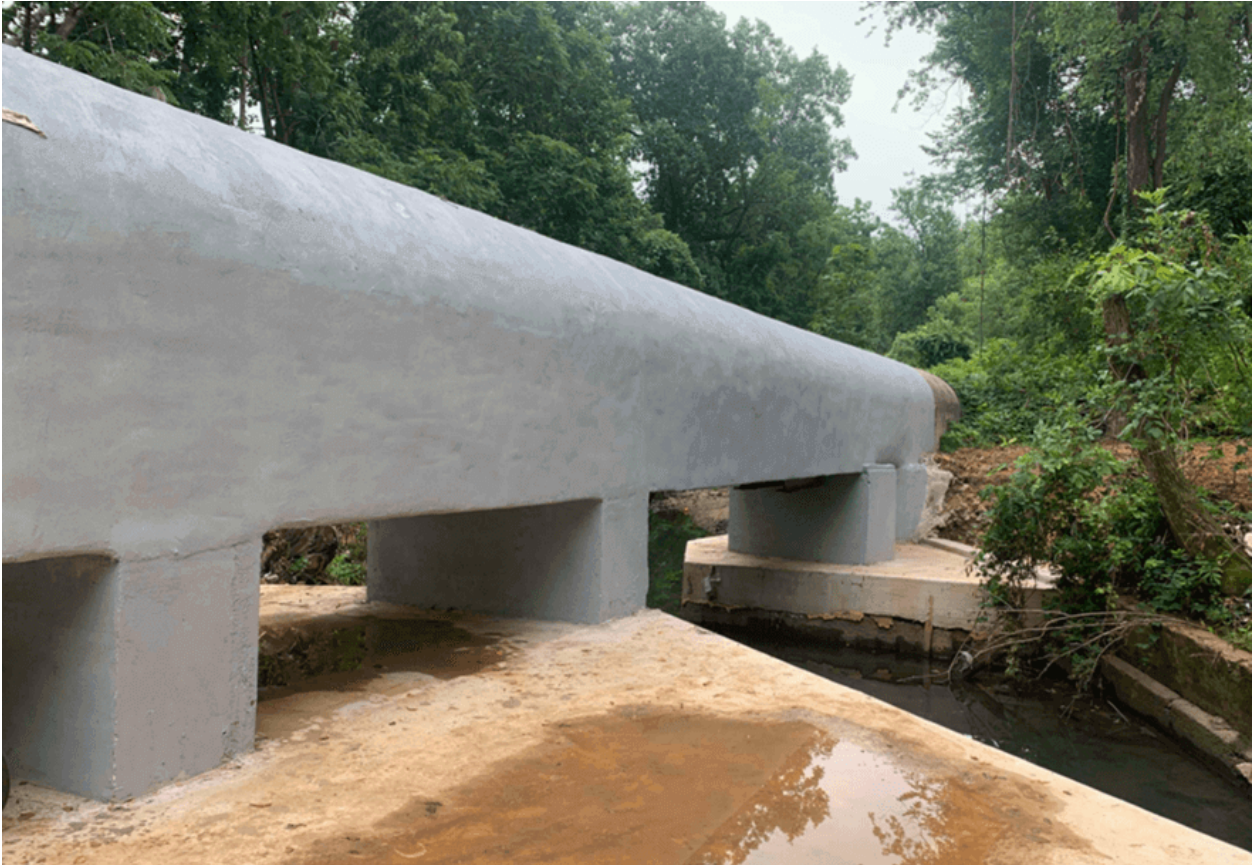
Completed in-situ rehabilitation of 58 LF of the aerial sewer crossing and critical support structure.
