CASE STUDY: Revitalizing a Century-Old Home's Plumbing System with Innovative CIPP Spot Repair

Homeowners facing a non-functional century-old farmhouse bathroom find a cost-effective, non-disruptive solution to severe clogging and deteriorating pipes, sidestepping excavation, and ensuring a lasting fix.

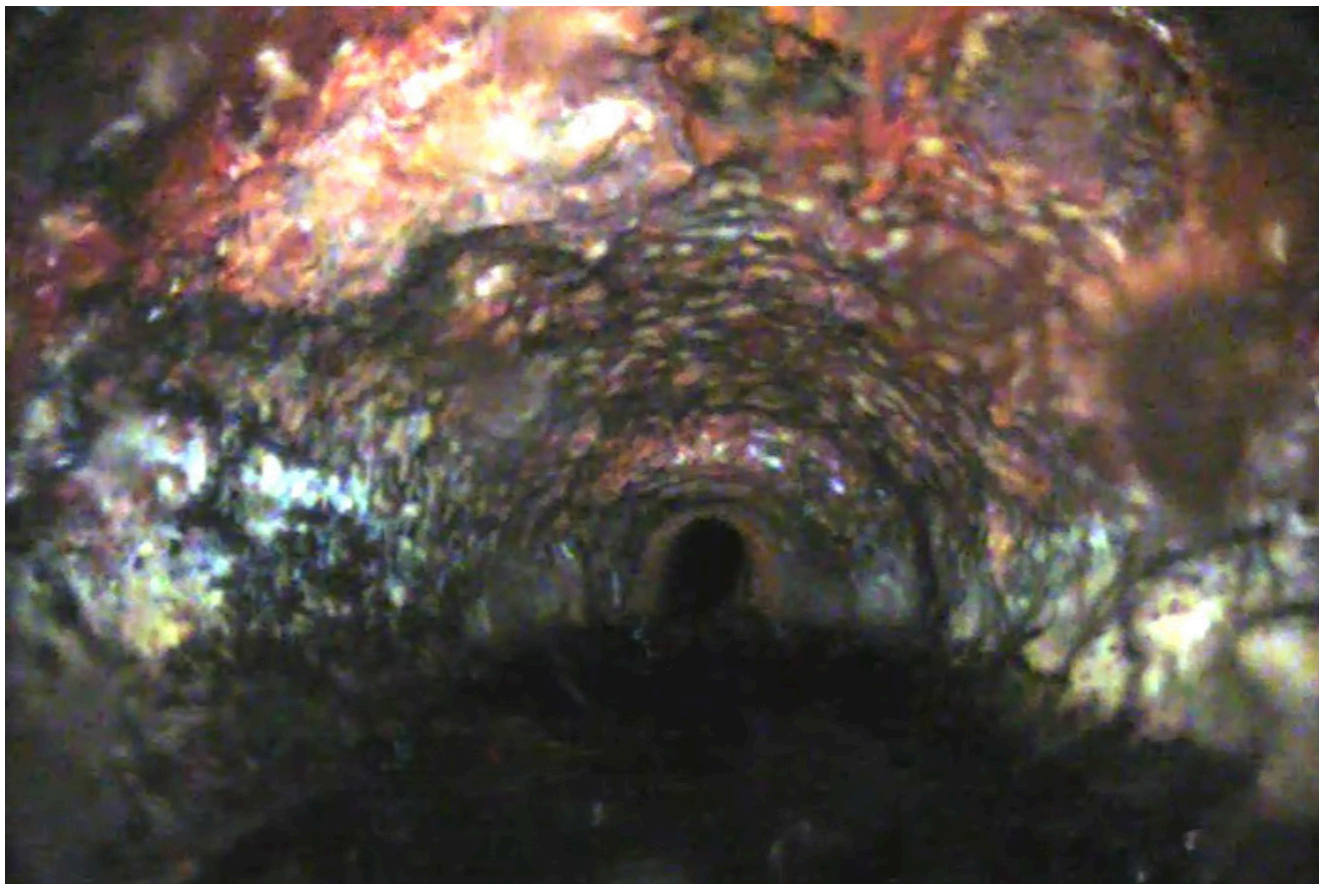
Deteriorating cast Iron pipes and blockage causing severe clogging and backups.

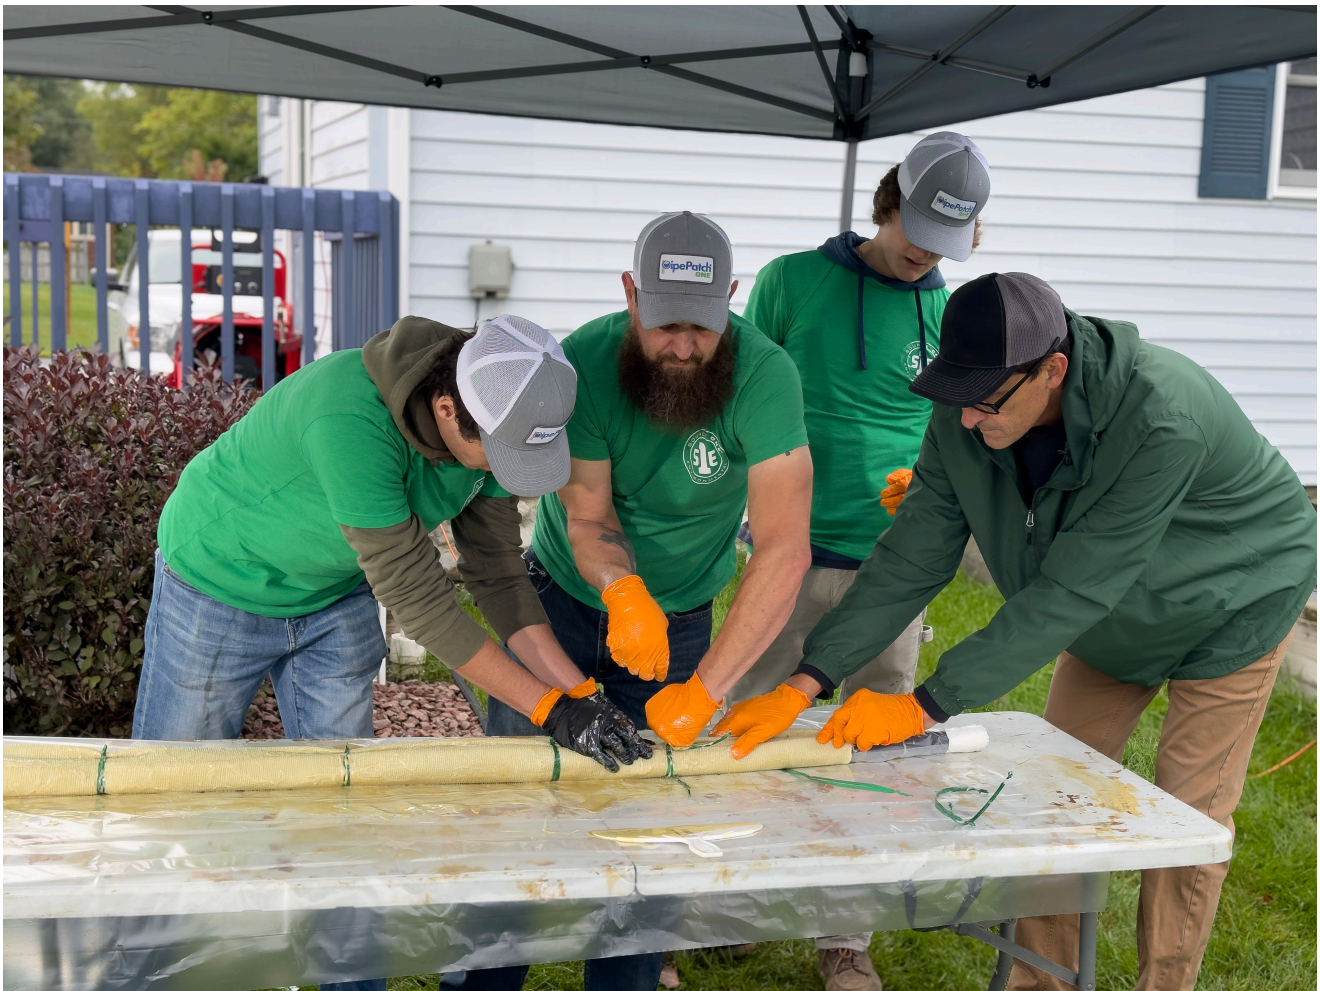
Prepping the XTEND Packer - Spot repairs offer faster solutions, targeting specific damage without the extensive downtime.

S1E connected the homeowner with a contractor who assessed the issue by utilizing a CCTV camera to inspect the line in advance and recommended The PipePatch® XTEND system for the primary issue. Available for 3"-10" diameter pipes, PipePatch® XTEND is a longer spot repair solution than standard 24" and 48" patches, featuring an extra-long packer and complete push-in-place or pull-in-place liner kit. By eliminating the necessity for excavation, the PipePatch® XTEND addressed the core issues by creating a new pipe within the cast iron pipes without disrupting the homeowner's property. This non-intrusive approach not only reduced costs significantly but also provided a sustainable, long-lasting solution to the homeowners' plumbing problems.
