# Project | CPM Pipelines

## Non-Destructive Phased Pipe Condition Assessment

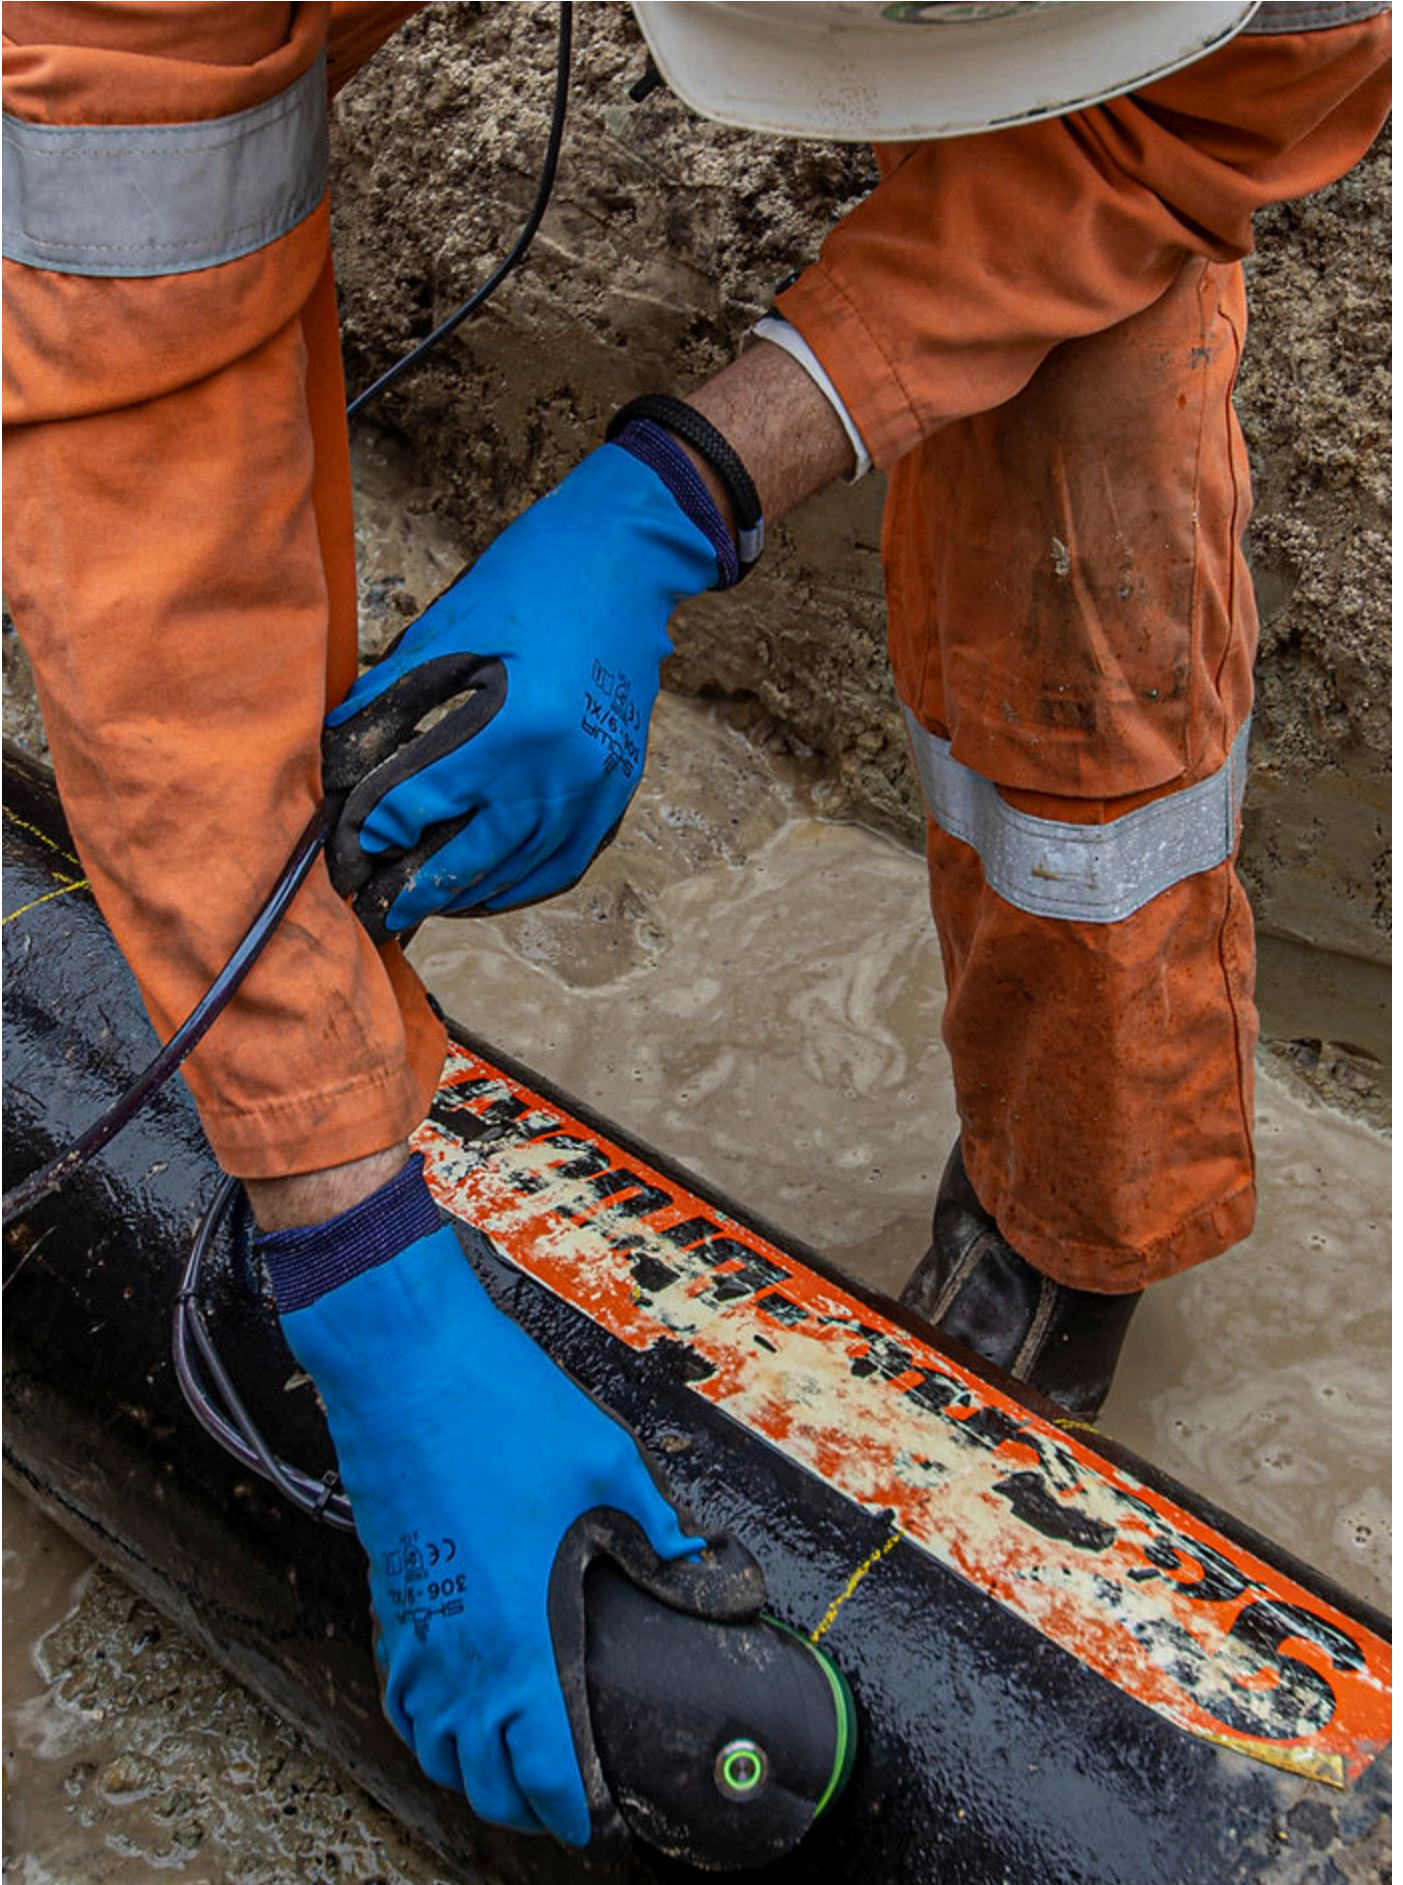
Like the DIP condition assessment, after the Pipers® detect areas of concern along the AC pipeline a specialized tool is used to precisely locate spots of degradation. For AC pipe CPM utilizes the AC PipeScanner by Acquaint. Like the Bracelet Probe, the PipeScanner (shown in Figure 1) allows the user to detect structurally degraded areas of pipe wall using ultrasonic transducer technology. The UT sensor within the PipeScanner unit is coupled to the pipe wall with

water to allow the signal to pass easily to, and through, the pipe wall. The tool is manually passed over the pipeline while it records thickness data according to portions of the pipe that have lost structural strength. As it is moved, a constant stream of water is introduced at the sensor. Scans are completed at a rate of several feet per minute and the tool moves longitudinally in the direction of flow. When one scan is complete, the tool is moved to the next clock position and another scan is performed. When the desired number of scans are taken, the PipeScanner is simply hooked up to a laptop computer and the data is transmitted for interpretation and reporting.

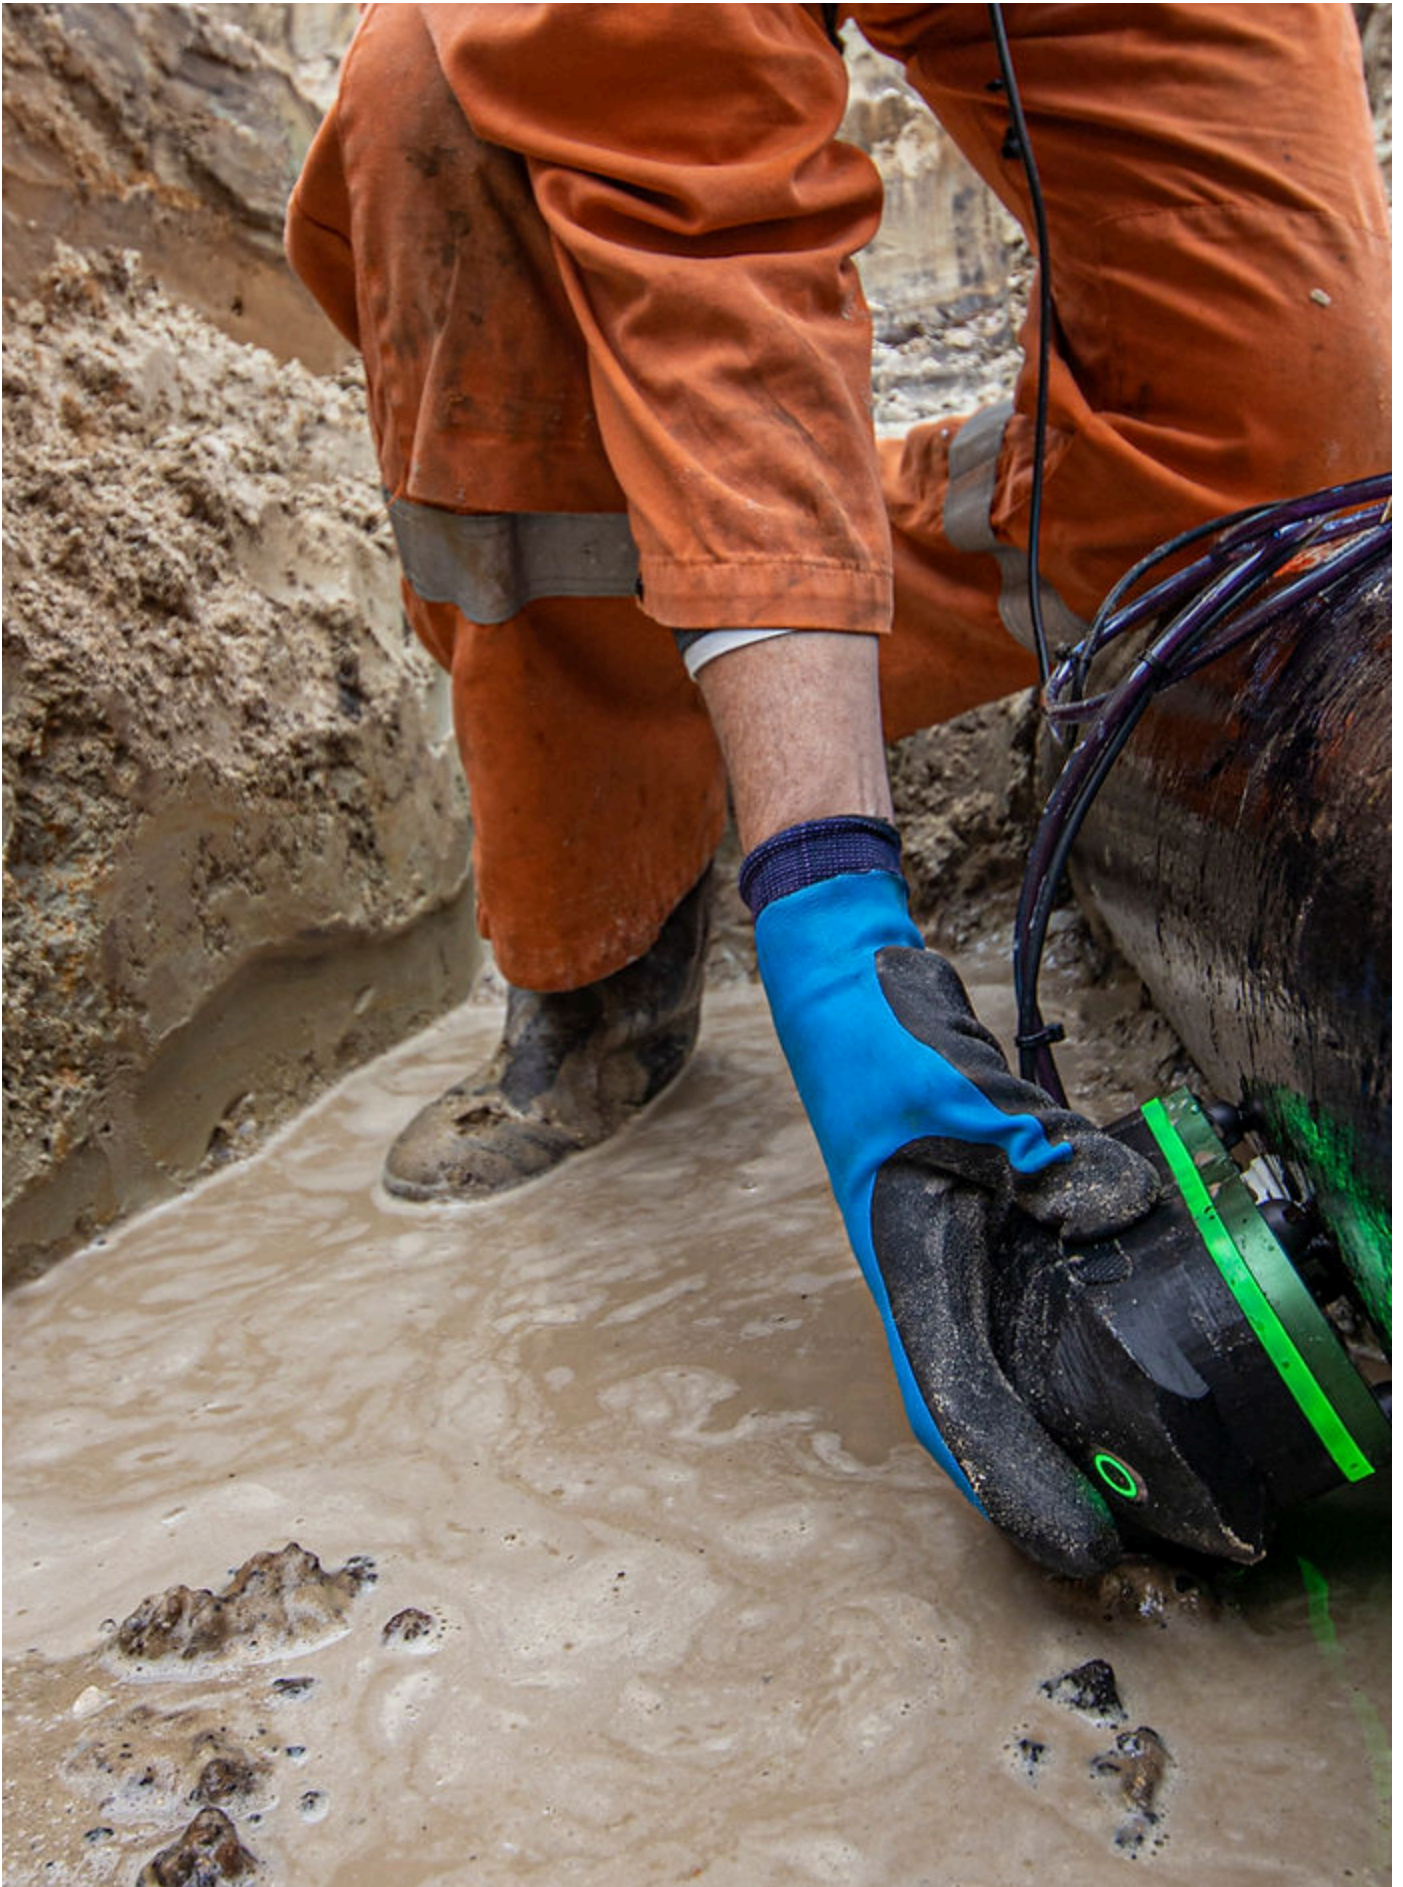
The full data output from the PipeScanner is shown in Figure 2. The graph shows the span of wall thickness measurements taken and notes have been added to aid in the interpretation of the results (clock positions are assigned as if facing toward the downstream end of the pipeline). For example, the scan carried out along the 1 o'clock position had an average, remaining structurally sound wall thickness reading of approximately 0.475-inches, a minimum of 0.380-inches, and a maximum of 0.525-inches.

As with the ductile iron pipeline, the results indicate that the AC pipeline has also undergone severe wall loss. According to prior communication, the wall thickness of the AC pipe at the time of installation was approximately 0.73-inches.

It was previously stated that wastewater pipeline degradation is typically most severe at the top portion of the inner pipe wall. As a testament to this trend, Figure 2 denotes substantial wall structure loss from the 10 to 3 o'clock positions of the section of AC pipe that was scanned. Based on the information gained with the AC PipeScanner tool, the most severely deteriorated sections of pipe were found to have experienced roughly 50% structure loss (10 and 11 o'clock position specifically). The remaining clock positions that were scanned were not much better, ranging from as much as 40% loss (2 and 3 o'clock positions) to the low end of about 30-35% loss (1 o'clock position). The loss of wall structure is caused by leaching of calcium within the pipe wall, resulting in a reduction of tensile strength.

Asbestos cement pipeline design is much less straight forward. Pipe suppliers provided specific design and operation parameters based on the mode of manufacturing, pipe diameter, and pressure class. The design parameters for the 16-inch AC line are unknown, yet with engineering judgment and the data gained from this assessment effort dictate that the severity of degradation of the inspected area is similar to that of the DIP section. Formal calculations for estimating allowable pressure or remaining useful life are not readily available for AC pipe but there are further options for analysis of the pipe.
