JOB REPORT

REHABILITATION IN A RESIDENTIAL AREA IN COLORADO SPRINGS

Rehabilitation of 535 linear feet of potable water transmission pipe under Lanagan Street between houses

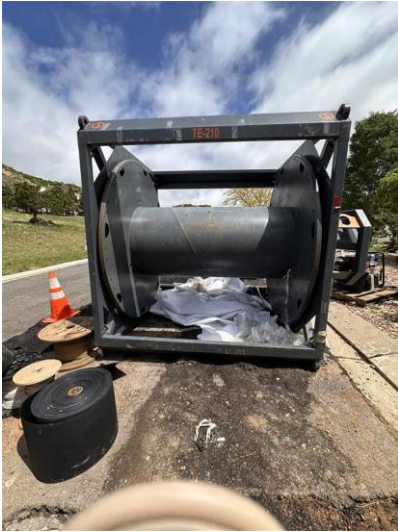
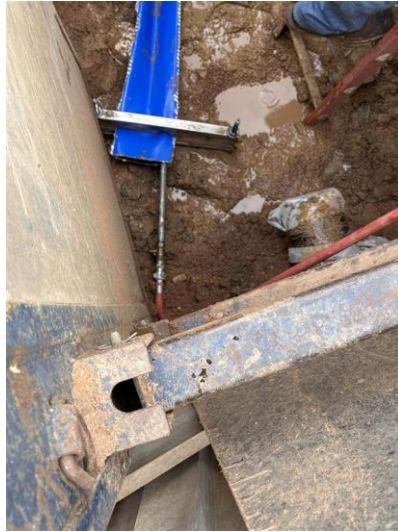
Material of Host Pipe:	Ductile iron with cement lining
Transported Fluid:	Potable water
Diameter of Host Pipe:	9.05" OD / 8.265" ID
Operating Pressure:	177 PSI
Primus Line® System:	MD DN200 / 8" - W
Total Length:	535 LF
Number of Sections:	1
Installation Time:	2 days
