Manhole Inspection and Rehabilitation

MANHOLE ENCAPSULATION SYSTEM HELPS ELIMINATE COMBINED SEWER OVERFLOWS

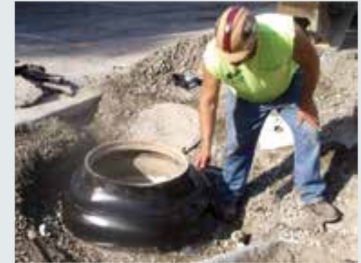
PROBLEM / In the rural area of Honesdale Borough, Pennsylvania, locals like to spend their time enjoying activities such as fishing, rafting and biking. As bicyclists pedaled around town, it became harder for them to overlook the increased cracking of the pavement above their manhole structures. The problem was several combined sewer overflows. The structures were receiving excessive inflow and infiltration, resulting in hydraulic overload conditions that needed to be addressed.

SOLUTION / The Central Wayne Regional Authority enlisted the assistance of Entech Engineering, which recommended the use of WrapidSeal Manhole Encapsulation System from CCI Pipeline Systems. “Entech has been using WrapidSeal on projects for over 12 years simply because it works,” says Bryon Killian, P.E., LO. “Starting in this industry 16 years ago, I personally conducted thousands of manhole inspections and found the manhole riser rings and joint sections were almost always the primary cause of infiltration. In addition to helping prevent I&I, we also use WrapidSeal to ensure pavement life by preventing fines being washed away with infiltration, causing pavement cracking around manhole structures.”

RESULT / Once these structures were repaired and protected with WrapidSeal, the amount of I&I causing the hydraulic overload conditions during wet weather was significantly reduced, accounting for the elimination of 13 CSOs over the last decade. 800-867-2772; www.ccipipe.com.
