# Concrete box culvert repair with polyurethane grouts

**Client:** National Cemetery Administration

**Design Consulting Engineer:** URS Group Inc.

**Grout Contractor:** Applied Foam Technologies (now Applied Polymerics)

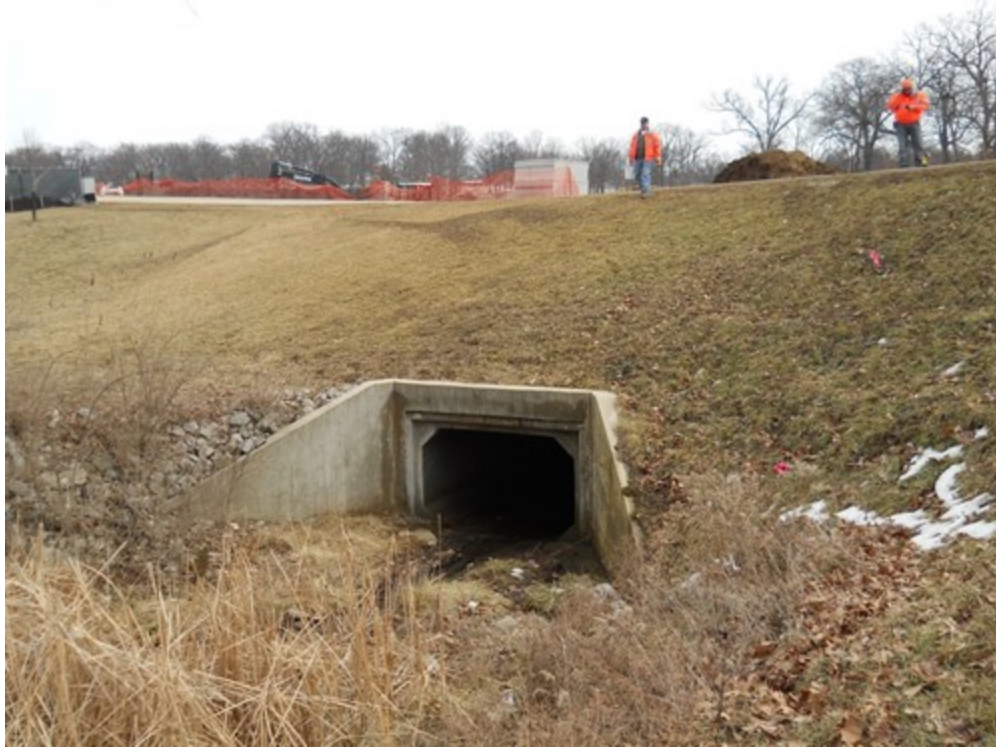
**Situation:** Jefferson Barracks National Cemetery, just south of St. Louis, is one of the nation's largest military burial sites. Established shortly after the Civil War, it covers 331 acres (134 hectares) and 188,000 graves. The cemetery sits on the banks of the Mississippi River, and a planned expansion in 2011 revealed that box culverts running alongside the expansion area were experiencing significant groundwater infiltration.

URS Group concluded that more than 100 joints would require repair in the 10' wide x 5' tall and 8' wide x 5' tall culverts. Some of the joints had opened as much as 3 inches, causing the rubber water stop to fall out of the joints.

**Solution:** Applied Foam Technologies was contracted to do chemical grouting to seal the leaks and restore the culverts. Given the wide gaps, the activated oakum technique was used: dry oakum was soaked in **Hydro Gel SX**, then packed into the gaps. Hydro Gel SX is a hydrophilic polyurethane resin that forms a structural foam or flexible gel—depending on

resin to water ratio—when activated with water. This was followed by injection of Prime Flex **900 XLV**, an extremely low viscosity, hydrophilic polyurethane resin. Repaired leaks were then sealed with **Prime Gel 2200** epoxy gel.

**Outcome:** More than 100 joints were ultimately repaired and fully sealed. No residual leaks remained. The total material used included: 720 gallons of Prime Flex 900 XLV, 540 gallons of Hydro Gel SX, 14 – 50# boxes of oakum and 60 gallons of Prime Gel 2200.

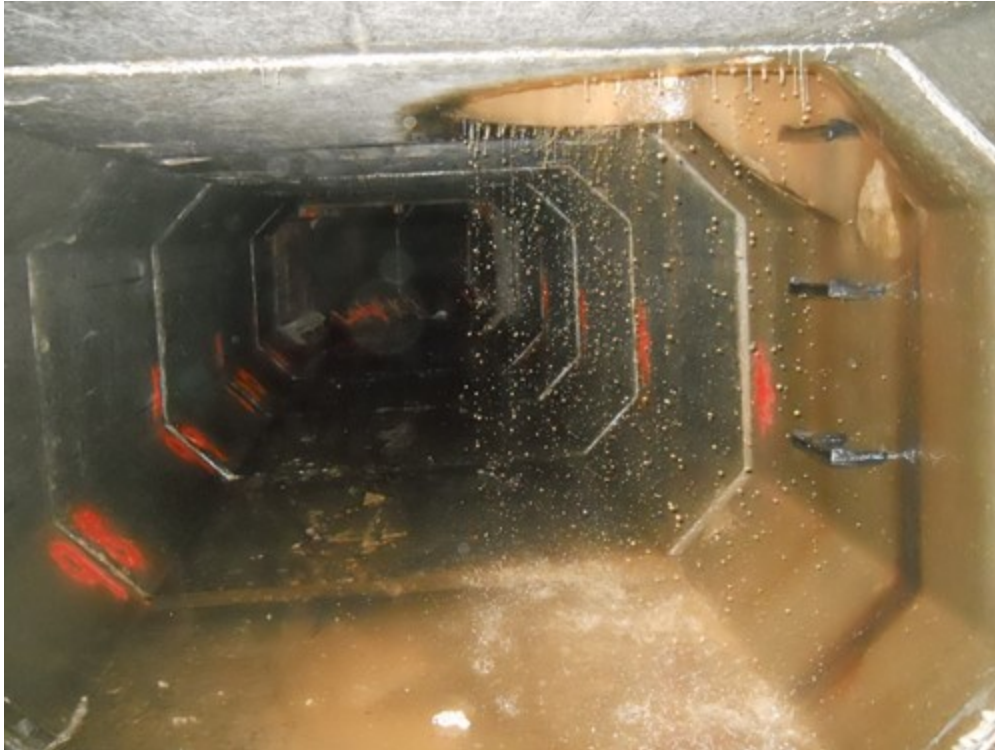
*Leaking manholes add to the groundwater infiltration*

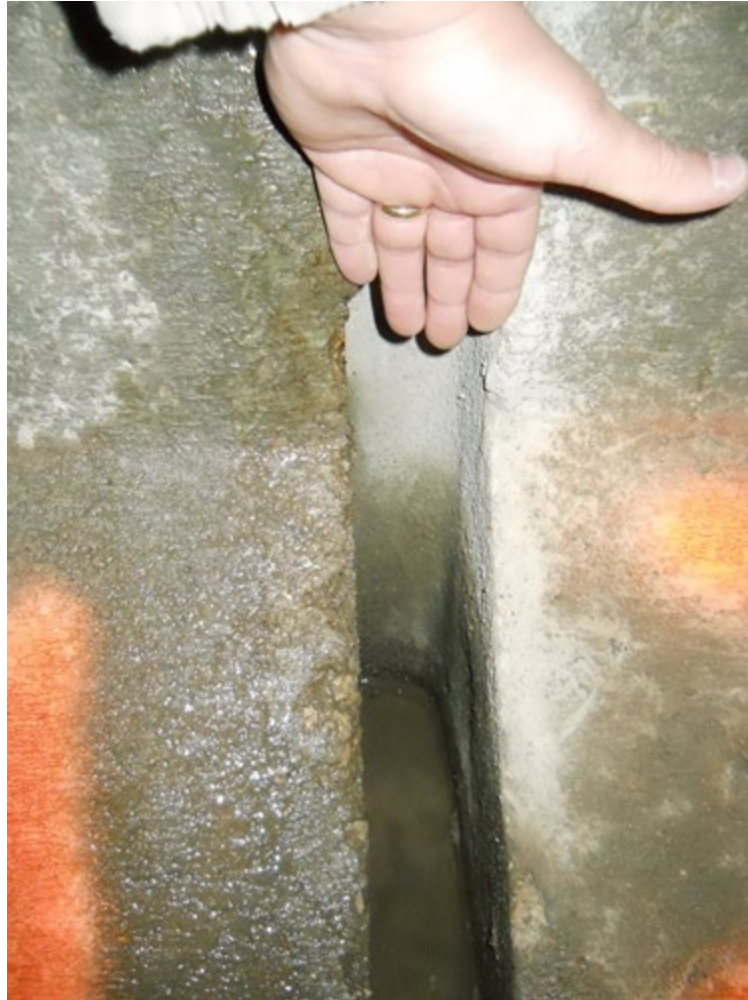
*Some culvert joints were open as much as three inches.*

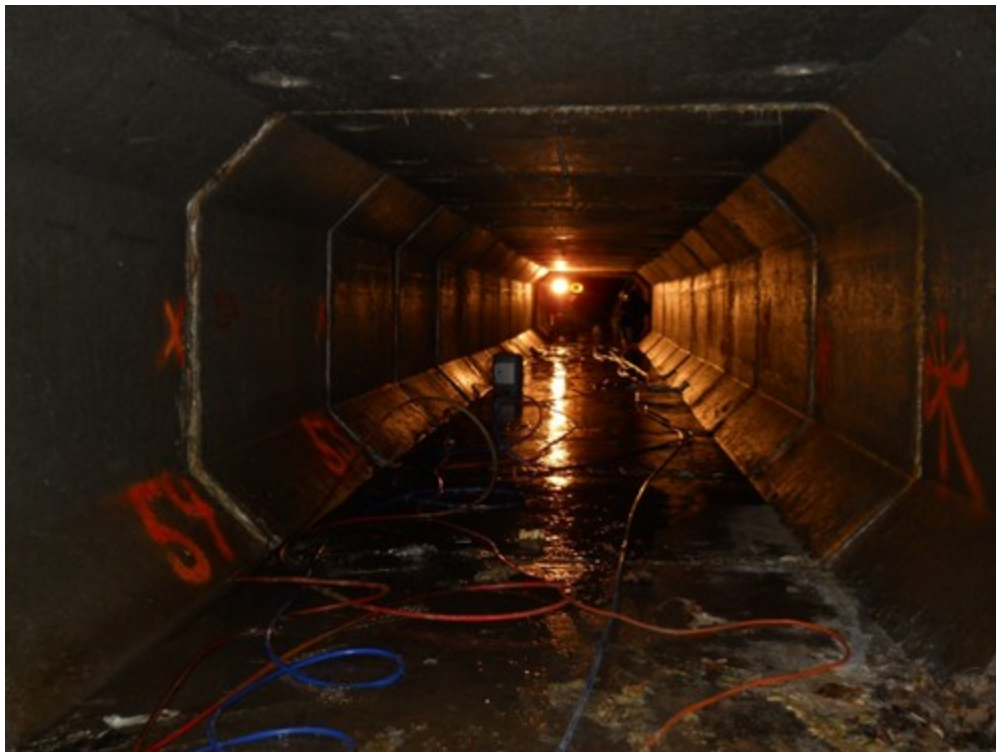
**Challenges:** Limited access was the biggest challenge. All the material, equipment and personnel could only reach the work site through a small number of manholes or the ends of the culvert. Cold weather conditions provided an additional challenge.

*Limited access through culvert ends and few manholes was a challenge.*

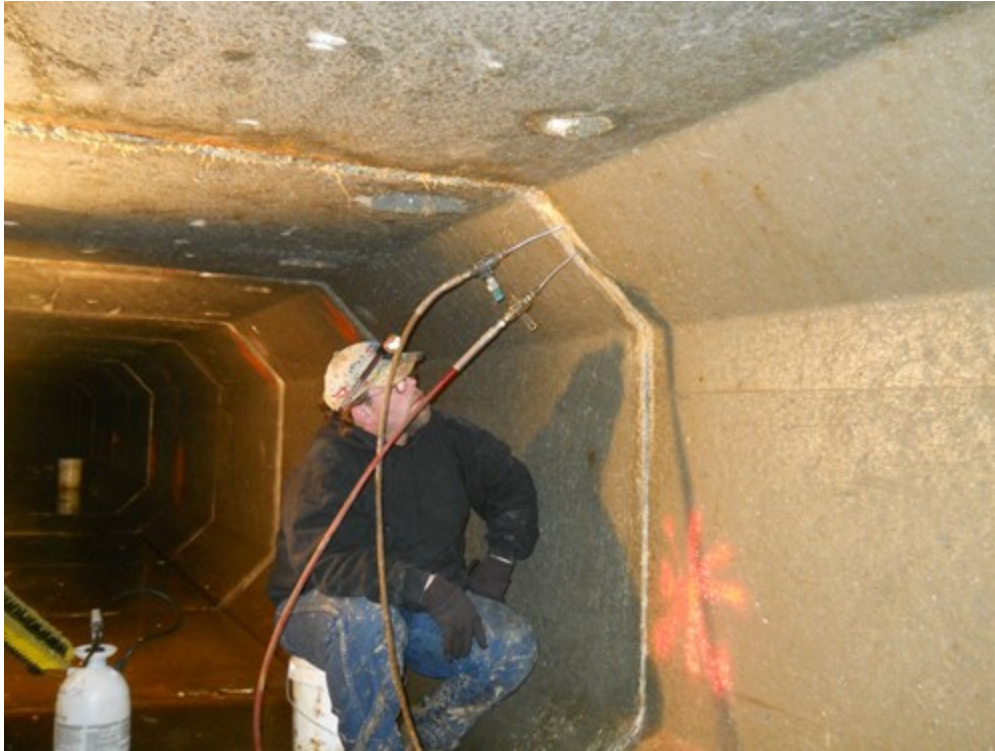
*Prime Flex 900XLV is twin streamed with water to seal culvert leaks*
