Gushing leaks in sliplined pipes - 920

Contractor:Precision Chemical Grout, Demopolis, AL

Client:Gadsden (Ala.) Water Works and Sewer Board

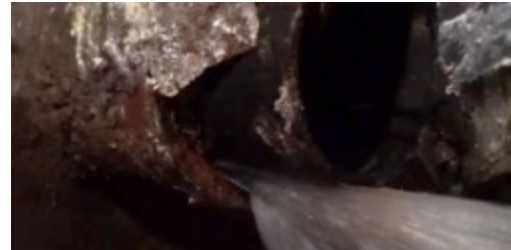
PROBLEM:Ken Kane and his company, Precision Chemical Grout, were recently called upon by the Gadsden Water Works and Sewer Board in Alabama to address a water infiltration issue. The municipality had installed PVC slipline pipes of various sizes (30-inch PVC slipline inside of 36-inch host pipe, 20-inch PVC slipline inside of 24-inch RCP host pipe, and 12-inch PVC slipline inside of 15-inch RCP host pipe, respectively). The PVC pipes were installed to stop infiltration of river and groundwater.

The space between the slipline and host pipes had active leaks that, according to the municipality's flow monitoring, were contributing an additional 3.5 million gallons per day (MGD) to their wastewater stream. To put that into perspective, that's more than **enough water to fill five Olympic-sized swimming pools.**

SOLUTION:The repair was completed in six days using chemical grout from Prime Resins to seal the annular spaces in the seven slipline sections. The project required roughly 100 gallons of **Prime Flex 920** (which meets NSF/ANSI Standard 61 for contact with potable water.) After some trial and error on the first section, the method was perfected and subsequent sections were completed in a fraction of the time with less material. **“This particular project was an engineer's worst nightmare to develop a permanent solution to stop the leaks at the manhole connections,”** said Gadsden Water and Sewer engineer Brian A. Purcell. “With the help from Prime Resins and the team at Precision Chemical Grout, the infiltration was eliminated, which resulted in substantial cost savings at our sewer treatment plant.”

HOW THEY DID IT:To inject the polyurethane resin, Precision Chemical Grout used 10-foot sections of 1/2-inch PVC pipe as a probe connected to an F-valve. This allowed for standing in the invert and pushing pipe 10 feet up into the annular space, typically installing two PVC pipes for each of the leaking pipes sealed—one at 4 o'clock and one at 8 o'clock to ensure grout would fully fill the annular space between the slipline and host pipe — packing open space with towels or sandbags to contain the resulting foam.
