MANHOLE RESTORATION PROGRAM

18-YEAR INSPECTION REVEALS PROVEN RESULTS FOR MANHOLE REHAB WITH WARREN'S EPOXY COATINGS

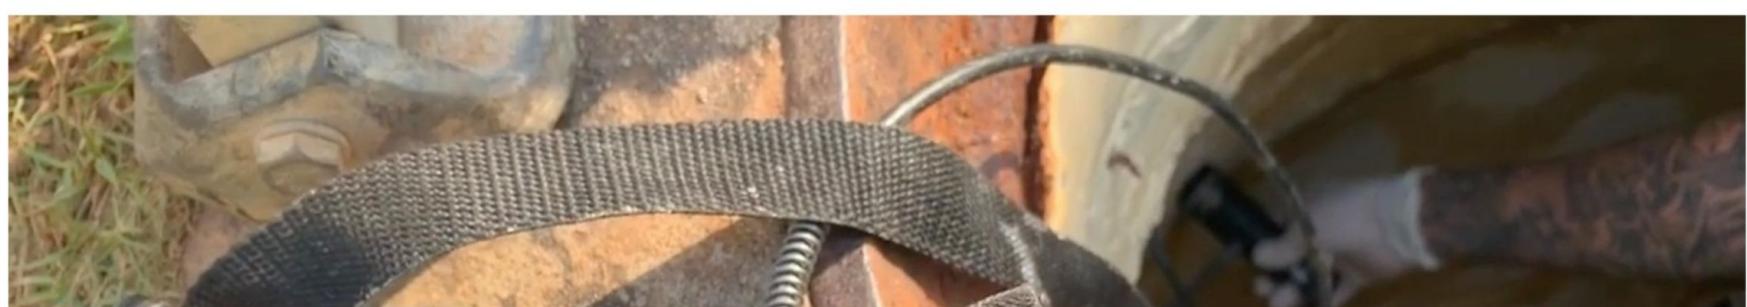
PHOTOS

A handful of the first manholes coated were inspected 18 years later, in September of 2019. The results were tremendous. Warren's epoxy coating was found to be in excellent condition. The pull tests provided results of 910 psi with the test glue (between the dollie and the epoxy) failing instead of the coating. This implies that the epoxy and the substrate were bonded higher than the force that caused the glue failure.
