Dam Spillway Leak Sealed

Case Study: Dam Spillway Leak Sealed After Multiple Failed Repairs

Background: Persistent Cold Joint Leak

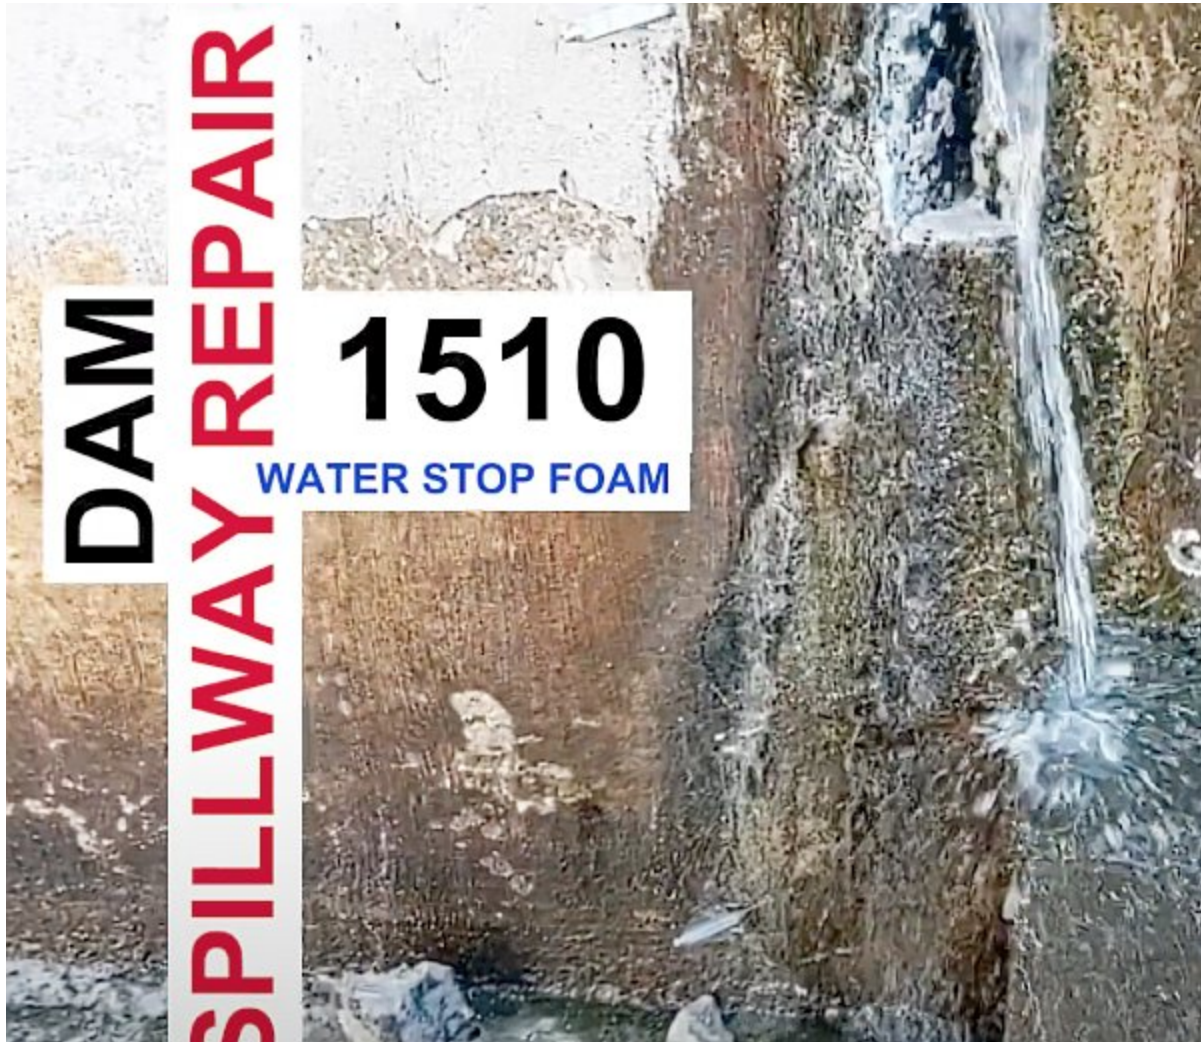
A spillway serves a critical function in dam systems. Either incorporated into the dam's structure or built adjacent to it, a spillway facilitates the controlled and secure discharge of surplus water downstream.
