Wet Wells

Exfiltration prevention and wet well rehabilitation 750 feet underground

Rehabilitation of wet wells serving restrooms 750 feet underground in caverns

National Park Service, Carlsbad Caverns,
New Mexico

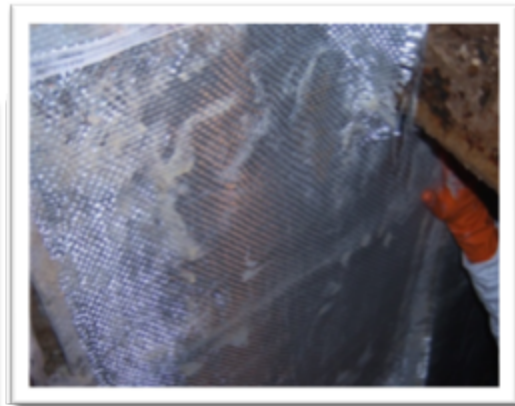
Upper Right: Panels cut to the exact length of the walls with sloped angle at the bottom are hung.

To prevent the likelihood of exfiltration into the cavern areas, the NPS chose to structurally line the wet wells with the Poly-Triplex Liner System. The Poly-Triplex system has a non-porous membrane that is laminated between fiberglass layers. The liner is cured in place and comes with a 10-year warranty. The non-porous membrane would permanently eliminate any

exfiltration into the surround areas. Installed in panels and cured with an inflation canister and inflation bladder from the adjacent room above, the liner was cured in place at 110 degrees overnight, resulting in a monolithic and non-porous liner, tying together the walls and floor section of the structure.

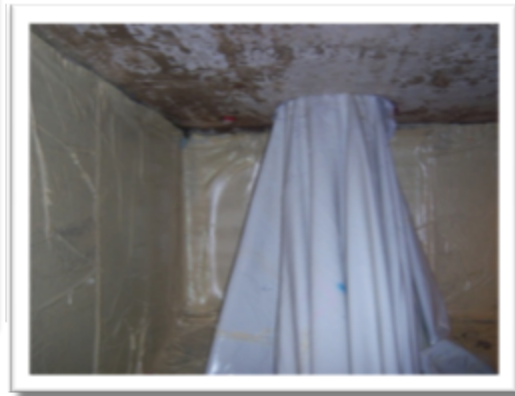
Lower Right: Photo of the walls lined with the Poly-Triplex Liner System and the inflation bladder, prior to removal.
