Environmental – Case Study 1

Severe infiltration in overflow pipe – lake losing water

Rehabilitation of stormwater overflow manhole (located in middle of lake in golf course community)

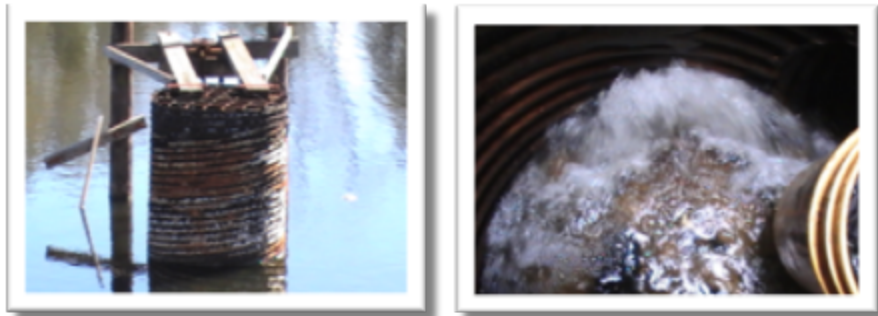
Tens of thousands of gallons of water per day were infiltrating into the structure primarily from the bottom of the lake. The infiltrating water was boiling in through the bottom and was being discharged into a ravine at the end of the storm drain pipe, steadily reducing the level of the lake.

Upper Left: Lake lowered approximately 5 feet lower than normal.

Upper Right: Lake water boiling into the structure.

The Poly-Triplex Liner System was chosen to structurally line the entire manhole structure. The liner was made considerable thicker in the bottom and floor section of the structure. Once installed, the liner is bonded to the host structure and has stopped all infiltration of lake

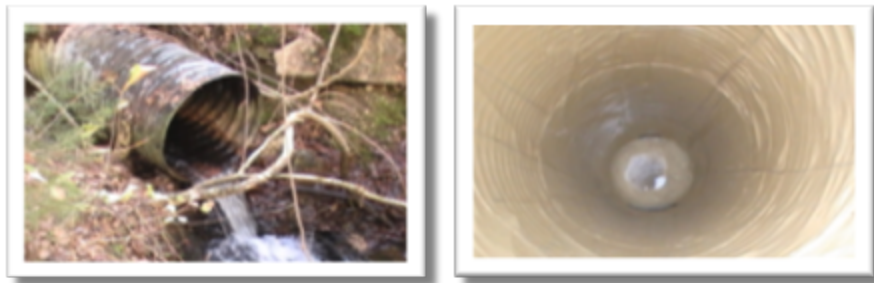
Upper Left: Lake water being discharged through overflow pipe.

Upper Right: Overflow pipe structurally lined and all infiltration stopped.
