# Culverts – Case Study 1

Rehabilitation of double culvert pipe

City of Sylvester, Georgia

24" x 72' double culvert in Sylvester, Georgia

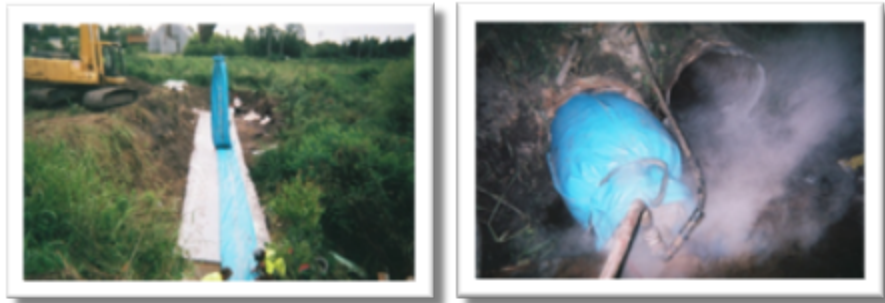
**Upper Left:** Liner is saturated and enclosed within a reinforced vinyl tube, lifted with a crane and pulled into place with a winch on the opposite end of the pipe.

**Upper Right:** Liner is inflated and cured-in-place with air pressure and steam heat injection.

The Poly-Triplex Certified Installer diverted the flow through one of the pipes and cleaned and prepared the structure and the liner. With a crane and winch, the liner was pulled through the structure. Liner was then cured-in-place using air pressure and steam heat.

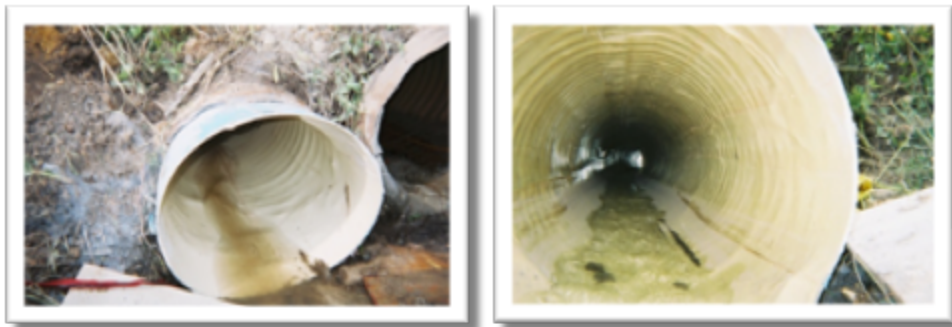
**Upper Left:** Installation of the liner is complete. Flow has been diverted from the unlined pipe to the lined pipe and the first culvert has been returned to full service.

**Upper Right:** Lining process has been duplicated on the second structure, with both installations combined taking less than 12 hours to complete.

Inflation bladder was removed to expose a structural and monolithic liner from end to end, extending approximately 12" beyond both ends of the existing culvert, then flow was diverted back into the lined pipe. The process was then repeated on the second pipe.
