GeoSpray® HCE proves its worth

Application: Interceptor Sewer Rehabilitation

Client: Lucas County (Ohio) Sanitary Engineer

Location: Holland, Ohio

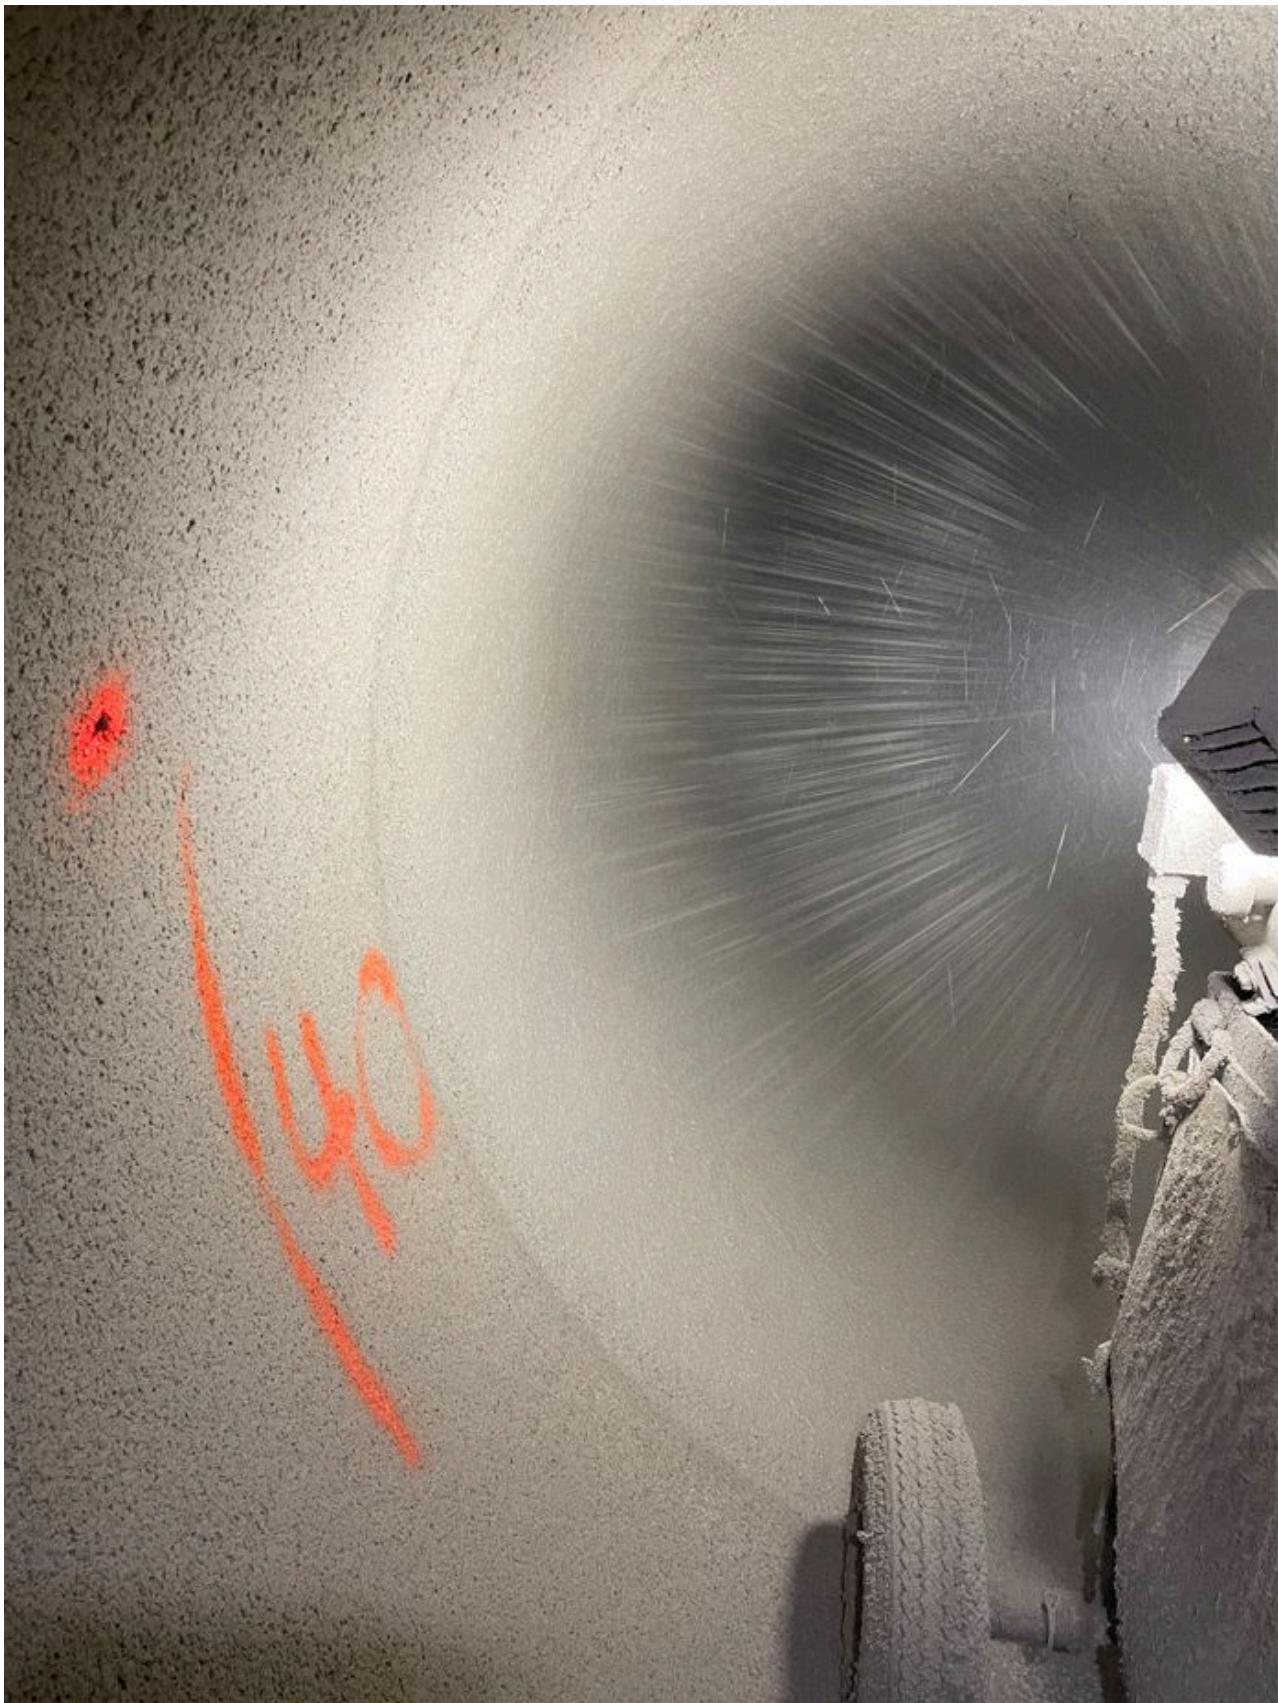
GeoSpray HCE installation via centrifugal force

The eight-man team accessed the sewer via manholes and used the spin cast method to clean the heavy sediment build-up and carry out the lining install. The applicator skid used to spray the mortar was erected inside the sewer. They also had to be aware and mindful of rainfall which resulted in heavy infiltration of water leaking into the sewer. This shut down the install on several occasions.

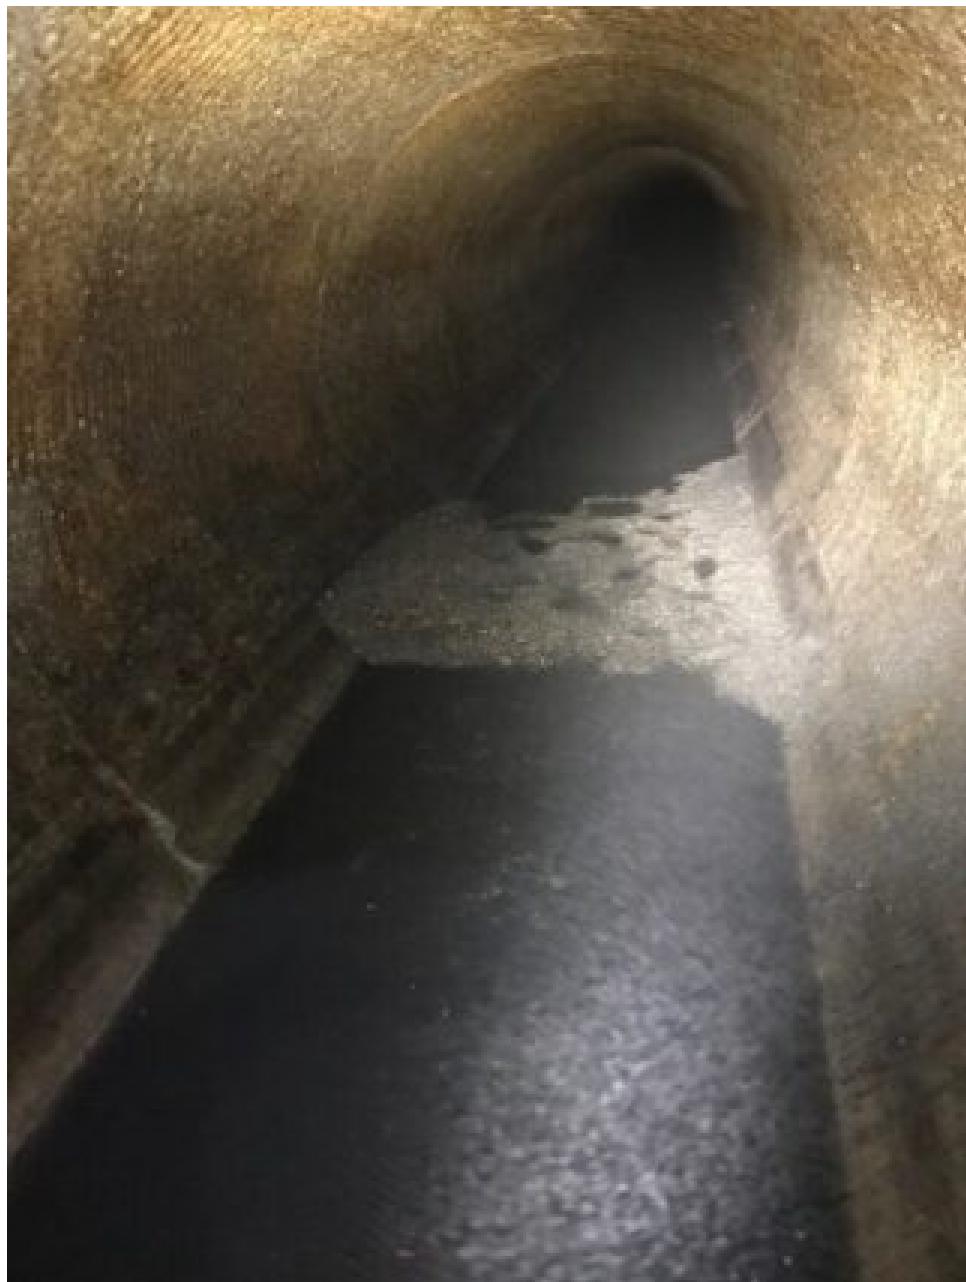
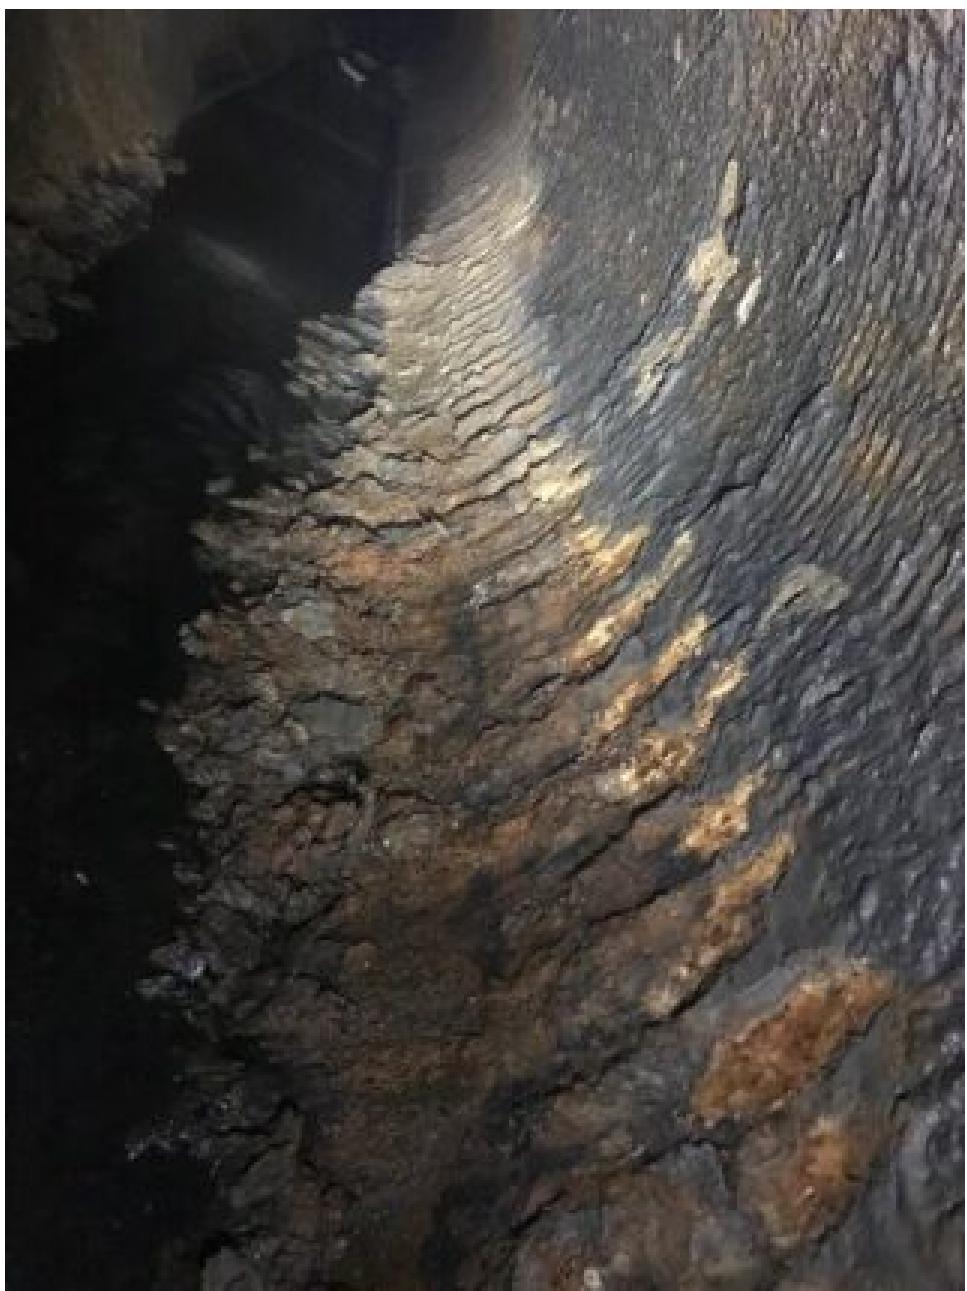
GeoSpray HCE Installation - Before and After

Before: Sewer showing signs of deterioration of existing concrete and heavy scale and sediment build up.
