# How North Olmsted, OH is Rehabilitating Its Wastewater Infrastructure

In the western suburbs of Cleveland lies North Olmsted, a bustling community of around 32,000. The city's infrastructure, including the North Olmsted Wastewater Treatment Plant (NOWWTP), was built in the 1950s and is starting to show signs of deterioration. One of the people leading the charge on rehabilitation projects is Greg Peters.

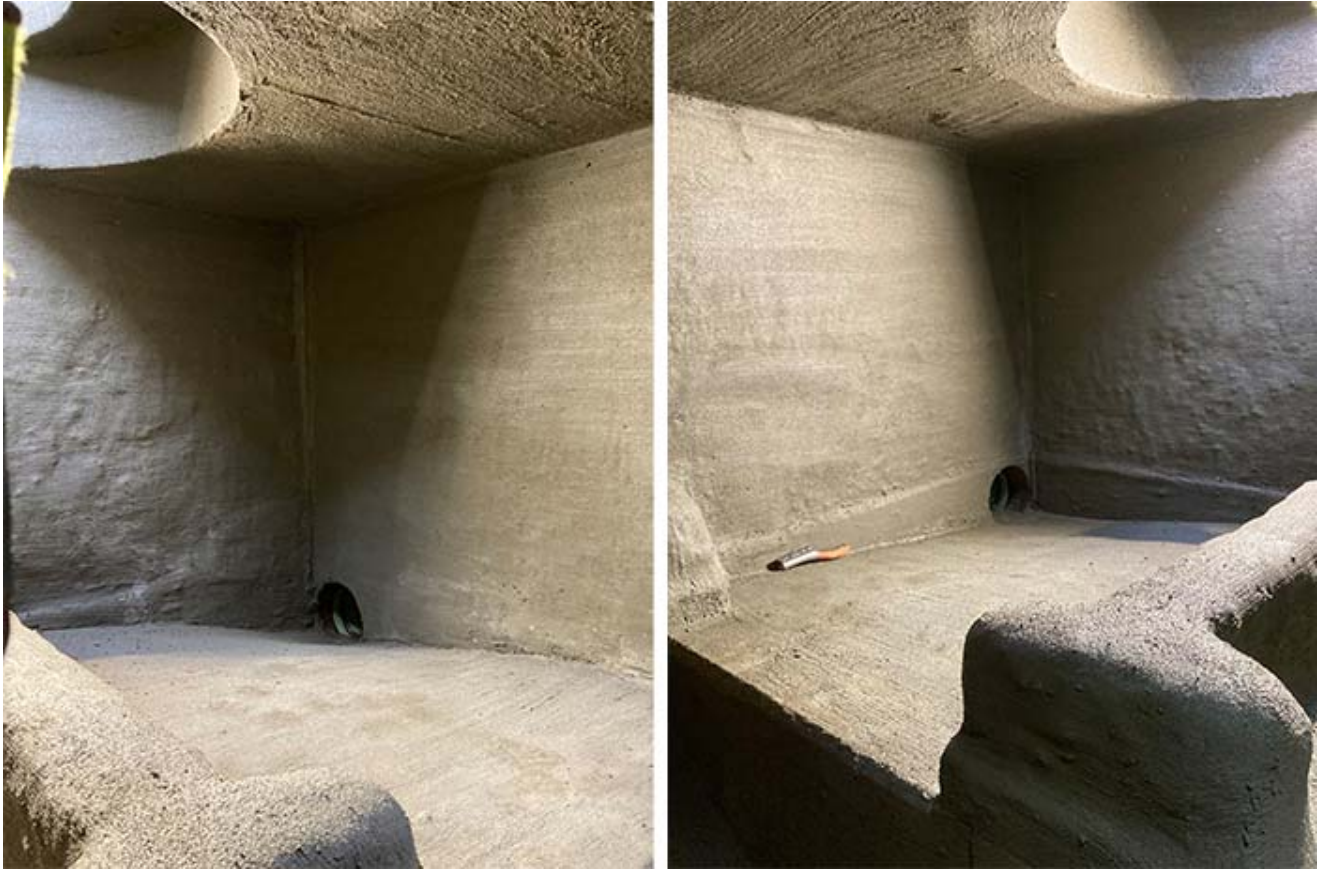
Step one was to create a base layer of Hyperform. Hyperform is a rapid-setting patching material designed for repairing vertical and horizontal concrete structures. Two layers were applied—the first to fill in the damaged areas and the second to create a smooth base for the next product.

### *Two coats of Hyperform*

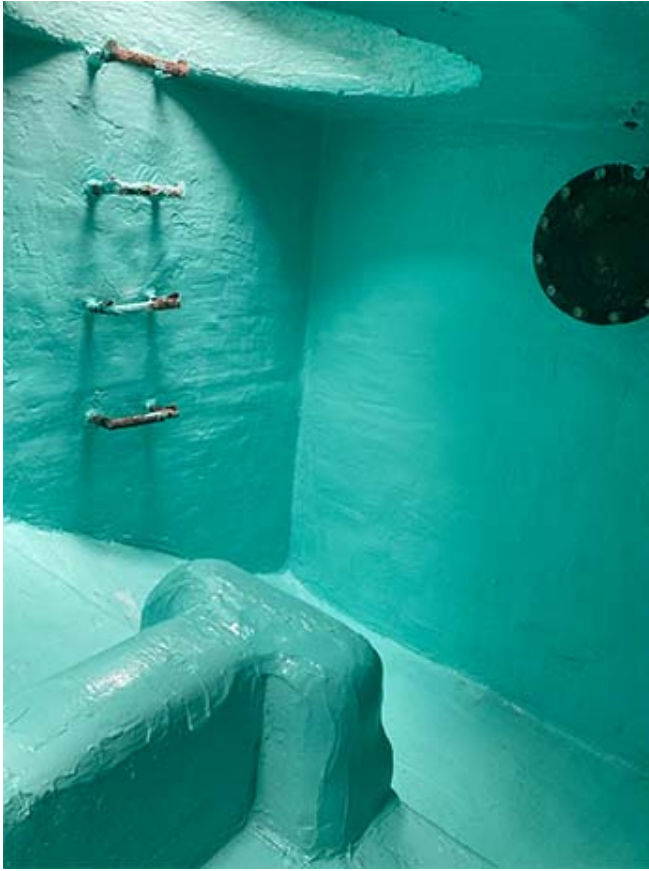
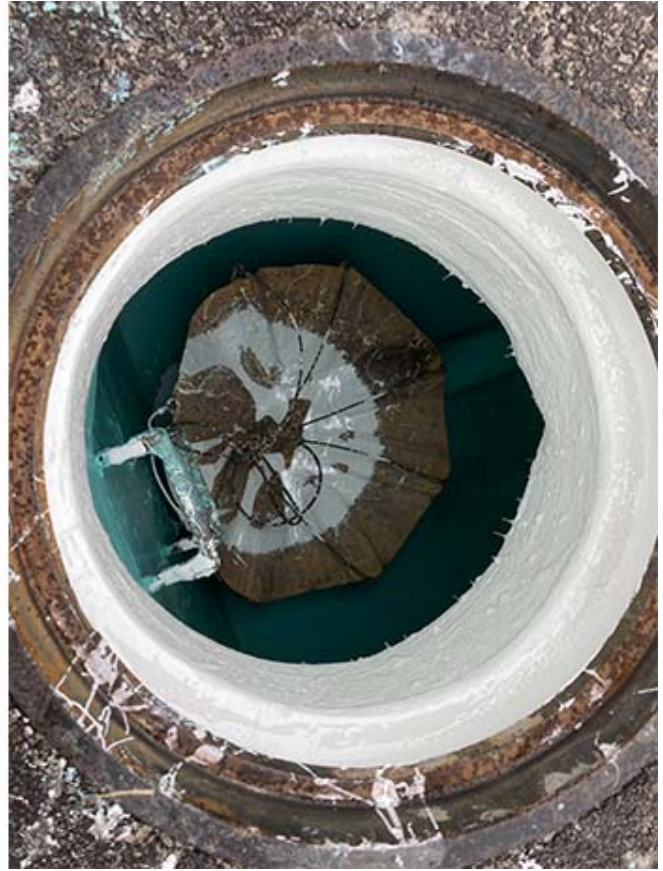
This particular splitter box has two manhole access points, so the team applied Chimney Guard at both openings. Applying Chimney Guard is a one-step process; it's designed to provide a highly flexible and securely bonded seal prepared to address heavy traffic loading and infiltration.

### *Hyperform and Chimney Guard*

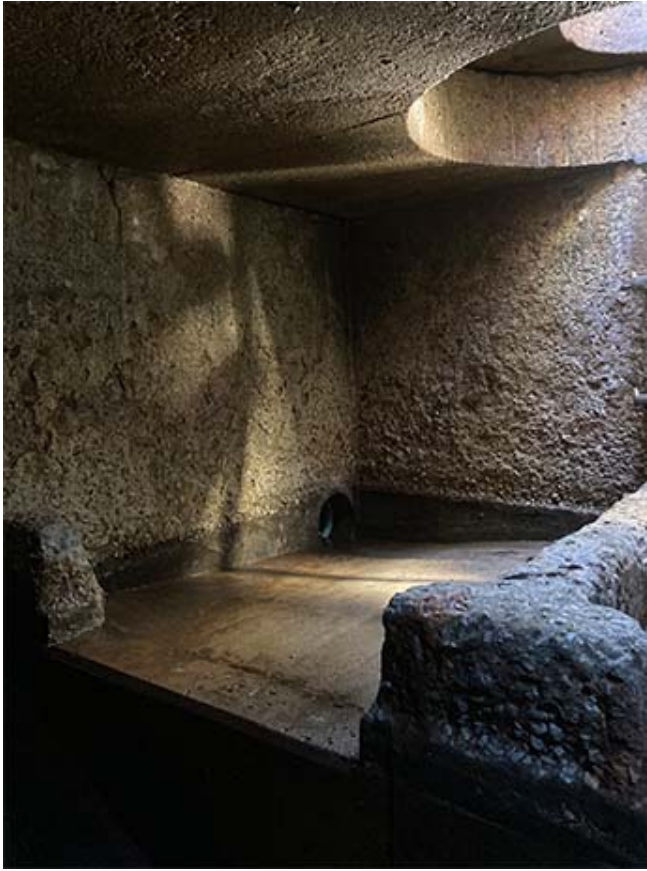
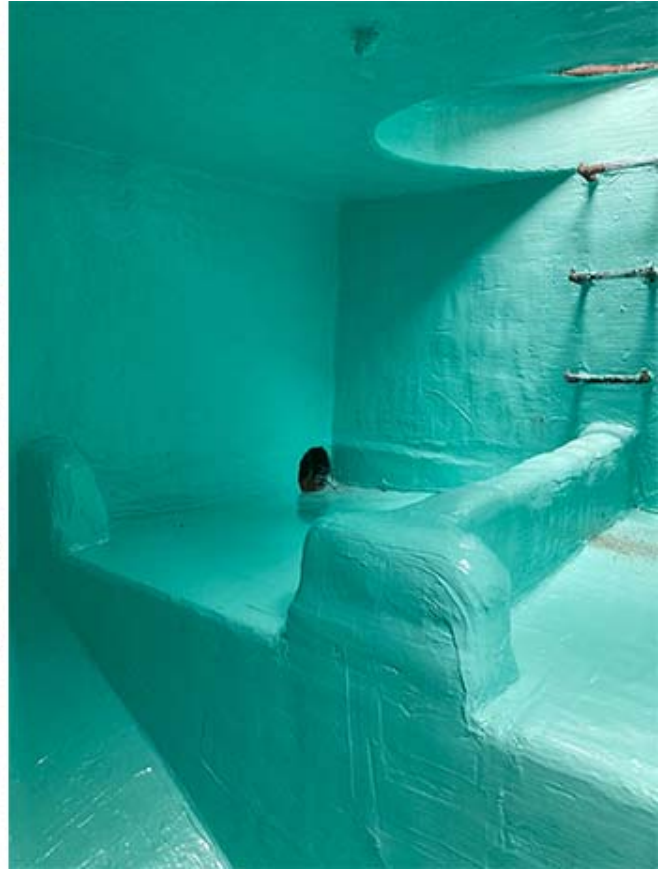
Peters and his crew recently rehabbed a splitter box at the city's wastewater treatment plant. There was heavy pitting and other corrosion throughout the chamber that was likely caused by hydrogen sulfide. While the splitter box was still fully functional, Peters and his team agreed that it needed some help. They turned to Source One to provide the [Quadex products](#) used in this project.

*Before & After*

When Peters works on a project, he makes sure it's done right the first time. "We replaced all [the] ductile iron pipe with PVC," he says. "We kind of went above and beyond because it was all rotted too."
